# Service Bulletin

Bulletin No.: 22-NA-173

**Subject:** Information on Transmission Fluid Leak

Brand:	Model:	Model Year:		VIN:		Engine:	Transmission:
		from	to	from	to		
Chevrolet	Corvette	2020	2024	—	—	All	All

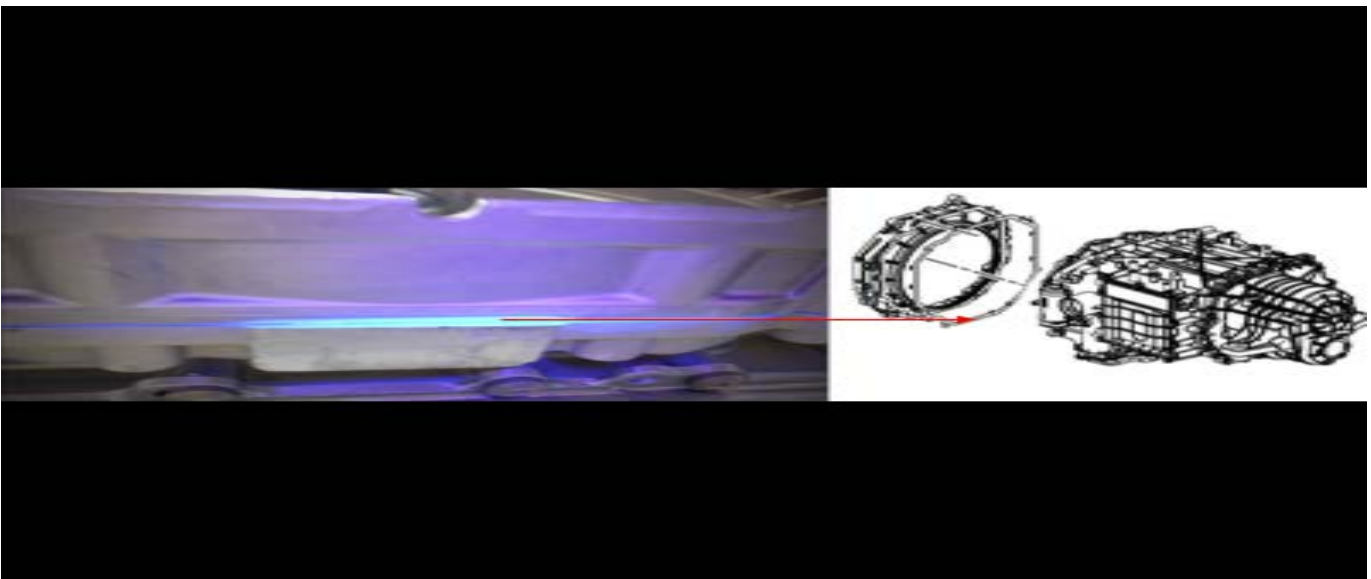
6142966

Leaks at the gasket area between the clutch and differential cover and the main case. There is a gasket in this area.

This video above shows transmission case porosity, issue during testing.

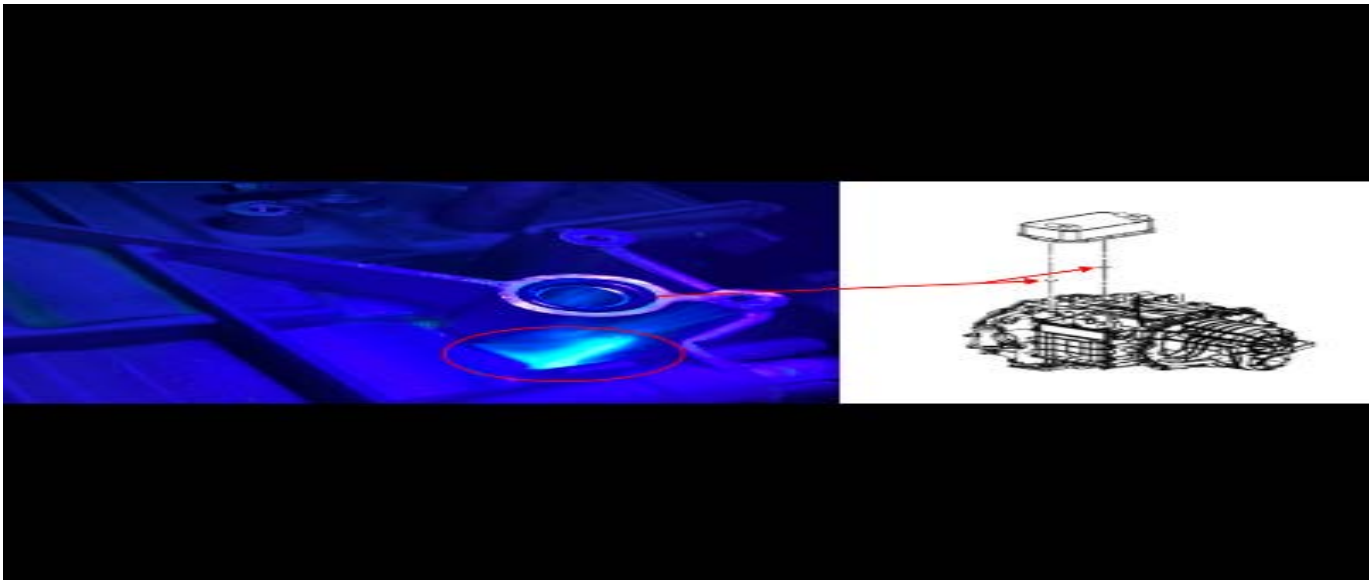
6142841

This is an area that is often mis-diagnosed as a transmission cooler issue. It was found that in most cases, leaks in this area are caused by transmission case porosity under the transmission cooler. Proper diagnosis in this area would be to inspect the cooler for any signs of physical damage. If no damage is found, carefully remove the cooler, and inspect the two (14) O-rings for damage and proper sealing. The dye photo shows a puddle of oil just under the cooler sealing area in the pocket, the fluid is being pushed through the case due to material porosity. This concern will require transmission assembly replacement.

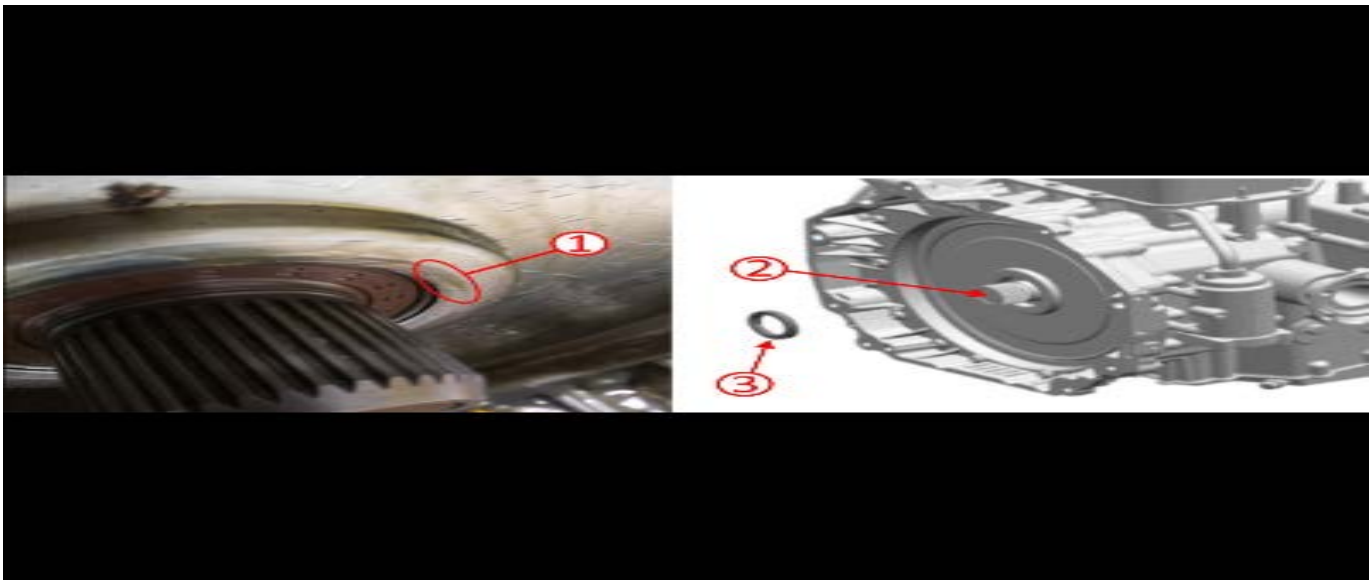
6142814

A small crack in the clutch cover area (1) of the input shaft seal can be mis-diagnosed as an input shaft seal leak (3). Additional cases have been verified at the input shaft end plug/seal (2), was damaged during transmission to engine mating.

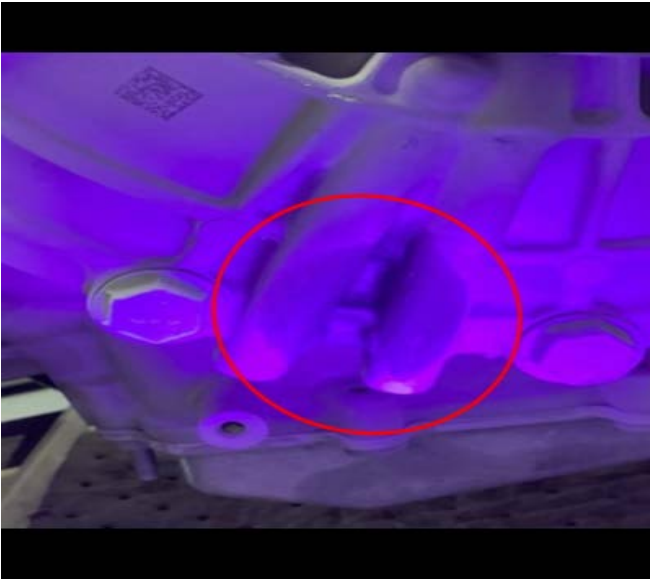
6142818

Porosity concerns with the differential cover. This area needs to be carefully powder tested to verify the leak is not associated with the cover seal (16) or the dog-bones and seals. Technicians have stated that they have found the cover double-gasketed when they confused the metal differential shims with what they thought were gaskets. All shims need to be re-installed to retain proper bearing load on differential. If porosity is found in the cover, the transmission will require replacement.

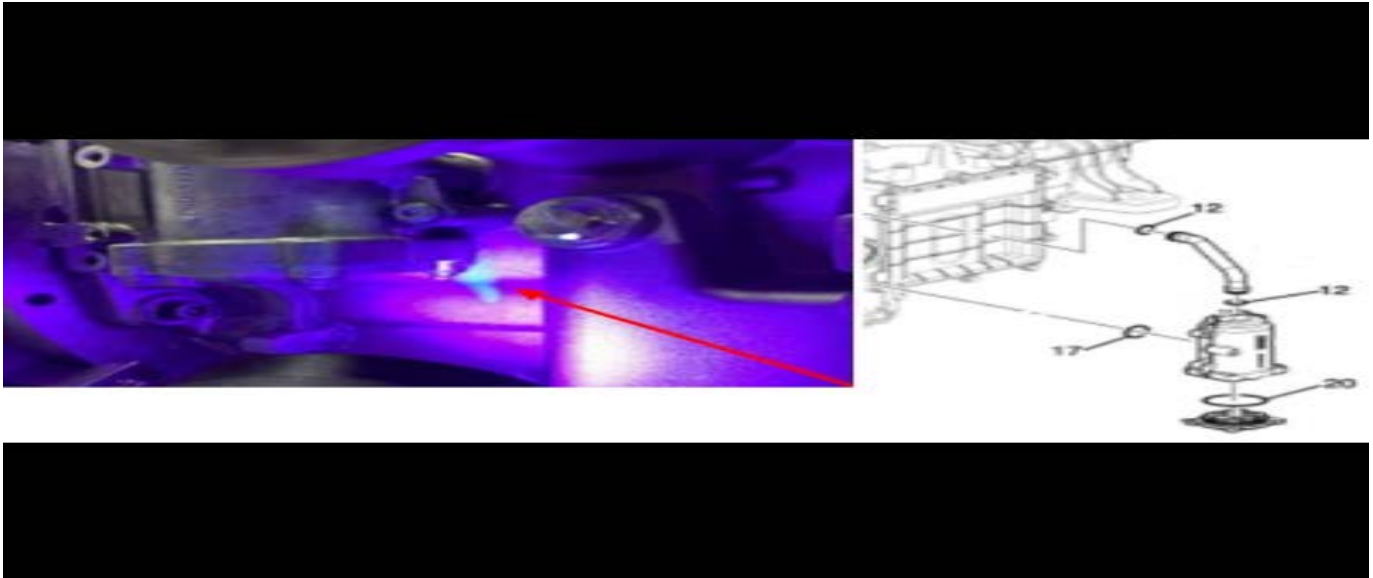
6142744

The auxiliary canister filter can create leaks in several areas. The most common area is cover seal (20), O-ring installation issues after filter replacement. Other areas of concern can be found at the are O-rings (12) and (17).

**Note:** Inspect the cover prior to replacement of the seal for porosity issues in the O-ring groove area.

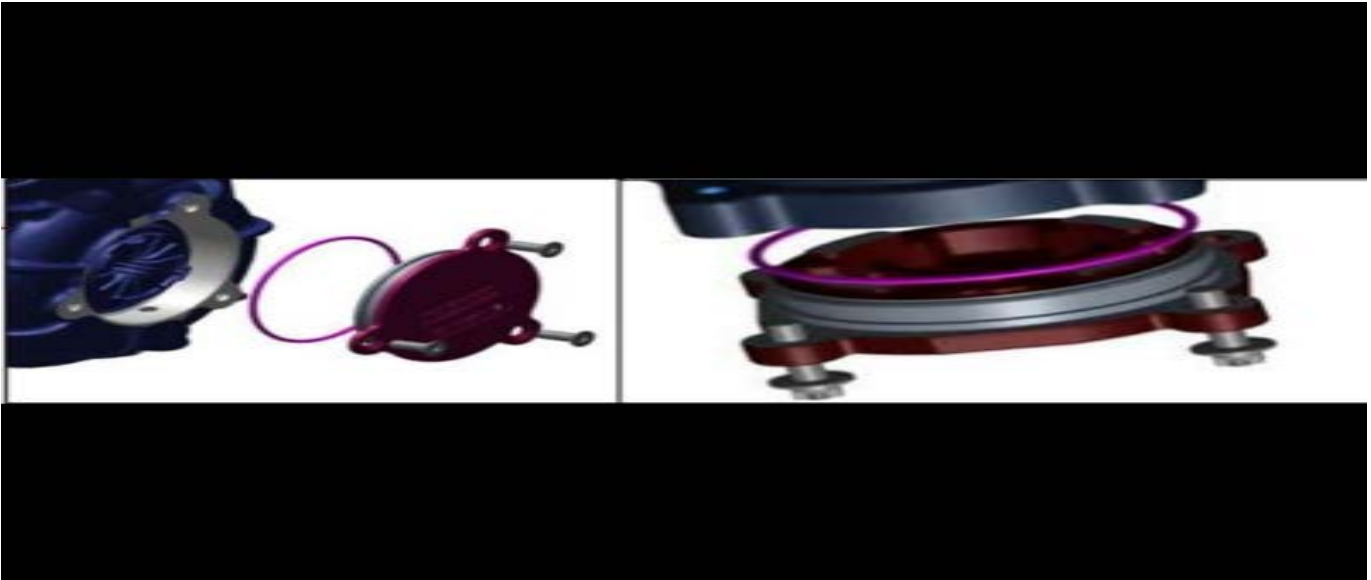
6456550

Transmission rear cover area leak. (Tremec name plate):

- If there seems to be a leak in this area, be sure to clean the area thoroughly. Residual oil can get trapped between the outer surface and the O-ring.
- After powder testing, if a leak re-occurs, remove the cover, and inspect the O-ring for damage.
- If no obvious damage is found with the O-ring, be sure to inspect the cover itself for porosity issues in the O-ring groove. It is critical to identify the difference between a leak and dampness.

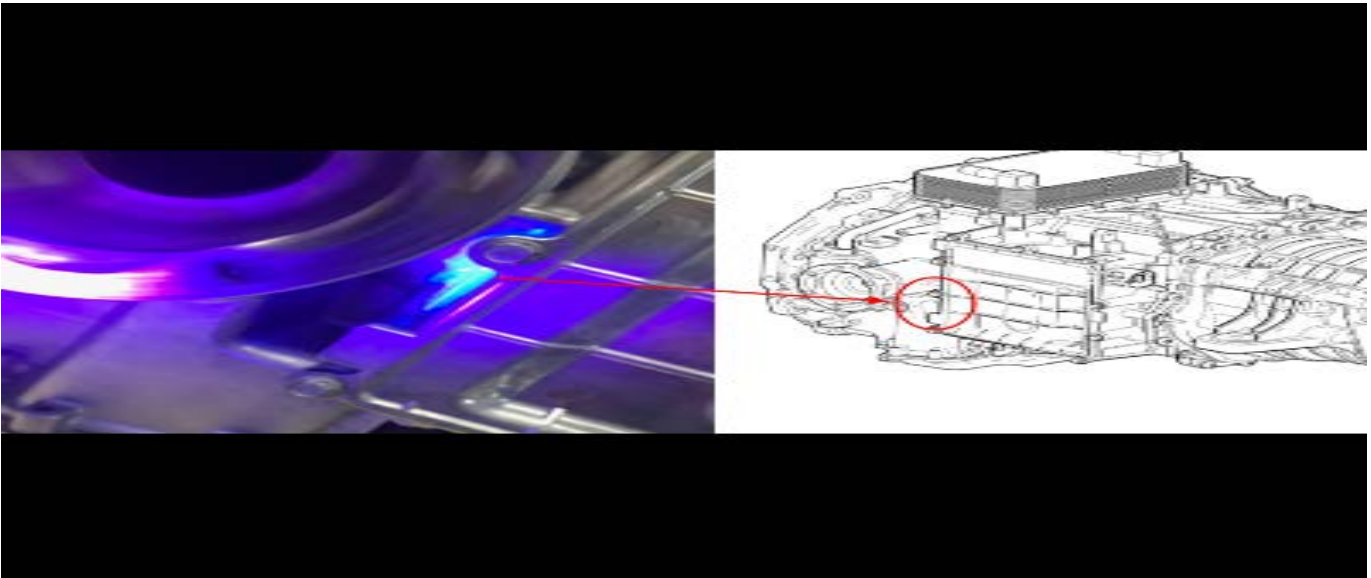
6142979

Transmission case porosity concerns have been found in the SAV cover area of the transmission. This is often the most misdiagnosed leak on this transmission. The fluid seeps through the case and runs down between the SAV cover and case to the pan rail, and often the transmission pan, and gasket get replaced, then the

SAV cover, and finally the transmission. Often these leaks will not develop by just allowing the engine to run. Usually, the vehicle will need to be lifted safely on a hoist with the wheels raised to allow the vehicle to run in gear. This action applies to most porosity leaks.
