Technical Service Bulletin

57J3 UPDATE

Door Seam Cavity Sealing – (NVLW)

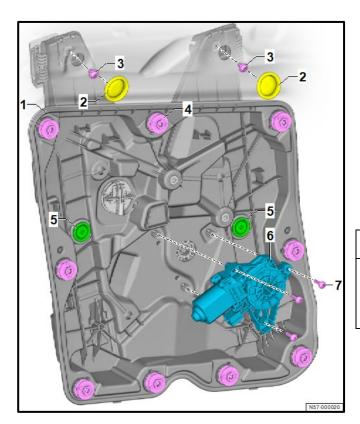
| This Update has been proactively released to prevent the following condition(s) from occurring in the vehicle: | | | |
|--|---|--|--|
| 01 | On Golf vehicles of a limited production period, there may be insufficient cavity sealing of the door seam area. This may cause corrosion of the doors over time. | | |

Apply cavity wax to the inside of all four doors at the lower seams in the area indicated <arrows>.

The cavity wax should be applied the length of the seams.
