Service Bulletin

Bulletin No.: 22-NA-173

Subject: Information on Transmission Fluid Leak

Brand:	Model:	Model Year:		VIN:		Engine:	Transmission:
		from	to	from	to		
Chevrolet	Corvette	2020	2024	—	—	All	All

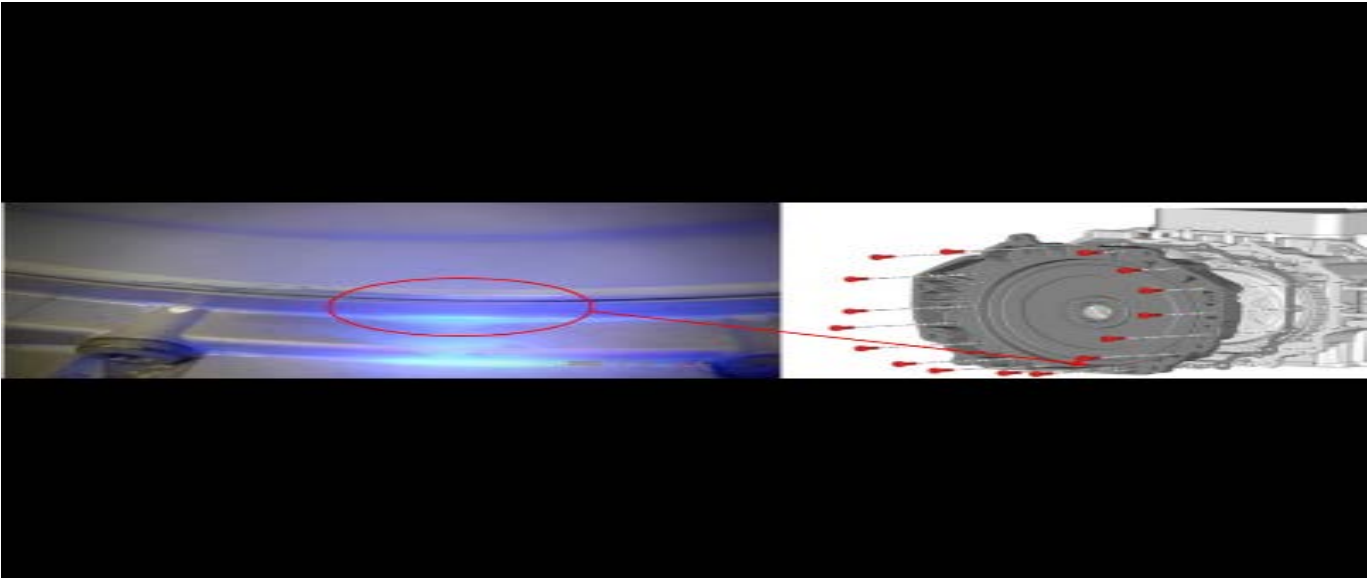
6142752

A leak between sealing plate and Bell Housing.

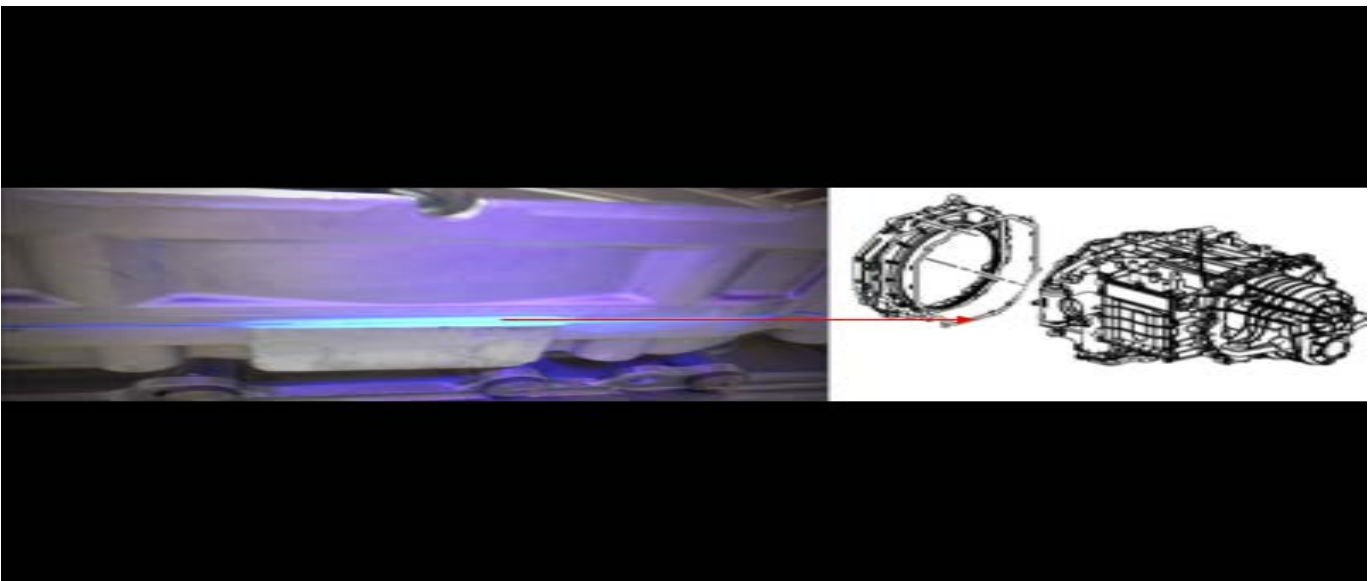
6142966

Leaks at the gasket area between the clutch and differential cover and the main case. There is a gasket in this area.

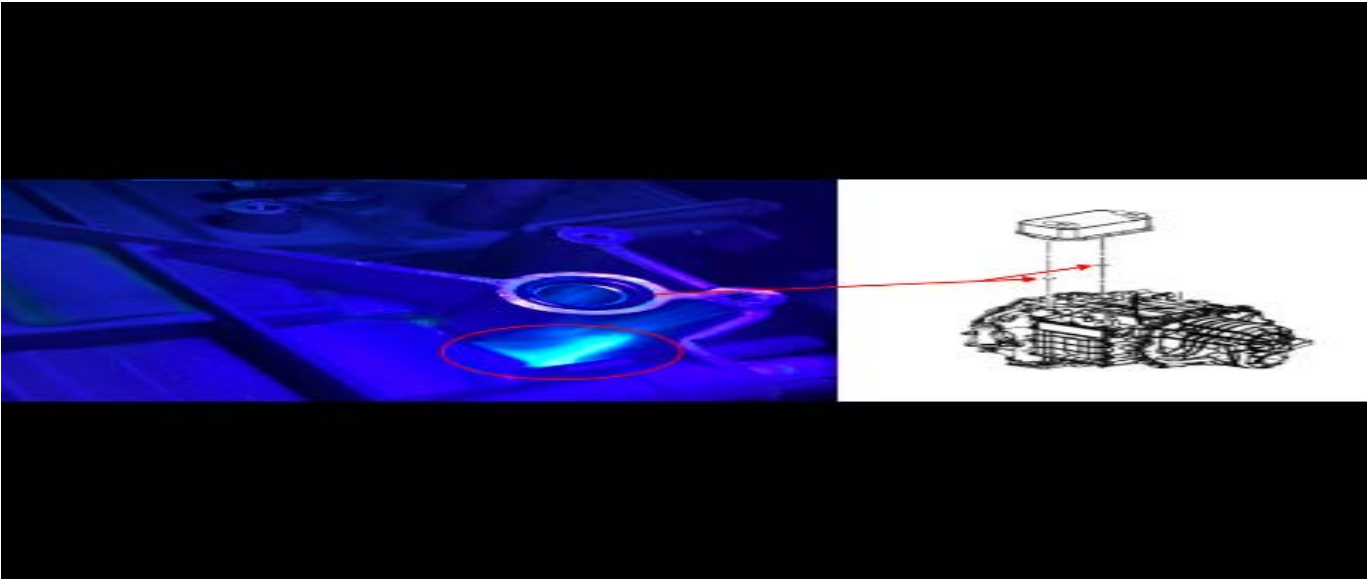
6142841

This is an area that is often mis-diagnosed as a transmission cooler issue. It was found that in most cases, leaks in this area are caused by transmission case porosity under the transmission cooler. Proper diagnosis in this area would be to inspect the cooler for any signs of physical damage. If no damage is found, carefully remove the cooler, and inspect the two (14) O-rings for damage and proper sealing. The dye photo shows a puddle of oil just under the cooler sealing area in the pocket, the fluid is being pushed through the case due to material porosity. This concern will require transmission assembly replacement.

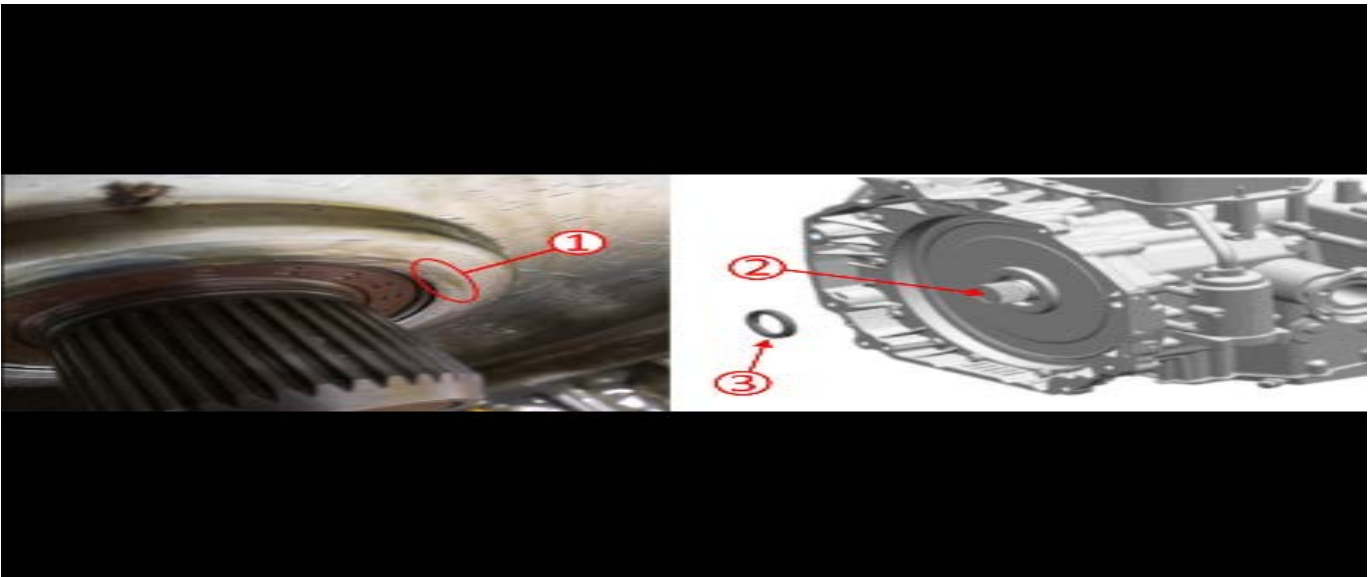
6142814

A small crack in the clutch cover area (1) of the input shaft seal can be mis-diagnosed as an input shaft seal leak (3). Additional cases have been verified at the input shaft end plug/seal (2), was damaged during transmission to engine mating.

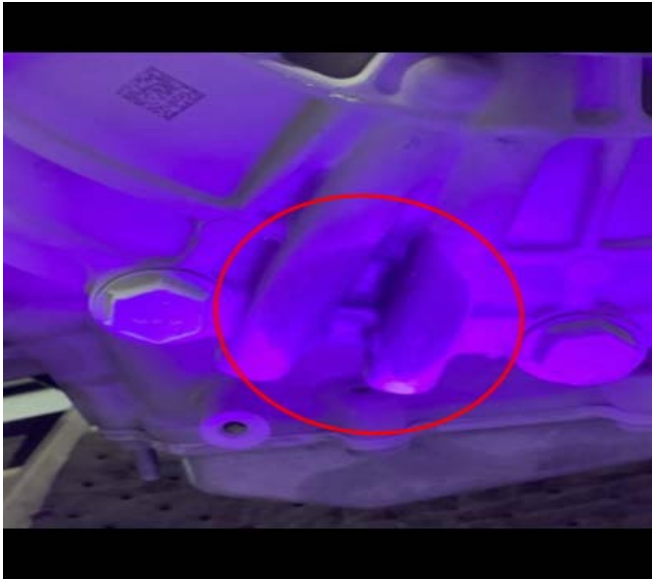
6142818

Porosity concerns with the differential cover. This area needs to be carefully powder tested to verify the leak is not associated with the cover seal (16) or the dog-bones and seals. Technicians have stated that they have found the cover double-gasketed when they confused the metal differential shims with what they thought were gaskets. All shims need to be re-installed to retain proper bearing load on differential. If porosity is found in the cover, the transmission will require replacement.

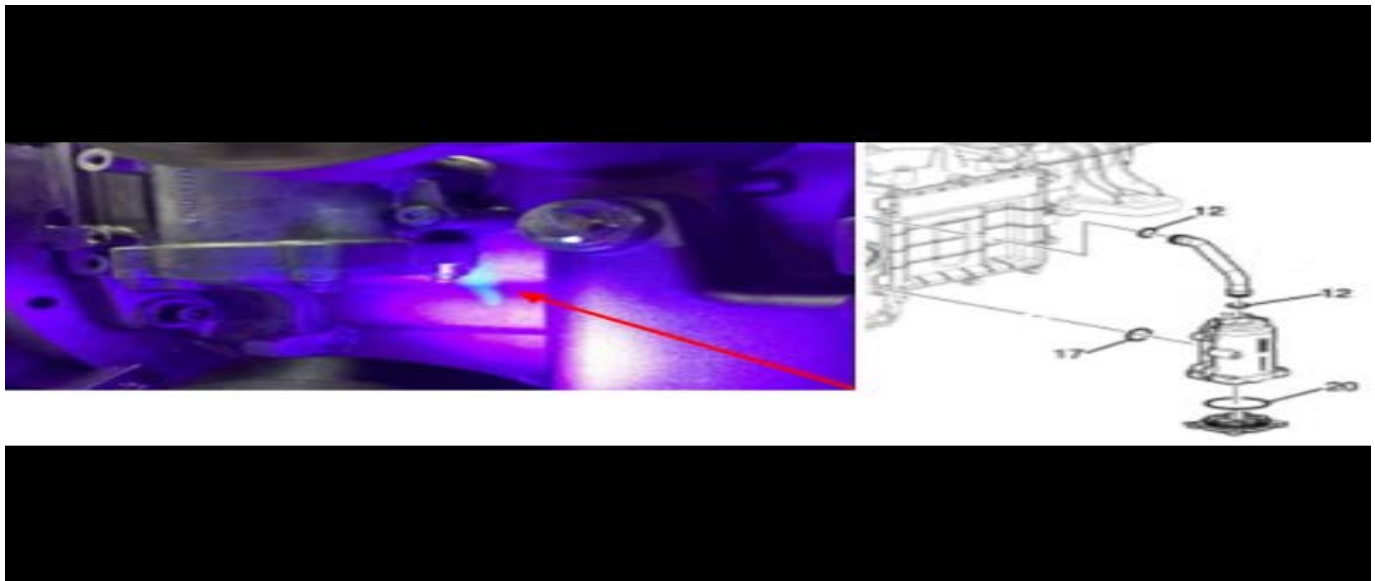
6142744

The auxiliary canister filter can create leaks in several areas. The most common area is cover seal (20), O-ring installation issues after filter replacement. Other areas of concern can be found at the are O-rings (12) and (17).

Note: Inspect the cover prior to replacement of the seal for porosity issues in the O-ring groove area.

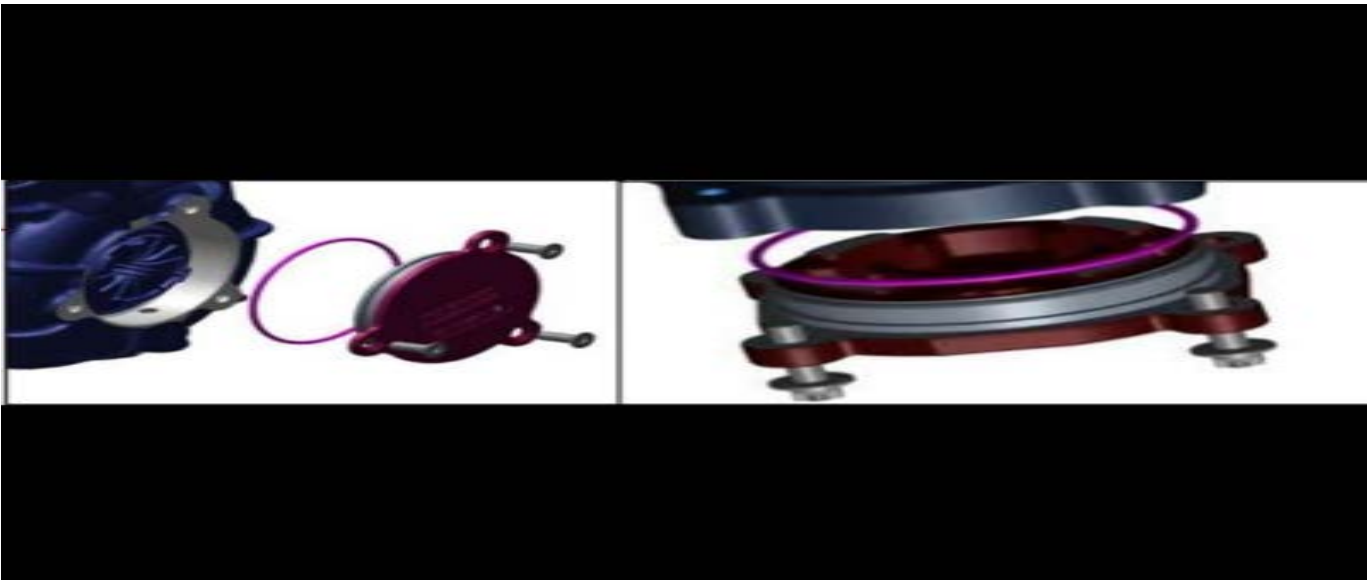
6456550

Transmission rear cover area leak. (Tremec name plate):

- If there seems to be a leak in this area, be sure to clean the area thoroughly. Residual oil can get trapped between the outer surface and the O-ring.
- After powder testing, if a leak re-occurs, remove the cover, and inspect the O-ring for damage.
- If no obvious damage is found with the O-ring, be sure to inspect the cover itself for porosity issues in the O-ring groove. It is critical to identify the difference between a leak and dampness.

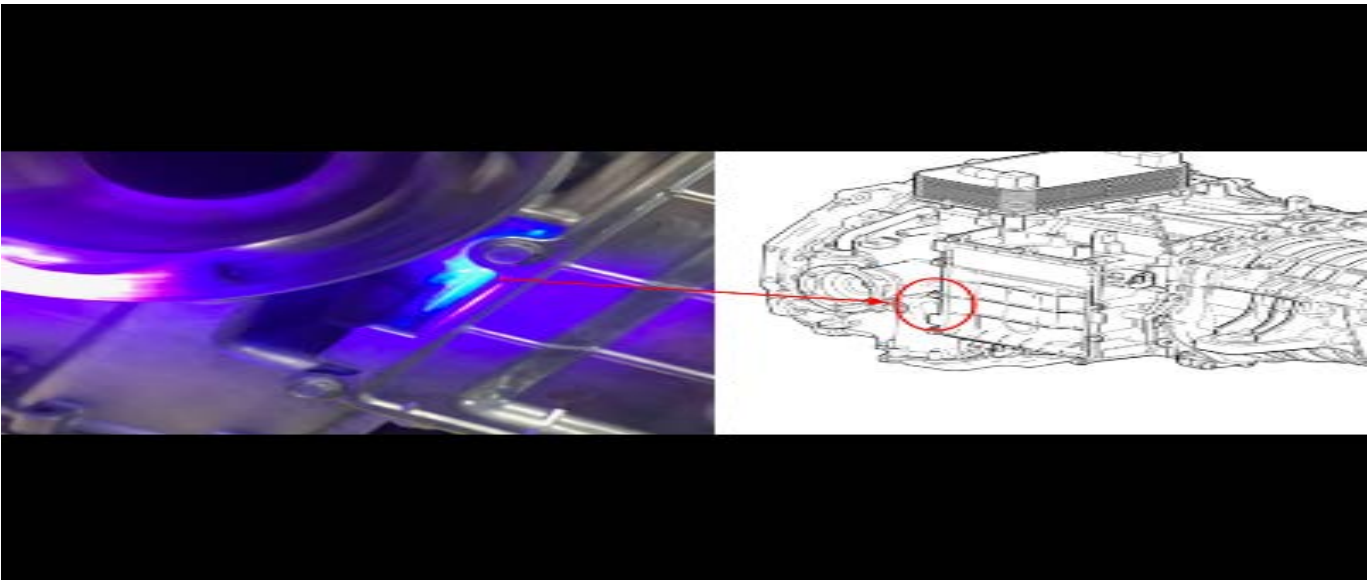
6142979

Transmission case porosity concerns have been found in the SAV cover area of the transmission. This is often the most misdiagnosed leak on this transmission. The fluid seeps through the case and runs down between the SAV cover and case to the pan rail, and often the transmission pan, and gasket get replaced, then the SAV cover, and finally the transmission. Often these

leaks will not develop by just allowing the engine to run. Usually, the vehicle will need to be lifted safely on a hoist with the wheels raised to allow the vehicle to run in gear. This action applies to most porosity leaks.
