# Service Bulletin

Bulletin No.: PIT4474D

**Subject:** Navigation or Radio Display Blank Or Flashing DTC B1265 B1288 Or B1289

**Models:** 2007-2013 Cadillac Escalade Models  
2007-2013 Chevrolet Avalanche, Silverado, Suburban, Tahoe  
2007-2013 GMC Sierra, Yukon, Yukon XL, Yukon Denali, Yukon Denali XL

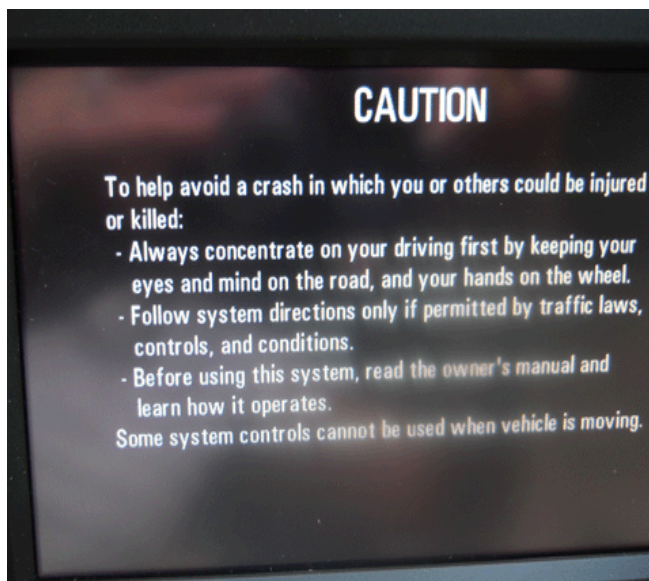
2901600

- Navigation or radio screen is blank or flashes on and off
- No sound from speakers
- Rear DVD screen inoperative
- DTC B1265, B1288 Or B1289
- Navigation disclaimer message intermittently will be displayed (see below)

This condition may be caused by the remote enable signal wire circuit 7066 being shorted to ground. This remote enable signal comes from the radio and feeds the Amplifier (except vehicles with RPO Y91 or any 2009 and later Chevrolet Utility equipped with RPO STZ), the antenna module (utilities only), and the rear video display (with RPO U42).

**Note:** When the remote enable signal wire (Circuit 7066) is first shorted to ground, the navigation screen or radio display may start to flash. If the wire remains shorted for more than 2 minutes, the navigation or radio display goes blank. The radio's current limiting logic will not re-enable the output on the entertainment remote enable circuit until after the radio performs a full power-down. It may be necessary to wait 5 minutes with the key OFF and retained accessory power OFF for the radio to re-enable this output.

If you experience this concern, check for a short to ground on the remote enable signal wire (Circuit 7066) and repair and re-route the circuit as needed. The most common area of concern is a shorted wiring harness near the rear DVD display screen under the headliner.
