# Service Update

## N232419270 Structure Plug Missing

Release Date: November 2023

Make	Model	Model Year		RPO	Description
		From	To		
Chevrolet	Malibu	2023	2023

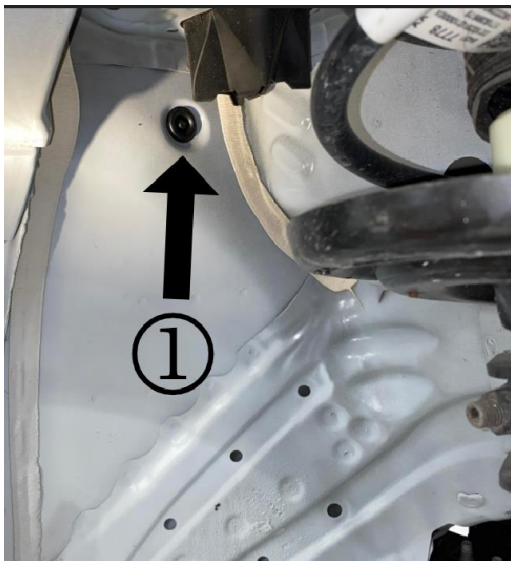
6453028

<b>Condition</b>	On certain 2023 model year Chevrolet Malibu vehicles, a structure plug may be missing on the passenger's side of the dash panel.
<b>Correction</b>	Dealers are to inspect, and if necessary, install the structure plug.

2. Look for the Structure Plug (1) located in the rear upper area of the Wheelhouse.
  - If the plug is in place, proceed to step 4.
  - If the plug is NOT in place, inspect for any water damage on the interior of the vehicle and repair as necessary. Proceed to step 3.
3. Install the NEW Structure Plug.
4. Install the Passenger Front Wheelhouse Liner. Refer to Refer to *Front Wheelhouse Liner Replacement – Right Side* in SI.
