Service Bulletin

Bulletin No.: 21-NA-228

Subject: Full Size Trucks Idle Time-out Disable

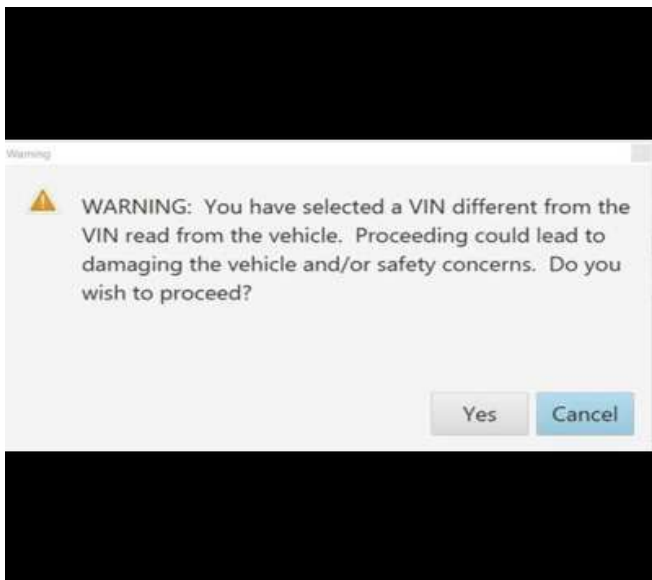
5877000

Important: If the vehicle VIN DOES NOT match, the message below will be shown
