Service Bulletin

Bulletin No.: 21-NA-270

Subject: Vibration Caused by Tires

Brand:	Model:	Model Year:		VIN:		Engine:	Transmission:
		from	to	from	to		
Chevrolet	Silverado 4500HD/ 5500HD/6500HD	2019	2023

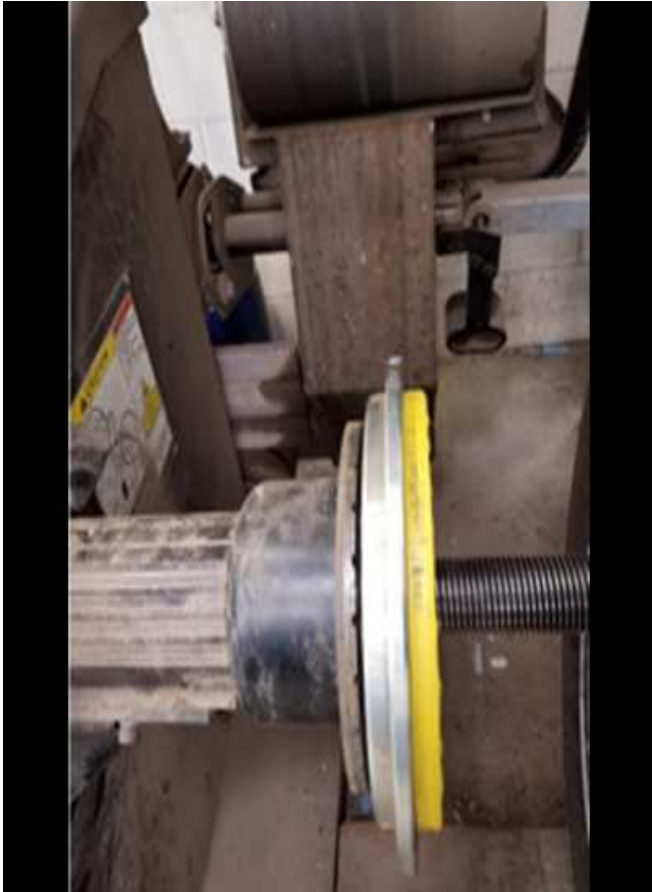
6473693

Helpful hints when using the 20-2977-2 (8 lug 19.5 inch stud kit).

This is the common setup for MD wheels on the Hunter 9700.

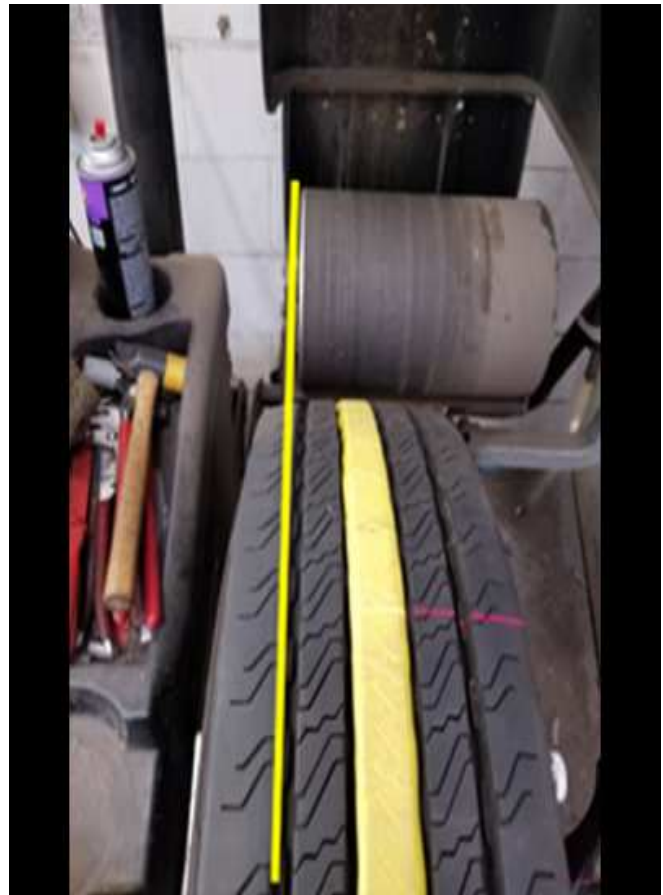
6473695

Adding masking tape to the centering ring to help with the Center Checking procedure. There is 2 layers of tape (2 times around). This especially helps with stamped steel wheels.

With this common setup, the Roadforce Roller does not fully contact the tire tread.

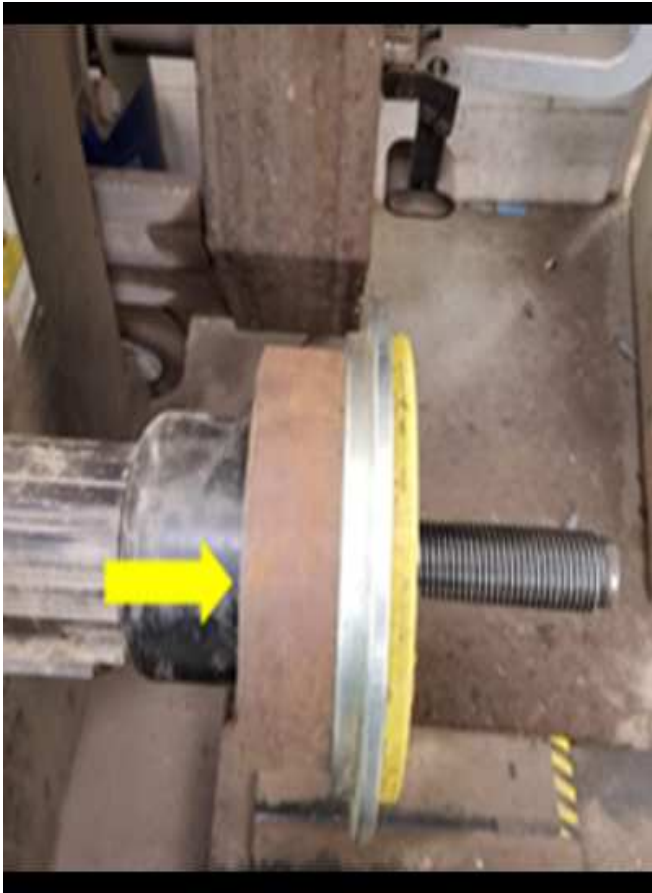
6473696

With the addition of this spacer, it will allow the Roadforce roller to fully contact the tire tread.

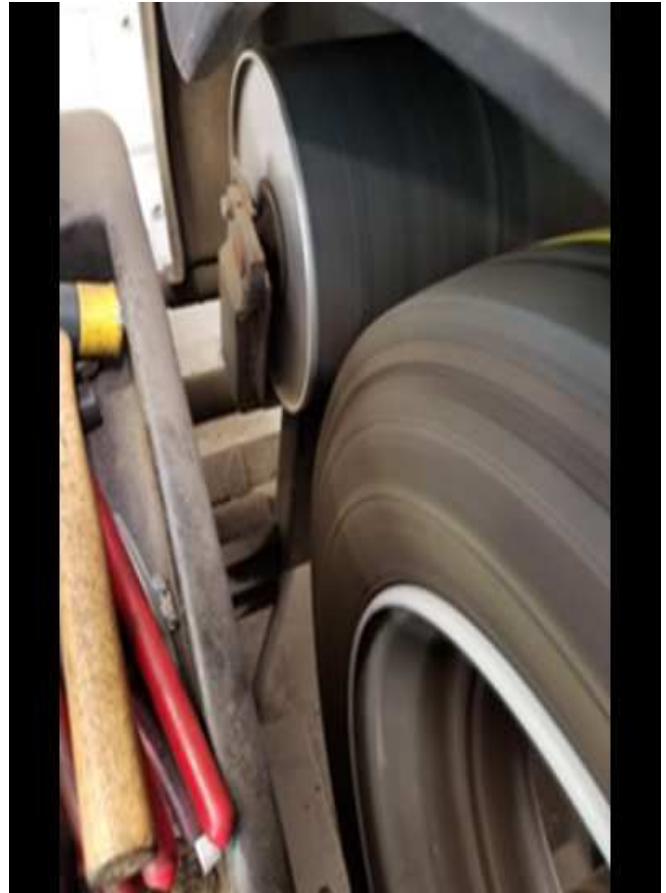
6473697

Here you can see the roller against the tire. With doing this, it reduced the Roadforce 9 Lbs. Nothing was changed with the process or tire/wheel assembly. Now the tire and rim can be marked. Rotate the tire on the rim and retest. This may help reduce the Roadforce if below 50. Balance the tire and reevaluate the customers concern with the PICO.
