TECHNICAL SERVICE BULLETIN

Equipped With Hybrid Engine - Illuminated MIL With DTC P0A1E In The PCM

23-2347

09 November
2023

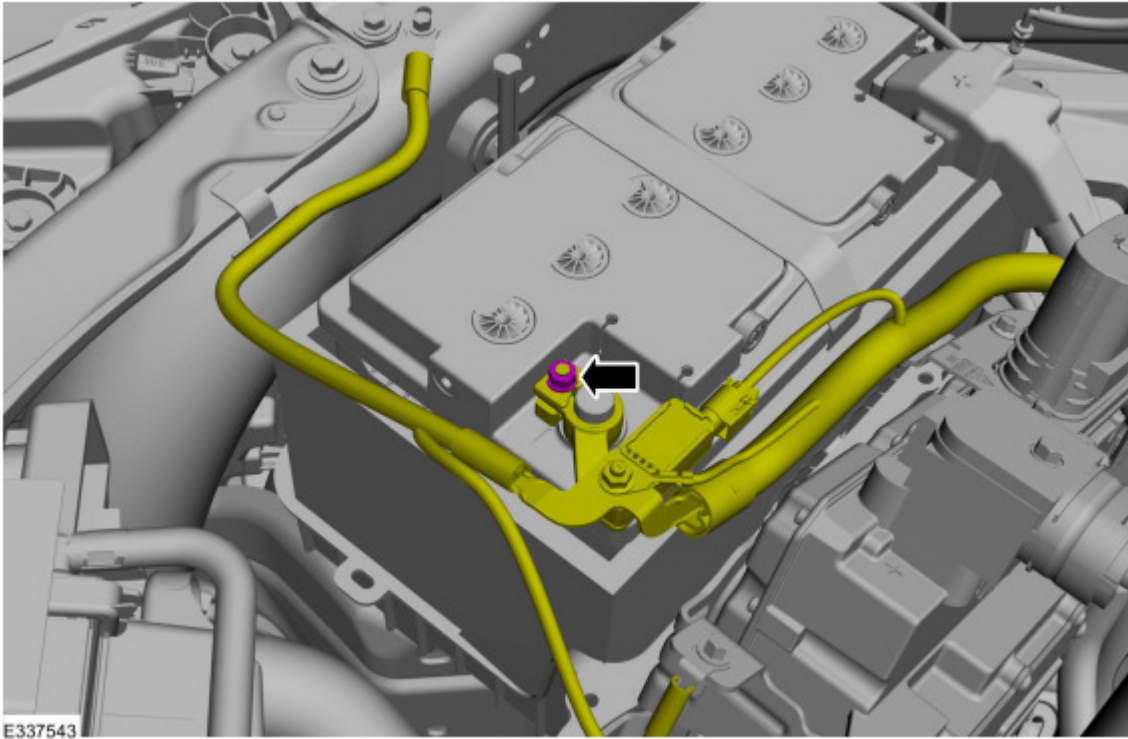
Figure 1 - F-150

- (1). Yes - repair is complete.
 - (2). No - proceed to Step 5.
5. At the 12V battery negative post, inspect the nut securing the battery monitoring sensor to the negative battery post. (Figures 1-2) If it is loose, tighten the nut to the specified tightening value. Refer to WSM, Section 414-01 Battery, Mounting and Cables, General Procedures, Battery Disconnect and Connect.

- For F-150 vehicles with a 3.5L hybrid engine, tighten to 55 lb.in (6.2 Nm).
 - For Explorer/Aviator vehicles equipped with a hybrid engine, tighten to 48 lb.in (5.4 Nm).

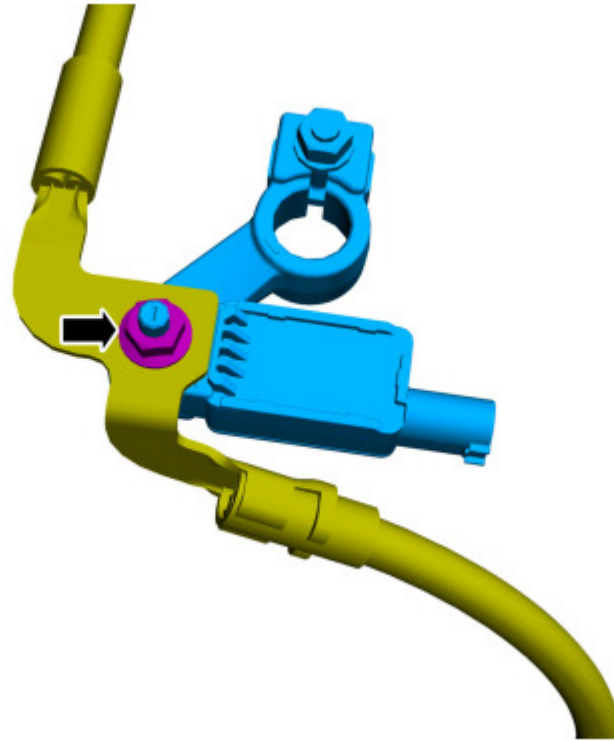
Figure 3

6. At the battery monitoring sensor, inspect the nut attaching the sensor to the ground cable. (Figure 3) If it is loose, tighten the nut to the specified tightening value. Refer to WSM, Section 414-01 Battery, Mounting and Cables, Removal and Installation, Battery Monitoring Sensor.

- For F-150 vehicles with a 3.5L hybrid engine, tighten to 97 lb.in (11 Nm).
- For Explorer/Aviator vehicles equipped with a hybrid engine, tighten to 80 lb.in (9 Nm).

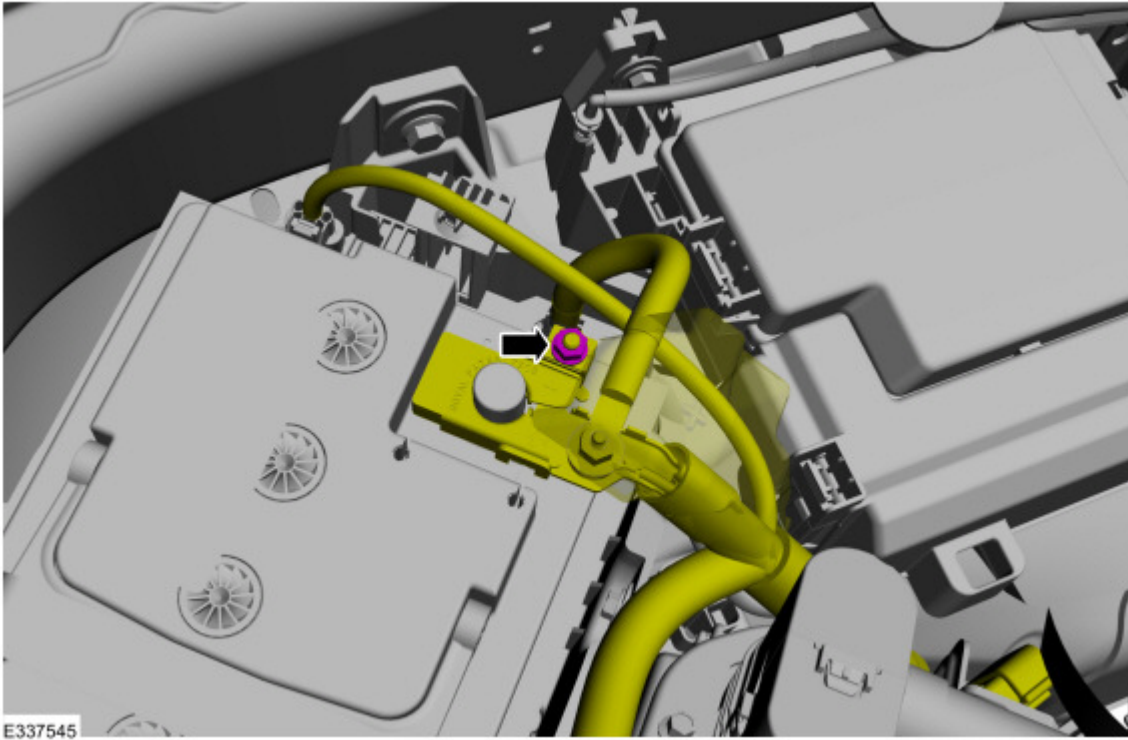
Figure 4 - F-150

7. At the 12V battery positive post, inspect the nut securing the positive battery cable to the post. (Figures 4-5) If it is loose, tighten the nut to the specified tightening value. Refer to WSM, Section 414-01 Battery, Mounting and Cables, General Procedures, Battery Disconnect and Connect.

- For F-150 vehicles with a 3.5L hybrid engine, tighten to 55 lb.in (6.2 Nm).
- For Explorer/Aviator vehicles equipped with a hybrid engine, tighten to 48 lb.in (5.4 Nm).

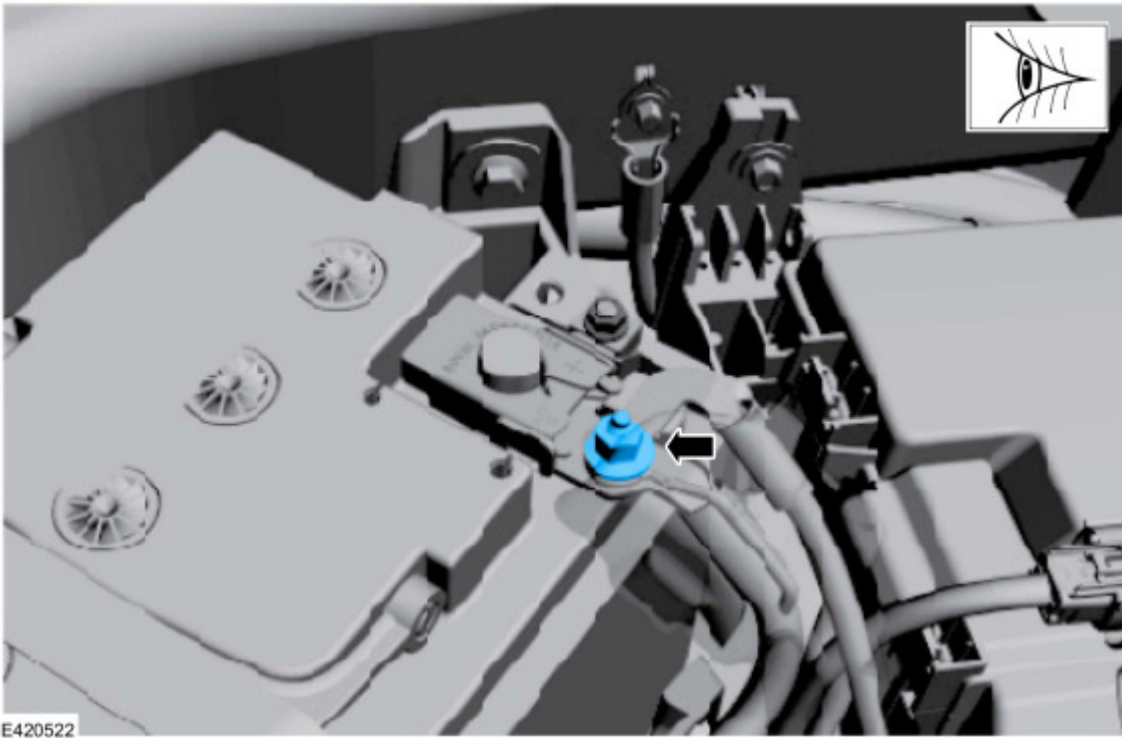
Figure 6 - F-150

8. At the 12V battery positive post, inspect the nut securing the positive cable eyelet lug. (Figures 6-7) If it is loose, tighten the nut to the specified tightening value. Refer to 414-01, Battery, Mounting and Mounting Cables, Removal and Installation.

- For F-150 vehicles with a 3.5L hybrid engine, tighten to 80 lb.in (9 Nm).
- For Explorer/Aviator vehicles equipped with a hybrid engine: 80 lb.in (9 Nm).

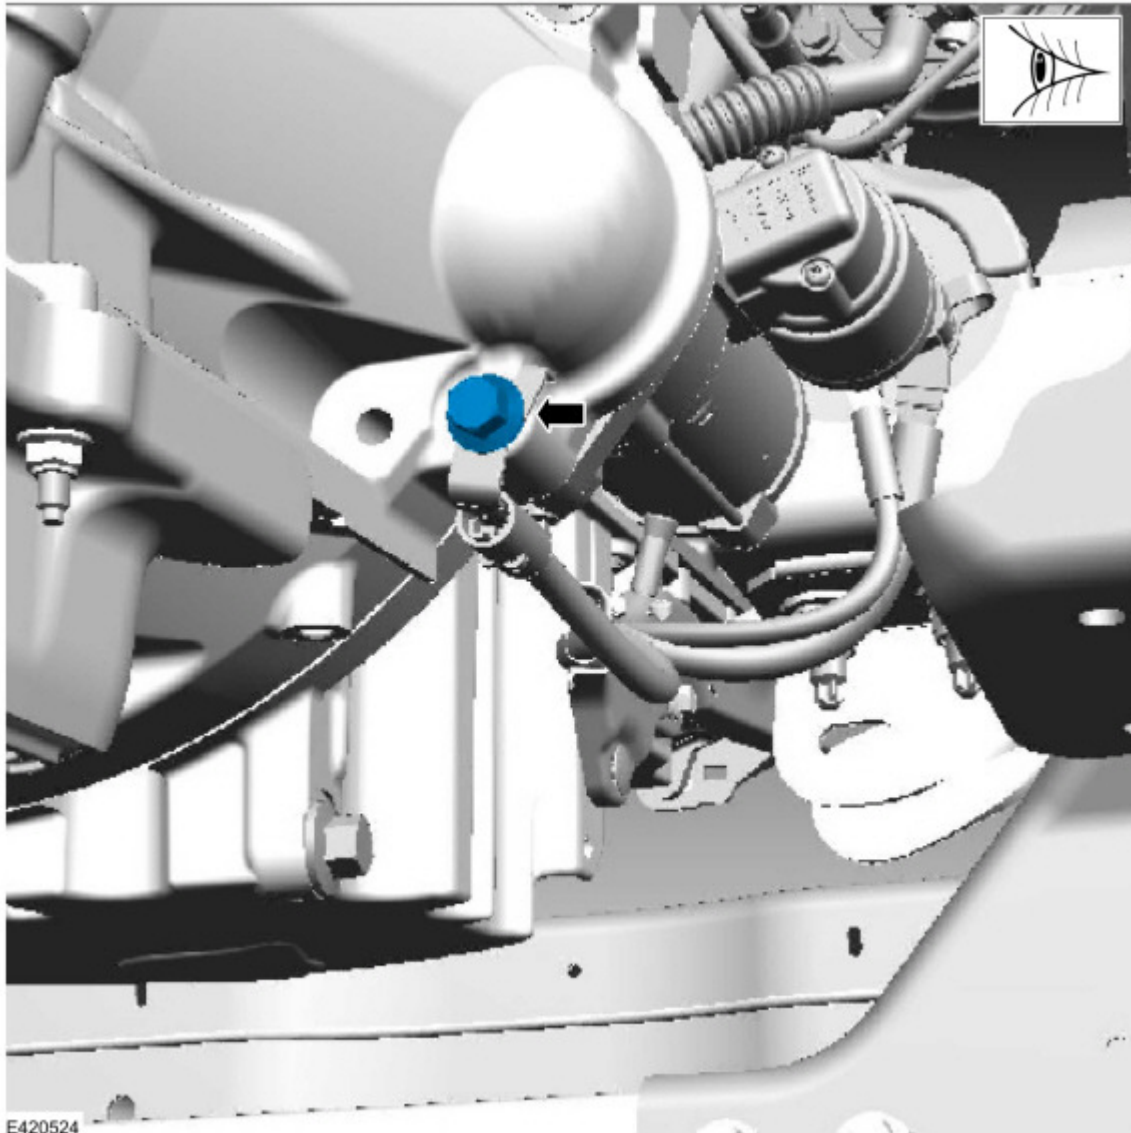
Figure 8 - F-150

9. Inspect engine ground G105. (Figures 8-10) Refer to Wiring Diagram, Cell 010, G105. If it is loose, tighten the bolt to the specified tightening value.

- For F-150 vehicles with a 3.5L hybrid engine, tighten to 35 lb.ft (48 Nm).
- For Explorer/Aviator vehicles equipped with a hybrid engine, tighten to 106 lb.in (12 Nm).
