SIB 41 04 23

2023-11-13

DELIVERY STOP: REAR BUMPER SUPPORT

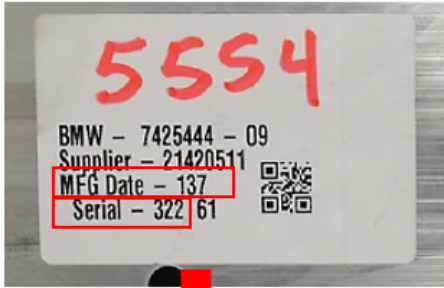
2. Check the production date and serial number on the rear bumper support label.

Note: If the number on the MFG date is 132,133,134,135,136, or 137 and/together with the serial number 322, the rear bumper support must be replaced, follow the repair instructions listed in ISTA/AIR 51 12 050.

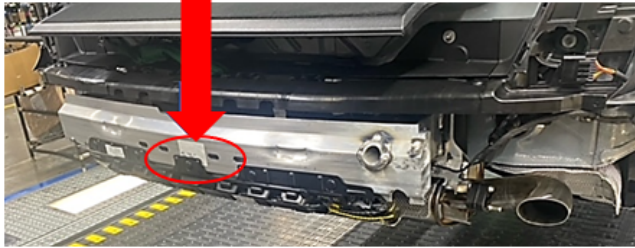
All other number combinations are OK!
