Service Bulletin

Bulletin No.: 18-NA-020

Subject: Malfunction Indicator Lamp Illuminated with DTCs P0300, P0299, P0234 and/or P2227 Set

Brand:	Model:	Model Year:		VIN:		Engine:	Transmission:
		from	to	from	to		
Chevrolet	Equinox	2018	2024	-	-	Equipped with 2.0L or 1.5L Engine (RPOs LTG, LYX, LSD)	All
GMC	Terrain

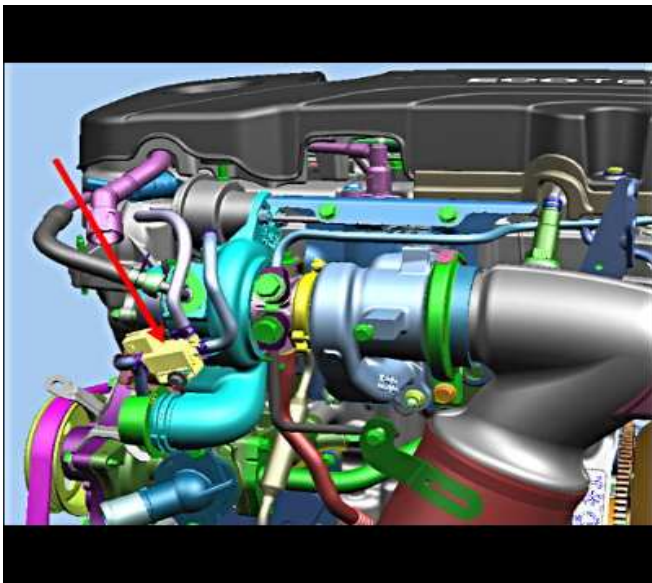
6055063

Inspect the Turbocharger Control Valve (TCV) to ensure it is not frozen.

1. Remove Turbocharger Wastegate Regulator Solenoid Valve.
2. Drain Turbocharger Wastegate Regulator Solenoid Valve (TCV) by turning valve upside down.

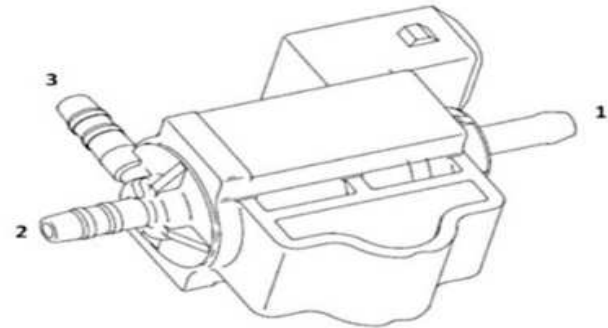
6055068

Note: Check port #2 to assure the spring gets lifted off the seat. This will be determined by the compressed air not dead heading when applied to port #2. When applying air to this port a small amount of air should be observed at port #3 and even less air will be noticed at port #1. If this does not happen, the TCV plunger may have hardened deposits from hot operating conditions which will impede TCV plunger movement, and the Turbocharger Wastegate Regulator Solenoid Valve should be replaced.

3. Using clean shop air regulated to 80-100 PSI (551-689 kPa), blow through all three ports (1, 2 & 3) for 5 seconds each. Repeat this step twice.
