Abnormal Fuel Gauge Operation

YEAR(S)	MODEL(S)	ADDITIONAL INFORMATION
2021 - 2022	Sienna HV

Some 2021 – 2022 model year Sienna Hybrid vehicles may exhibit a condition in which the fuel gauge reading changes when the vehicle is driven up or down an incline and left at an angle of up to 15° for five minutes or longer. The combination meter assembly ECU logic has been modified to reduce the possibility of this condition. Follow the Repair Procedure in this bulletin to reprogram the combination meter assembly ECU.

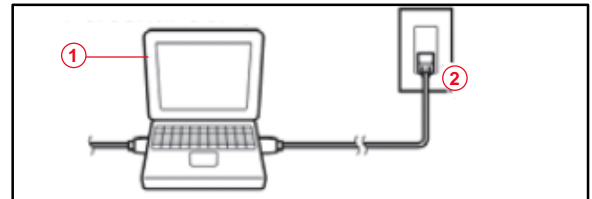
Figure 3.

The ECU could be damaged if the battery voltage of the GTS+ drops while reprogramming.

- A. Connect the GTS+ to an external AC power supply.

1	GTS+ or Computer
2	AC Power Supply

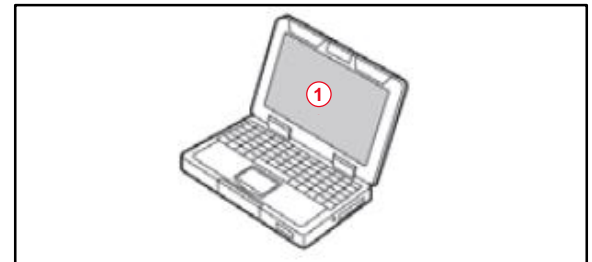
Figure 4.

If the screen saver or power saving mode launches while reprogramming, the communication may be disconnected.

- B. Turn OFF the screen saver and power saving mode of the GTS+.

1	Turn Off the Screensaver and Power Saving Mode
---	--

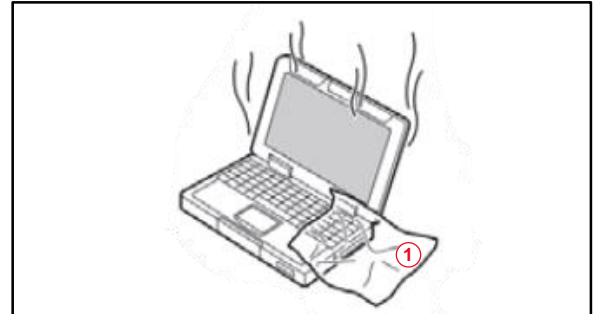
Figure 5.

If the ventilation opening for the cooling fan is blocked with a sheet cover or similar, the GTS+ may overheat, causing reprogramming to stop and potentially damaging the ECU.

- C. Do NOT block the ventilation opening for the cooling fan of the GTS+.

Do Not Block the Ventilation Opening for the Cooling Fan
