<b>Tesla, Inc.</b> Service Bulletin		<h2>Replace Steering Wheel Due to Material Separation</h2>	
<b>SB-23-32-003</b> October 11, 2023			
<b>Classification</b>		<b>Section/Group</b>	<b>Mobile Service</b>
Repair Bulletin		32 - Steering	Can Perform (where permitted)
<b>Model Year</b>	<b>Model</b>	<b>Country/Region</b>	<b>Build Location</b>
2020 - 2023	Model 3, Model Y	All	Fremont
<small>The model(s) and model year(s) listed are a general approximation of the affected VIN list. Refer to the VIN/Bulletin Tracker or Customer/Vehicle profile to determine applicability of this bulletin for a particular vehicle.</small>

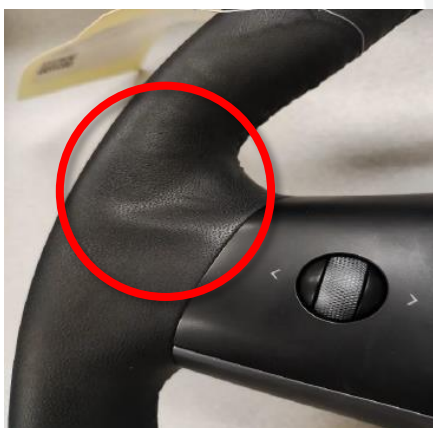
Figure 1

On some Model 3 and Model Y vehicles, the steering wheel cover material may separate from the steering wheel at the 3 o'clock and 9 o'clock position (Figures 1 and 2).

**NOTE:** The material separation of the steering wheel cover is cosmetic only and does not affect the performance or function of the steering wheel.

Inspect the vehicle for symptoms related to the condition. If symptoms are present, replace the steering wheel.

Replace the steering wheel (refer to Service Manual procedure 32051802; [Model 3](#), [Model Y](#)).
