Technical Service Bulletin

01 MIL on, Whistling noise, leaking air Bank 2 - DTC P2ADF00, Engine Crankcase breather

01 23 92 2071318/4 November 6, 2023. Supersedes Technical Service Bulletin Group 01 number 23-87 dated October 23, 2023, for reasons listed below.

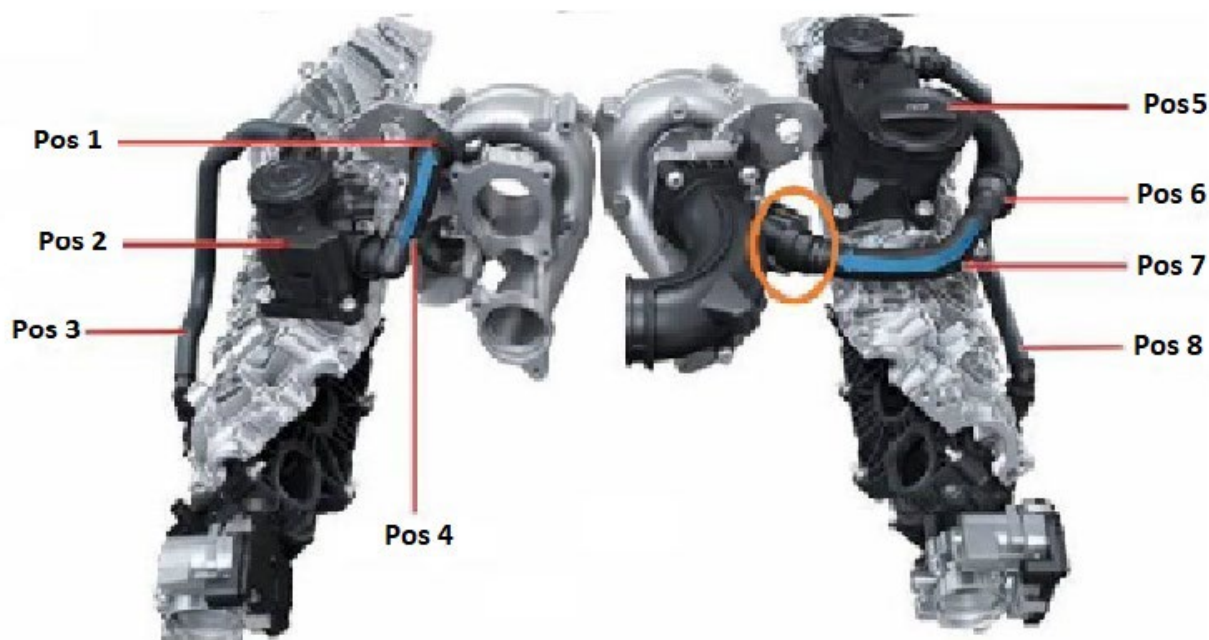
1. Do not replace the oil separator for bank 1 or bank 2 or the part load breather lines.
 - a. Please refer to image of the crankcase from the Self Study Program 920493 as a guide.

- Item 1: Non-return valve
- Item 2: Oil separator for bank 1
- Item 3 Part load breather line for bank 1
- Item 4: Full load breather line for bank 1
- Item 5: Oil separator for bank 2
- Item 6: Non-return valve *(Not applicable for engine codes CWWB, and DWKA, because Non-return valve is integrated into the intake manifold)*
- **Item 7: Full load breather line for bank 2**
- Item 8: Part load breather line

In this case, replace the full load breather line for cylinder bank 2.
