Technical Service Bulletin

55 Trunk lid tension spring mounting clip broken

55 23 82 2071955/1 November 1, 2023.

Model(s)	Year	VIN Range	Vehicle-Specific Equipment
A6 allroad, and RS 6 Avant	2022 – 2024	All	Not Applicable

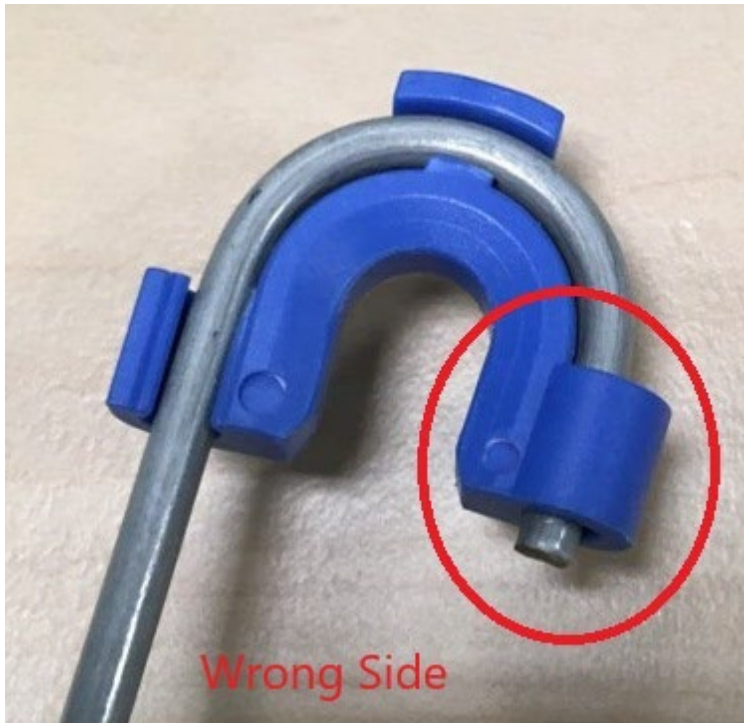
Figure 1. Spring clip installed *incorrectly*. Closed loop on short side of tension spring.

1. Replace the affected trunk lid tension spring(s) according to: *Elsa>>Repair manual>>Body>>Body Exterior>>55 Hood, Lids>>Rear Lid>>Tension Spring, Removing and Installing.*
2. Before installing the new tension spring(s), check if the mounting clip installation is correct. The closed end of the spring clip has to be looped around the spring to the long side of the spring (Figure 1, 2). If the clip installation is incorrect, rotate the mounting clip on the spring by 180° prior to installation.

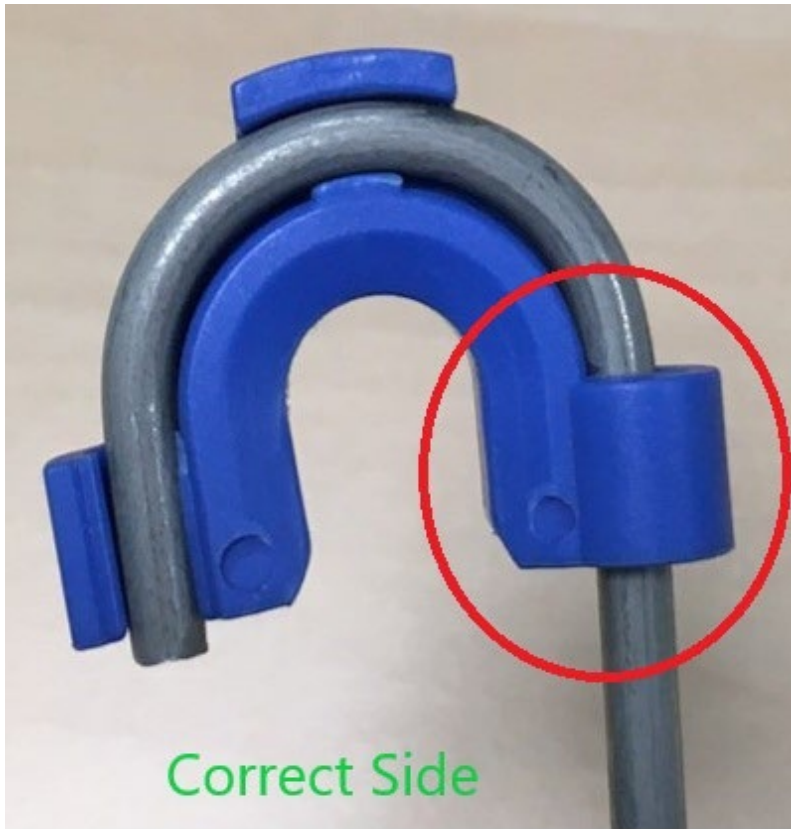
Figure 2. Spring clip installed **correctly**. Closed loop on long side of tension spring.
