Technical Service Bulletin

70 Leather dashboard blistering, bubbling, wrinkled, loose, wavy, detached, delaminating

70 23 85 2071698/1 November 3, 2023.

Model(s)	Year	VIN Range	Vehicle-Specific Equipment
R8, and R8 Spyder	2017 – 2018 2020 – 2022	All	Not Applicable
Q8	2019 – 2022		
e-tron quattro	2019 2021 – 2022		
e-tron Sportback quattro, SQ8, and RS Q8	2020 – 2022

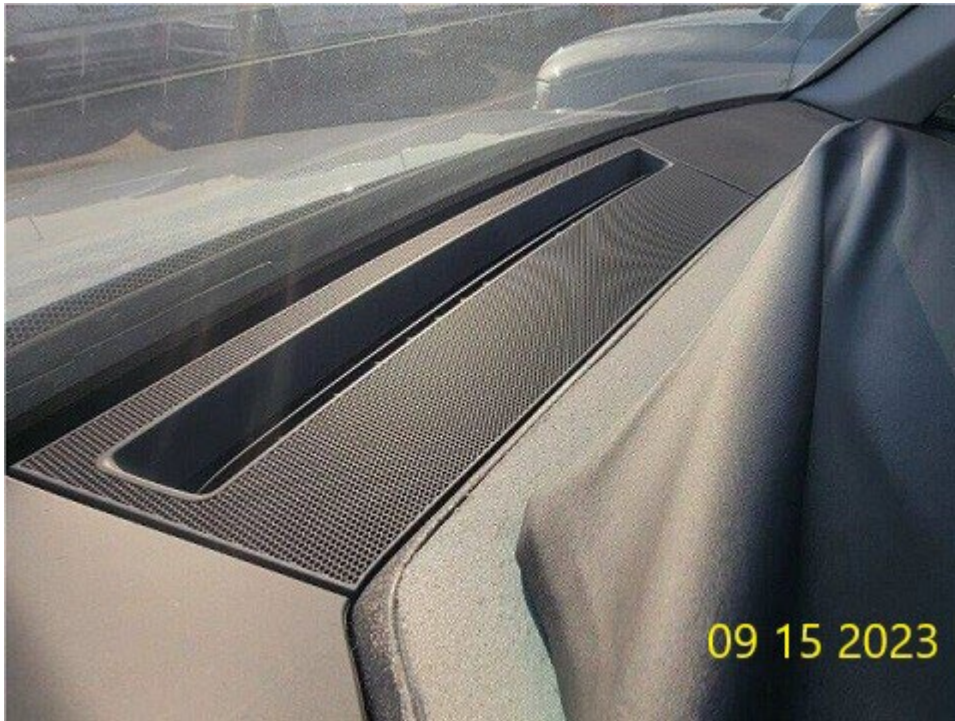
The leather detaches from the dashboard substrate due to process weaknesses and extreme stresses caused by hot and humid climates. The material reaches its physical load limit.

Figure 1. Massive, large-scale delamination.

- Replace the dashboard according to: Elsa>>Repair manual>>Body>>Body Interior>>70 Interior Trim>>Instrument Panel>>Instrument Panel, Removing and Installing.

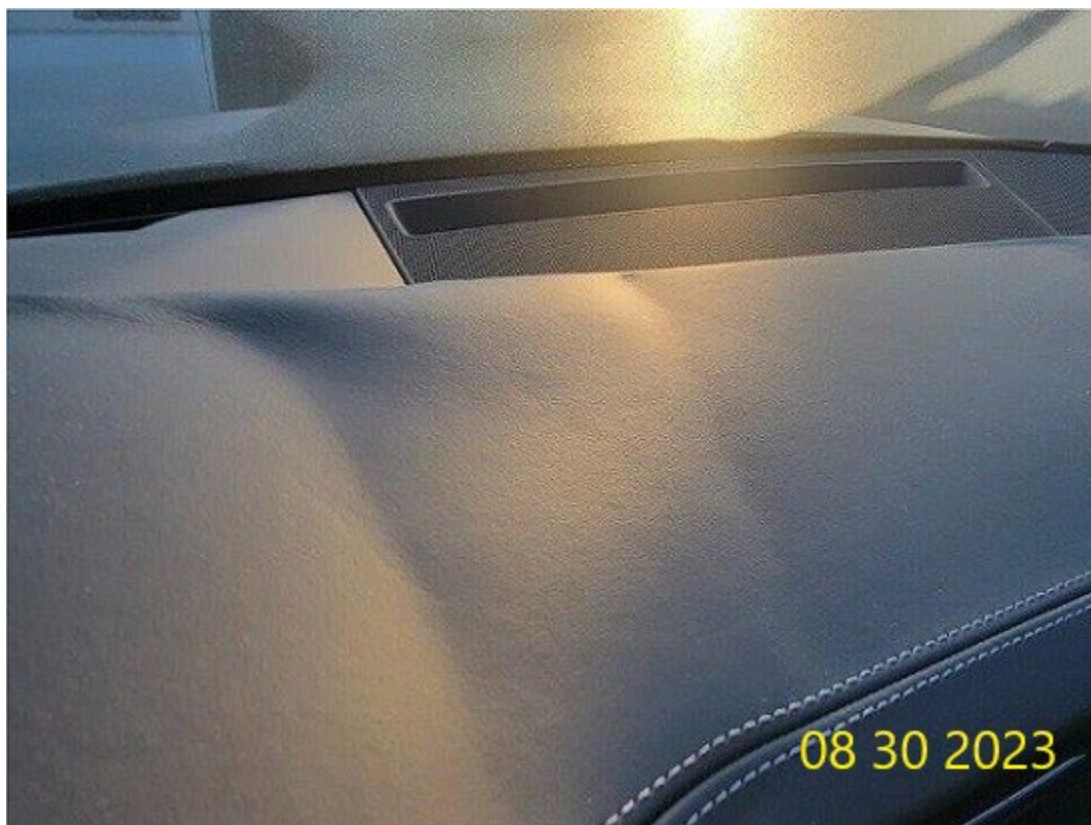
Figure 2. Massive, large-scale delamination.

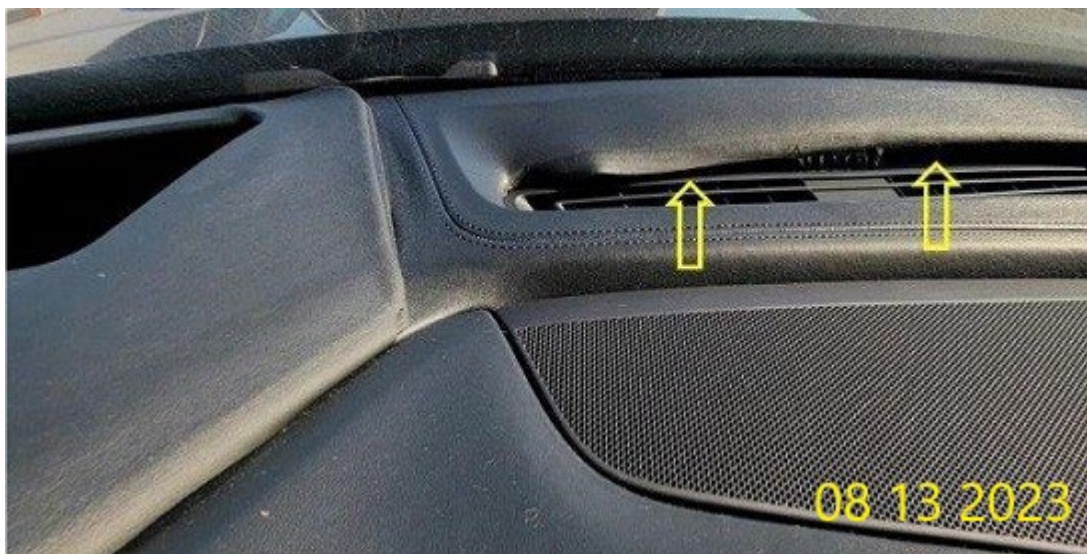
Figure 3. Massive delamination at the defroster vent.

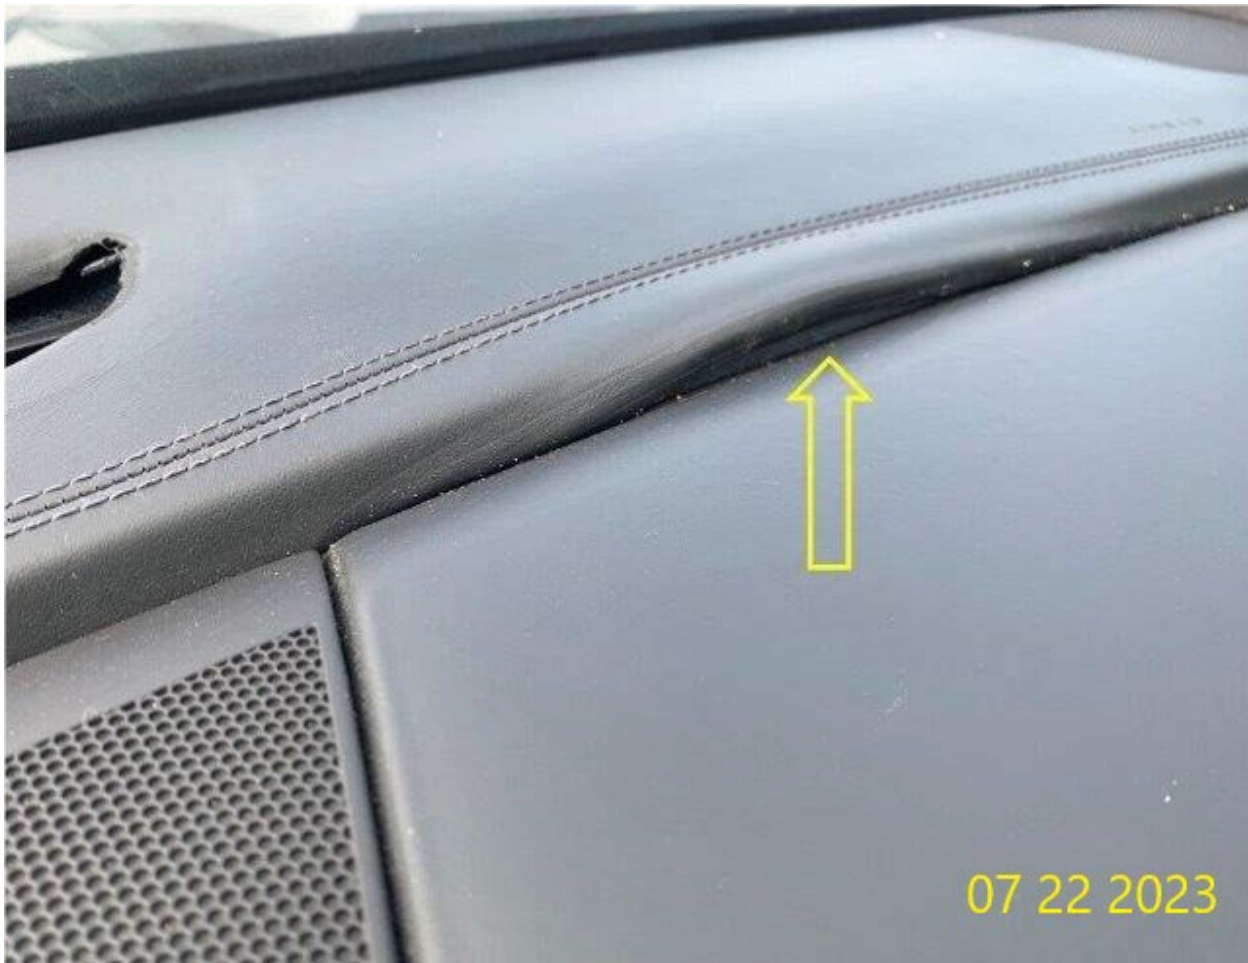
Figure 4. Delamination at the bend / radius.

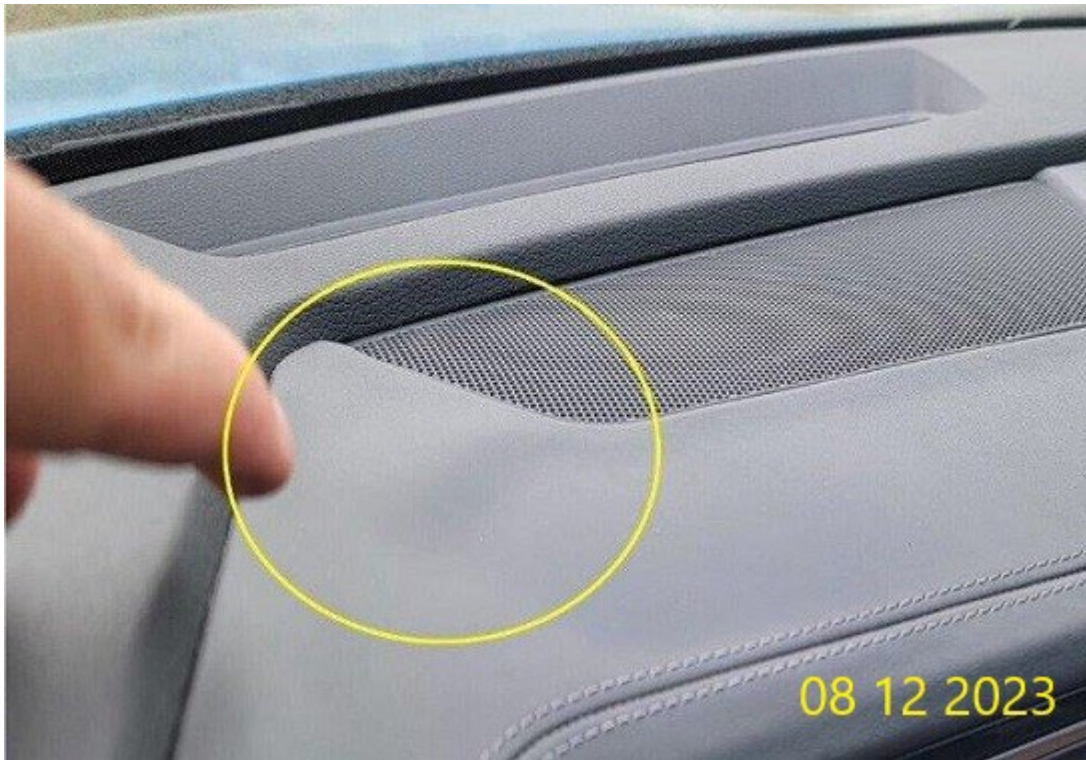
Figure 5. *Slight blistering / bubbling.*

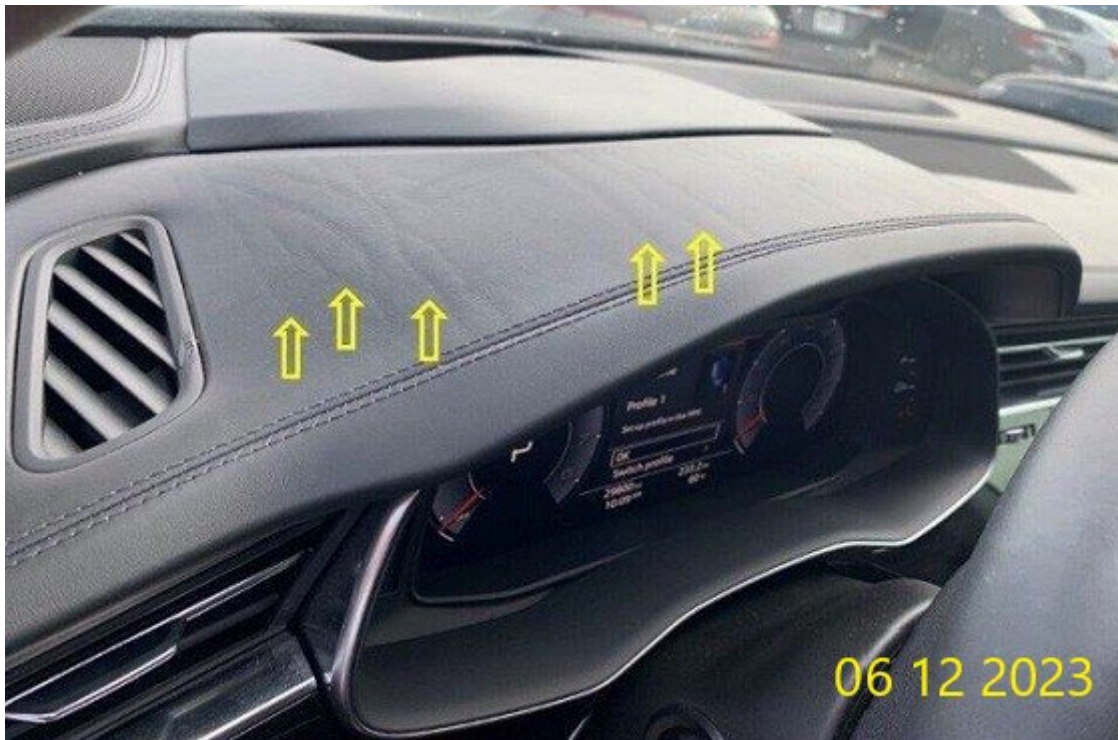
Figure 6. *Wrinkles due to shrinkage.*

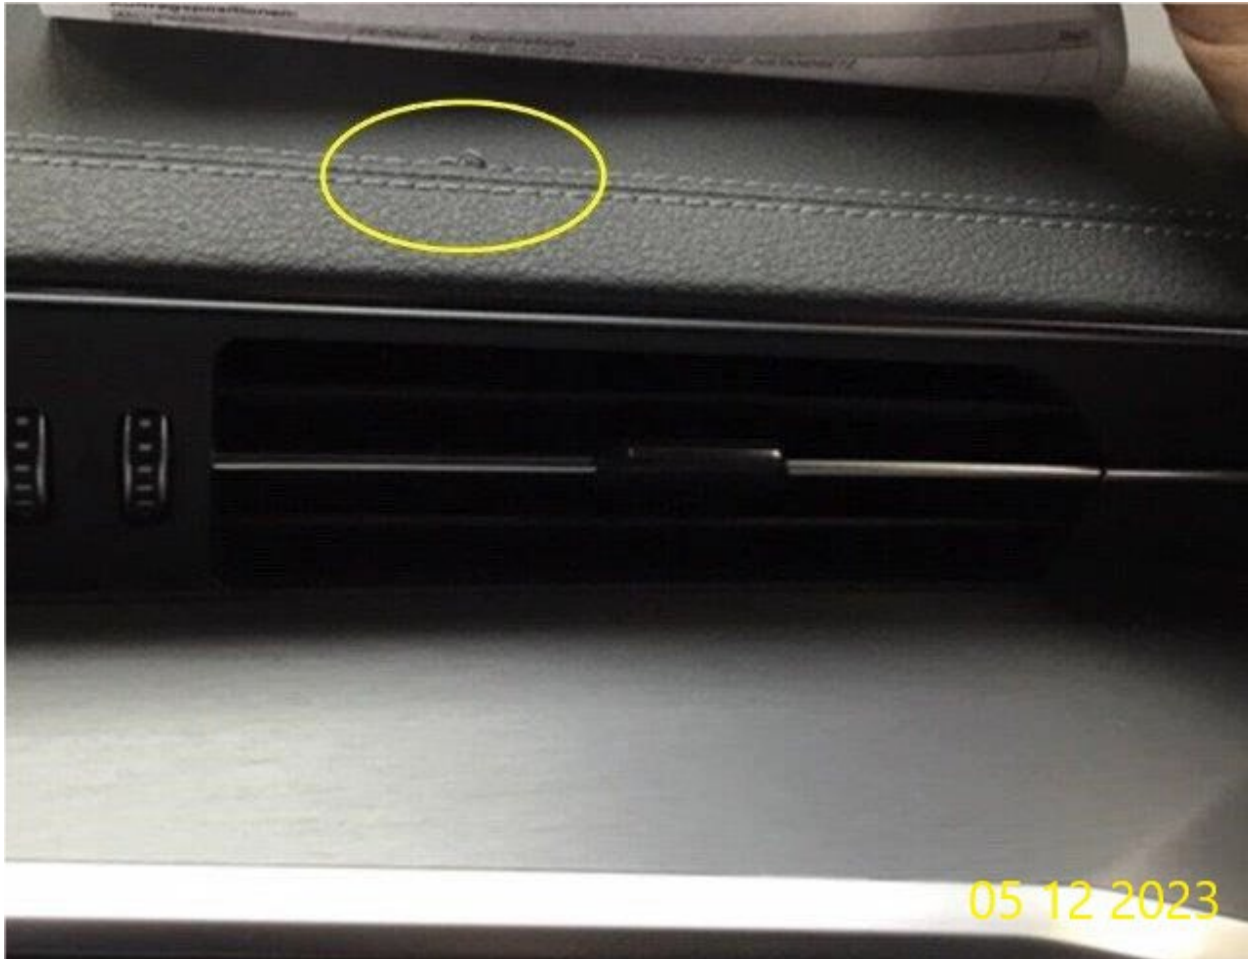
These customer complaints are covered under the “Trim items” warranty coverage.

Figure 7. Stitching defect.

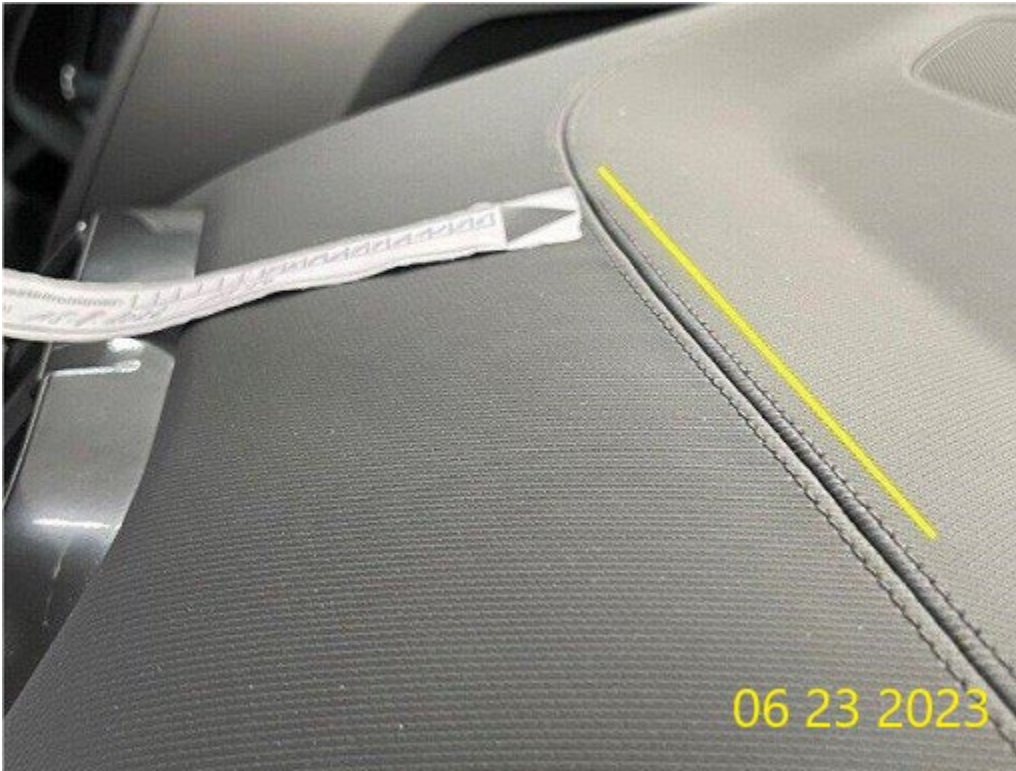
Figure 8. *Uneven seam.*

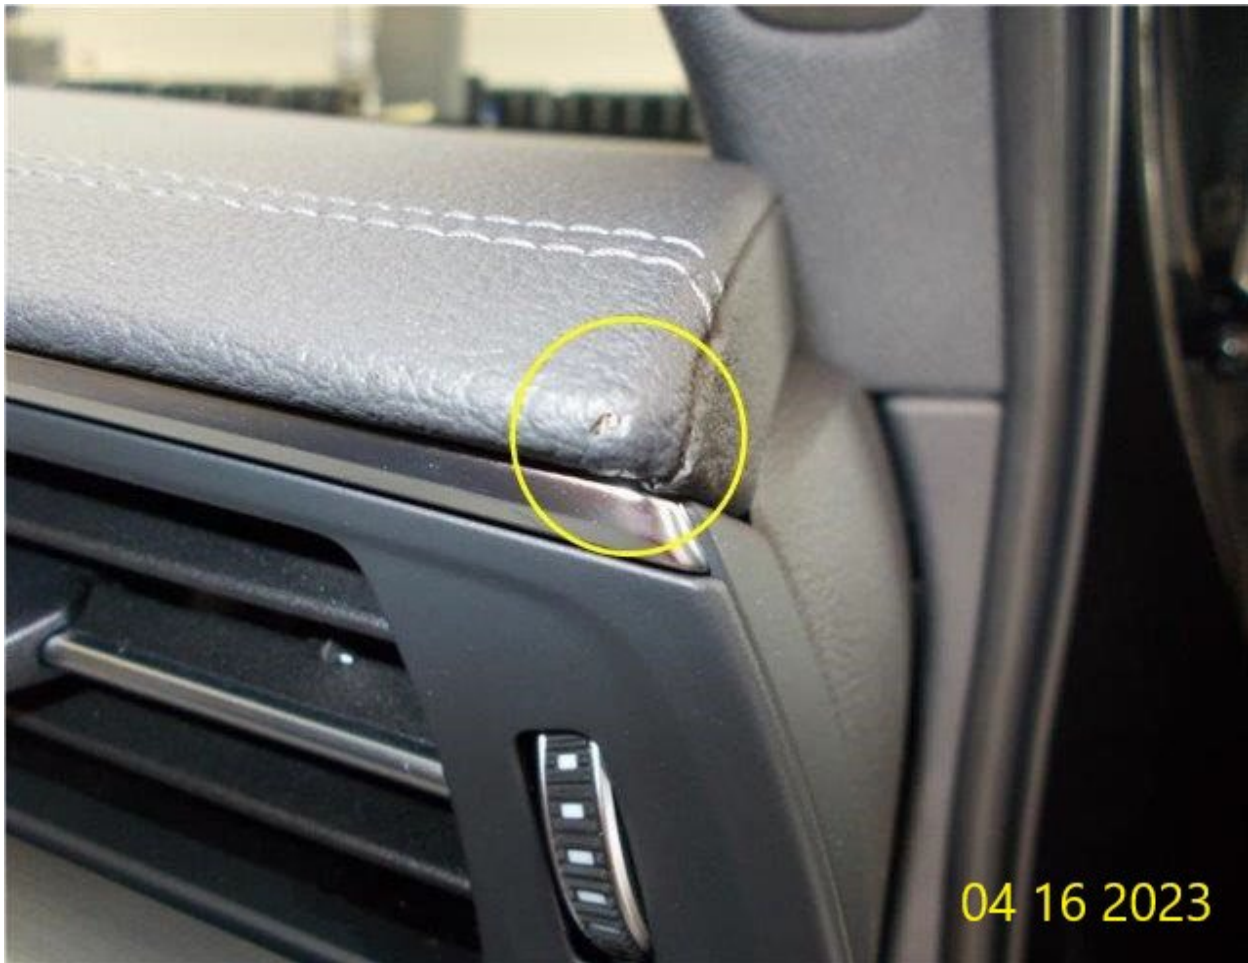
The following three photos show damage patterns caused by outside influences. These are not warrantable defects and **cannot be claimed under Warranty** (Figures 9-11).

Figure 9. Leather damaged by mechanical force.

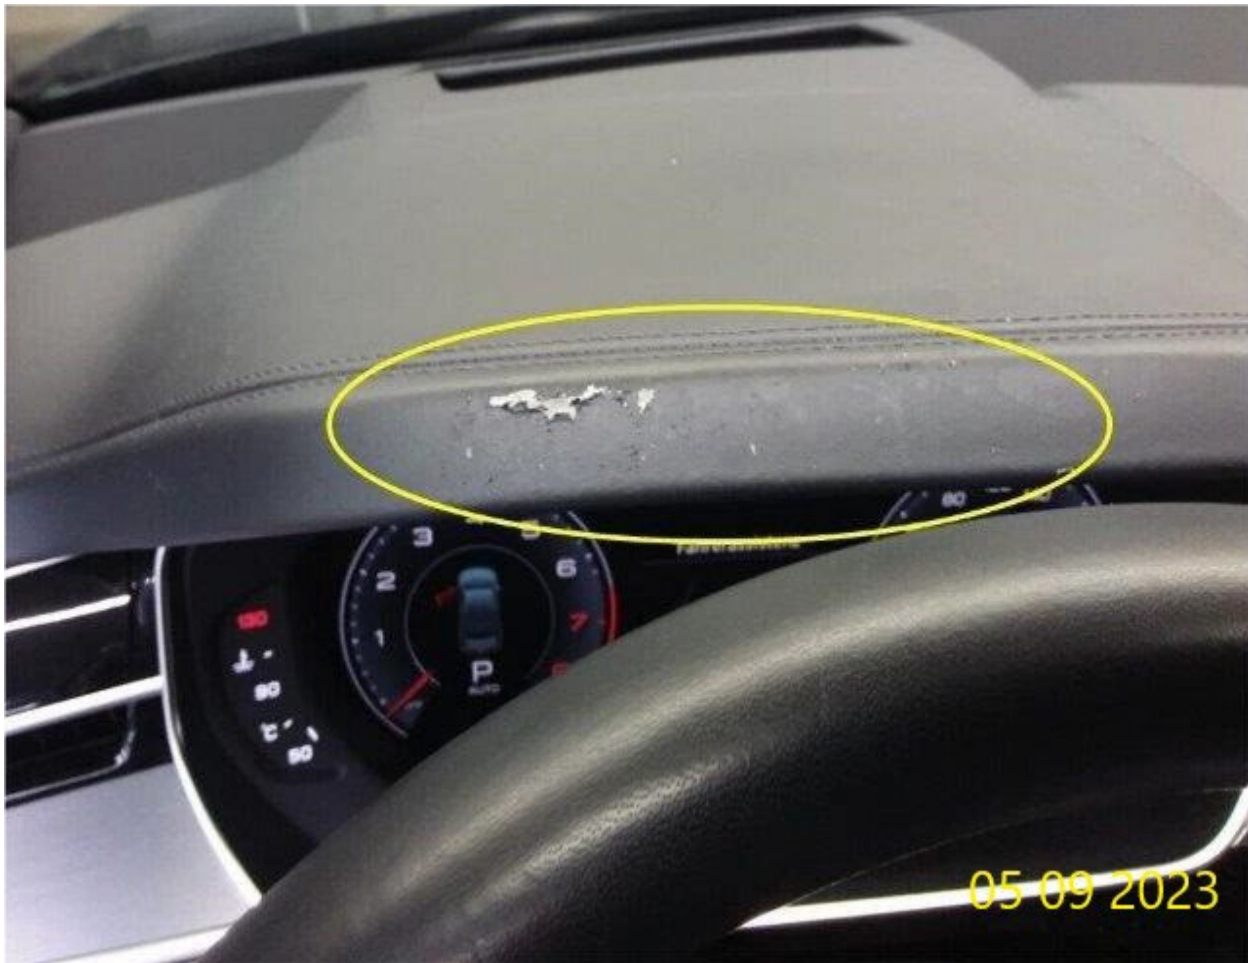
Figure 10. Leather detachment due to the use of harsh cleaning agents.

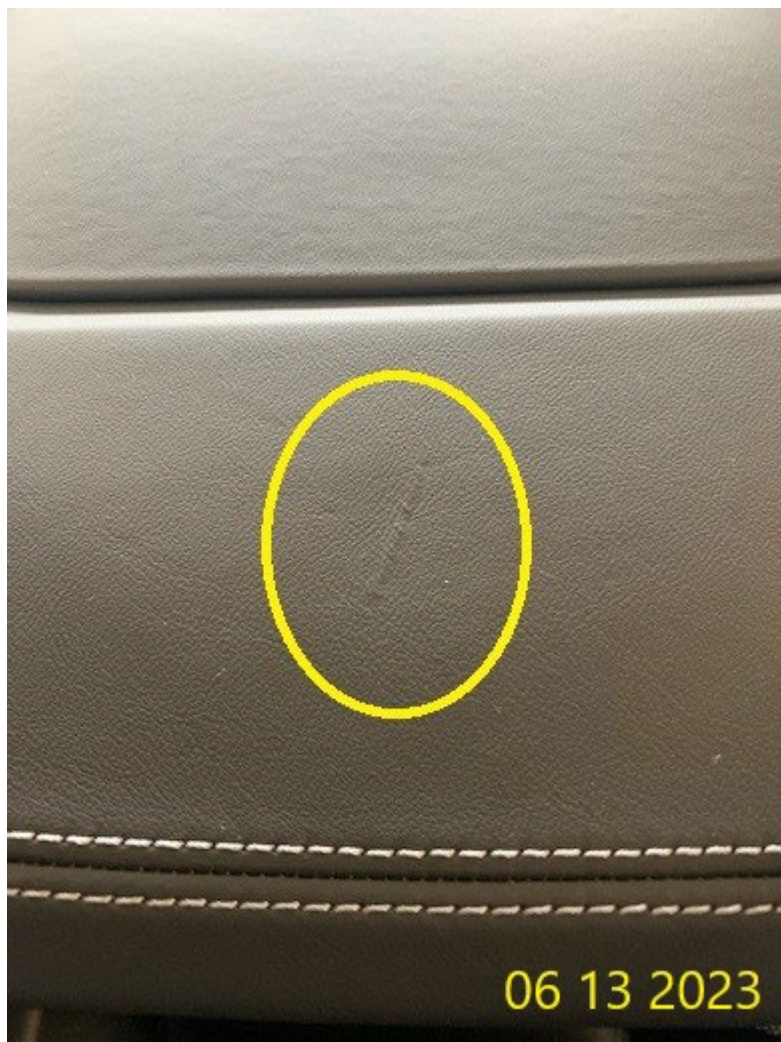
Figure 11. *Leather surface scratched.*
