Technical Service Bulletin: TSB190165

Released Date: 13-Nov-2023

Soot or Ice Deposits in the Intake Air Connection and Fault Codes: 1866, 3361, 3382, 3383, 3389, 7232, 7233 and/or 4729

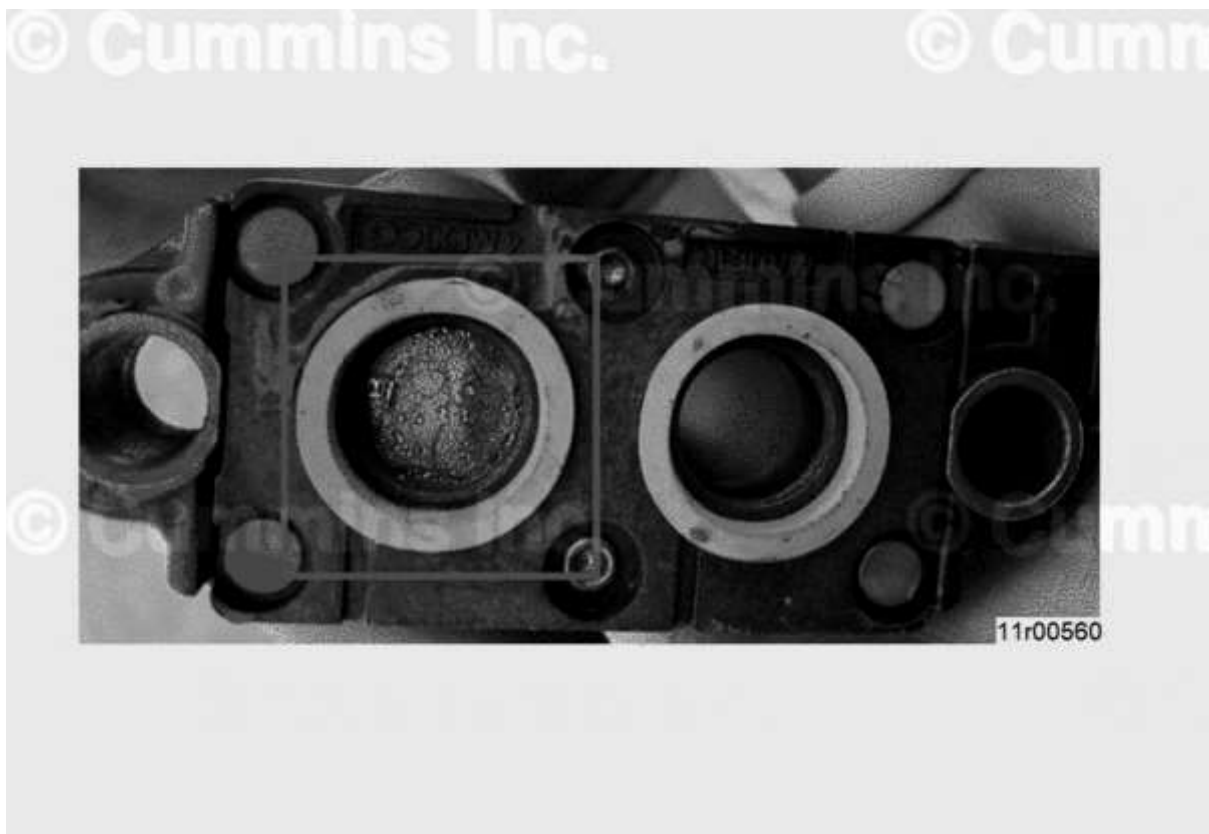
- Icing may **not** be present at the time of the repair, but presence of condensation/water droplets in the EGR Differential Pressure sensor indicates that icing of the sensor is the root cause of this issue.

Figure 1, Condensation on the EGR Differential Pressure Sensor.

- If soot is found, gently wipe away with a clean towel. Be sure not to apply too much pressure on the sensor elements, as they can become damaged.
 - If ice or condensation is found (See Figure 1 below), gently wipe away with a clean towel. Be sure **not** to apply too much pressure on the sensor elements, as they can become damaged.
