Technical Service Bulletin

72 Noises from the front center armrest

72 23 50 2064920/2 November 20, 2023. Supersedes Technical Service Bulletin Group 72 number 22-38 dated January 8, 2022 for reasons listed below.

Model(s)	Year	VIN Range	Vehicle-Specific Equipment
Q8	2019 – 2022	All	Not Applicable
Q7, SQ7, SQ8, and RS Q8	2020 – 2022

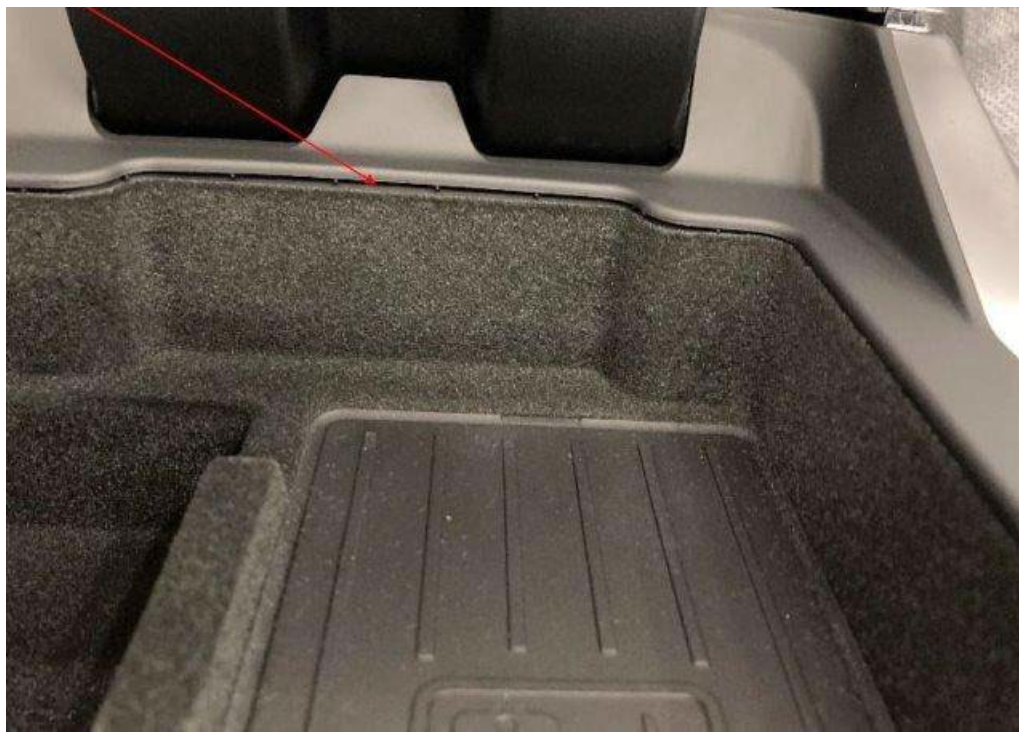
The contact between the armrest and center console upper section leads to noises when under load.

- 1 Check the gap between the center console upper section and the storage compartment (Figure 1). The gap should not exceed 0.5 mm.

Figure 1. Check the gap between the center console upper section and the storage bin.

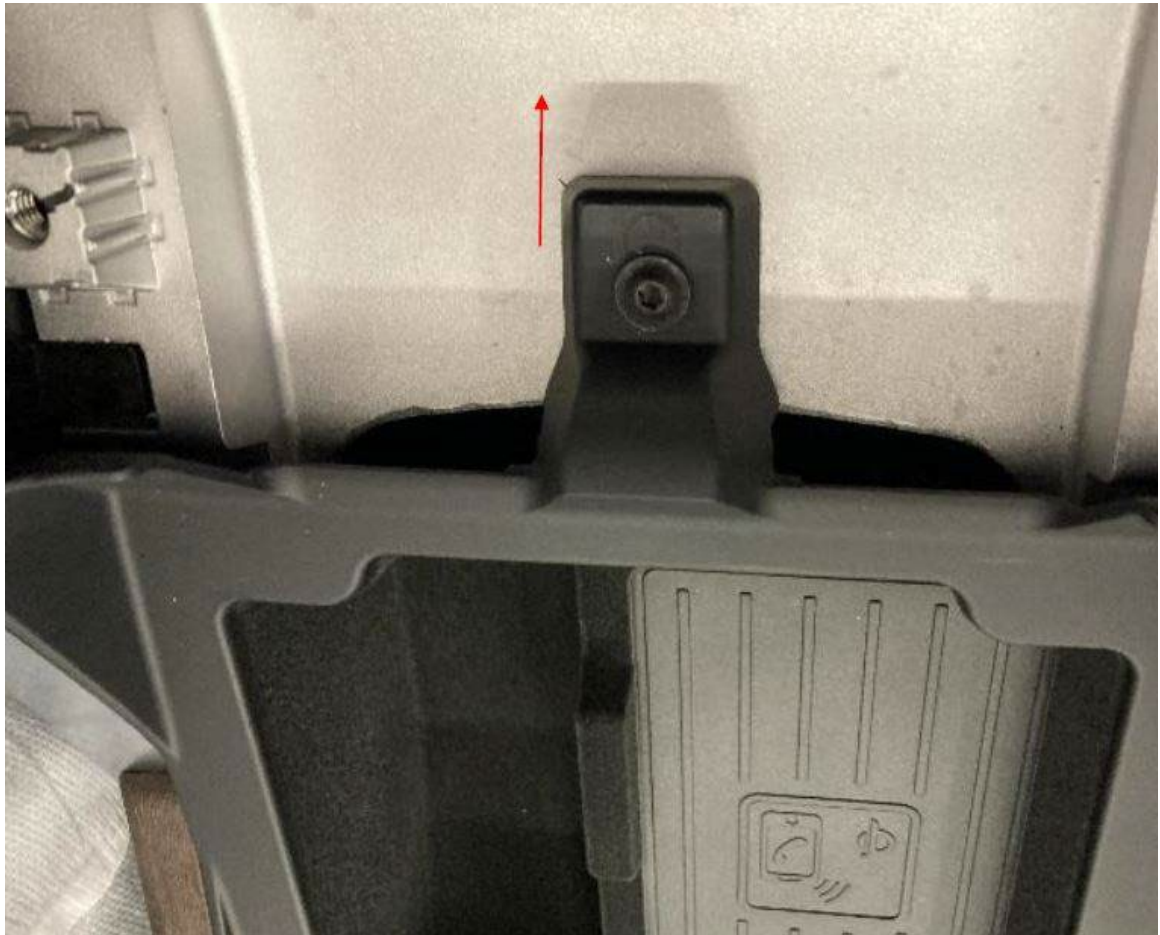
Figure 2. Moving the center console upper section towards the rear of the vehicle

- 2 Remove the armrest trim and the rear center console trim.
- 3 Remove the center armrest following the Elsa Repair Manual.
- 4 Loosen the center console upper section screw (Figure 2).

- 5 Pull the center console upper section towards the rear of the vehicle and tighten the screw (Figure 2).

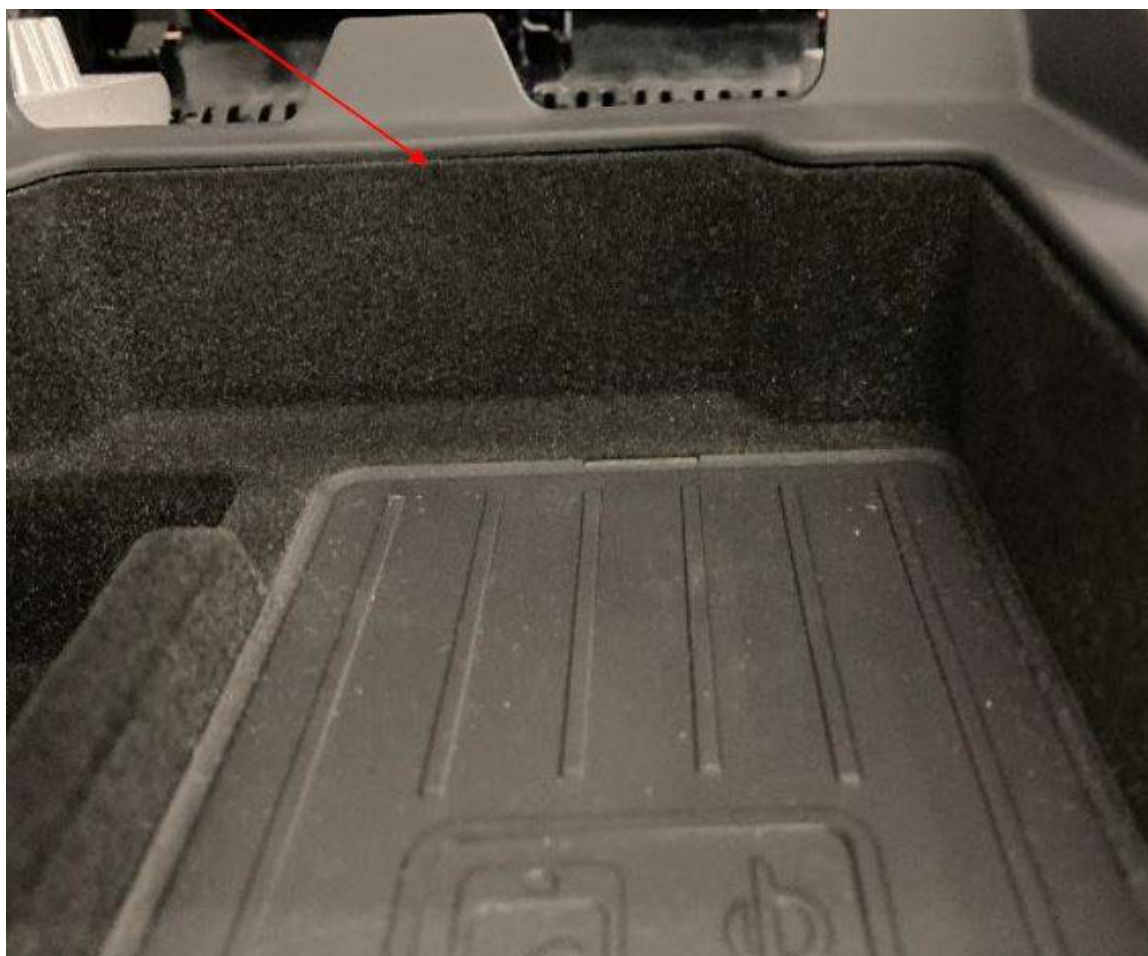
- 7 Recheck the gap of the center console upper section (Figure 3). The gap should be even and approx.0.5 mm.

Figure 3. Center console upper section to storage bin gap, even and approx.0.5 mm wide.
