# Technical Service Bulletin

## 90 Audi pre sense - restricted function icon is displayed after engine starts

90 23 52 2059891/5 November 10, 2023. Supersedes Technical Service Bulletin Group 90 number 23-10 dated March 8, 2023 for reasons listed below.

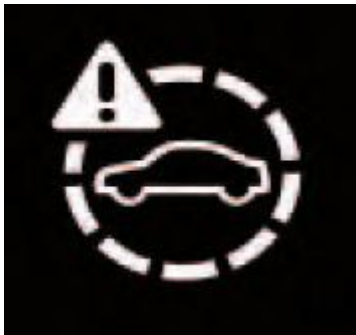
- One of the symbols for “Audi pre sense not available at the moment” is shown for about 20 seconds after the engine starts, and then it disappears (Figures 1 – 2).
- In some models, the vehicle must be moved before the initialization indicator goes out.

**Figure 1.** Symbol for “Audi pre sense not available at the moment”.

This icon is shown for about 20 seconds after switching the ignition on because Audi pre sense is not available at the time. The front camera for driver assist systems R242 needs about 20 seconds, or, in some models, a velocity signal, to start up.

2. Inform the customer that it takes the front camera for the driver assist system (R242) about 20 seconds to start up and the icon informs the driver of this fact. This is normal behavior.
