## Preliminary Information

### PIP5943 Diagnostic Aids for 8 Speed Transmissions With Shift Concerns

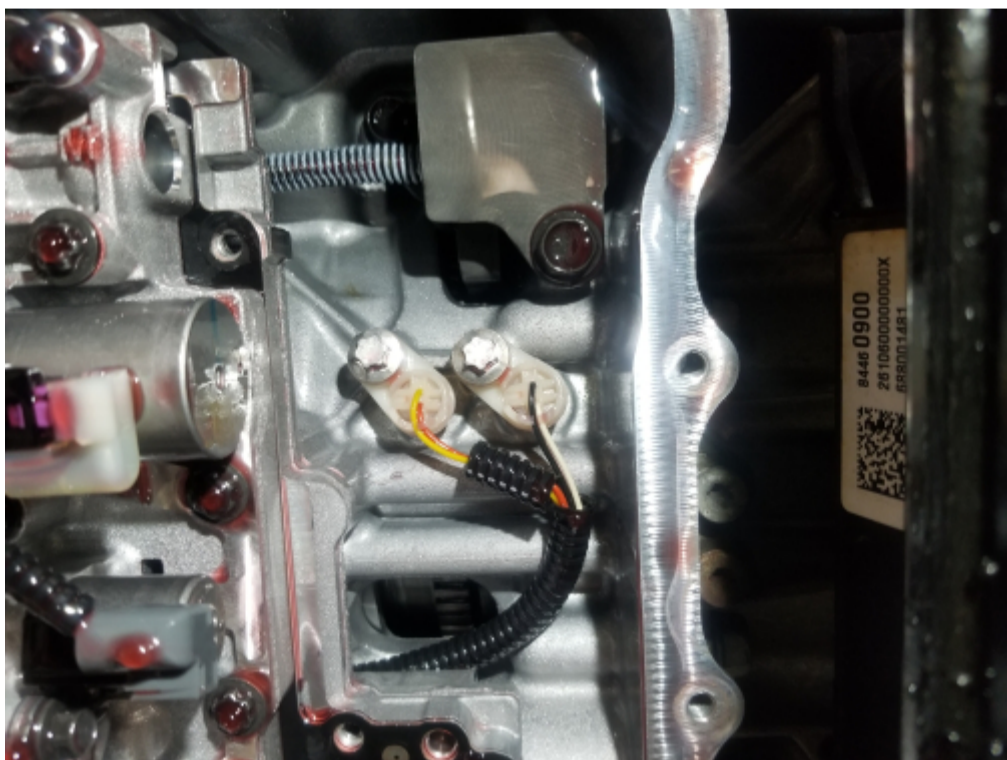
Incorrect Installation

Also, If the speed sensors were just replaced and the Service Fast Learn fails for excessive vehicle speed, or If P0717, P0722, P0746 and/or P0796 also sets the Speed sensors should be inspected for the proper orientation as seen in SI, Meaning the smaller portion of the conduit should be facing the rear of the unit

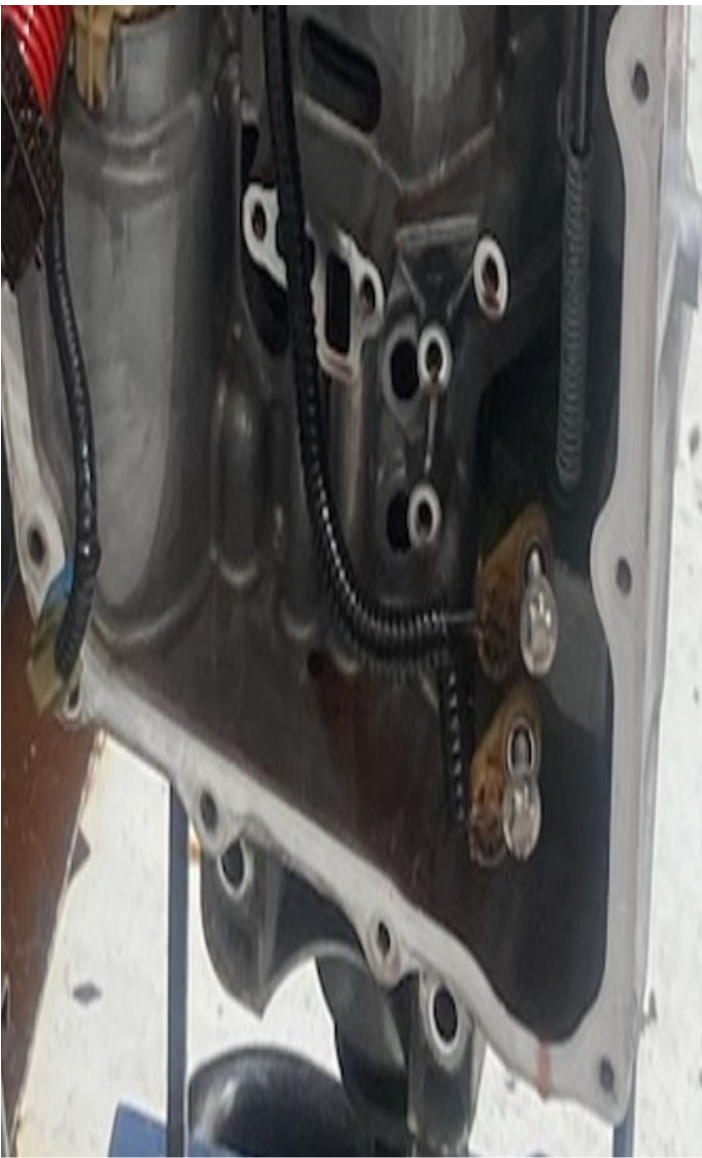
Correct Installation
