Bulletin No.: PIT6077
Published date: 10/24/2023

PIT6077 Exhaust Tailpipe Tips Misaligned When Comparing Left To Right Sides

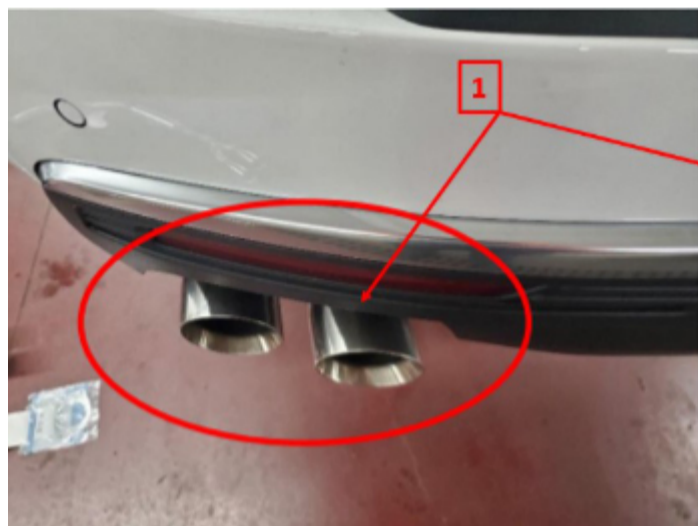
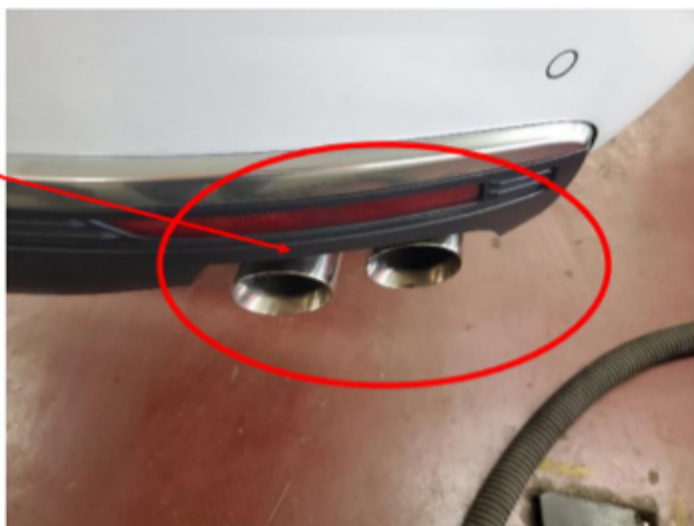
Involved Region or Country	North America
Condition	Some customers may comment that the exhaust tailpipe tips are misaligned. The left side exhaust tip will protrude further out from the rear bumper fascia when compared to the right side exhaust tip, as shown below (1).
Cause	The cause of this concern, is a manufacturing variation when the S-pipe is welded to the muffler.

Do Not replace the tailpipe assembly.

To correct this concern, replace the muffler, shown below (2).
