PRODUCT CAMPAIGN BULLETIN

APPLICABILITY: 2015-2021 MY WRX STI **NUMBER:** WRE-22R
SUBJECT: Safety Recall – Back-Up Lamp Switch Failure **DATE:** 09/02/22
REVISED: 11/10/23
NHTSA: 22V-522

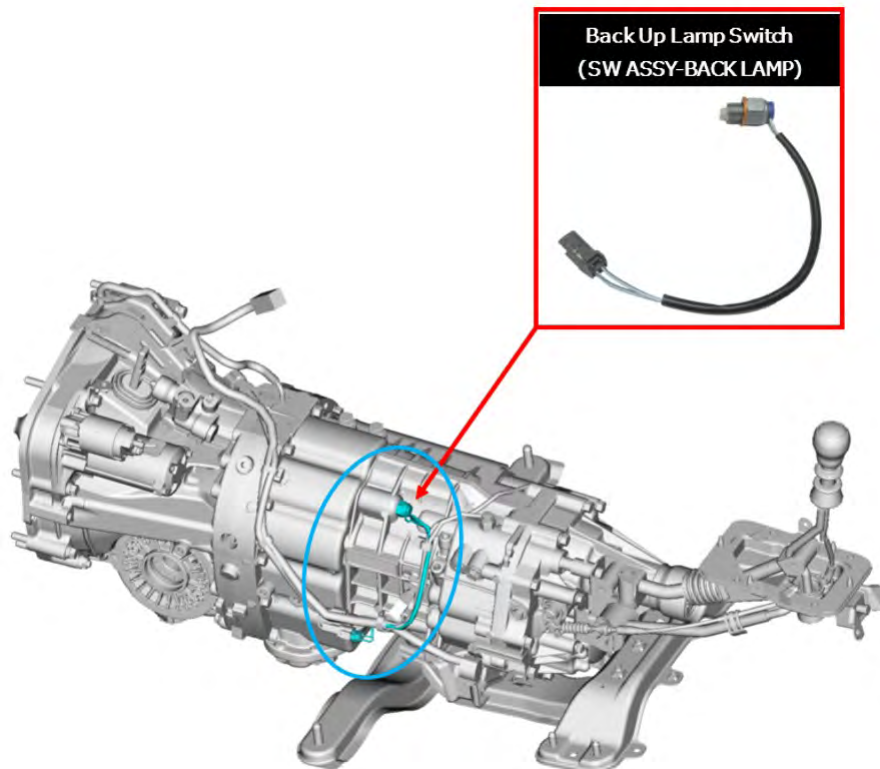
COMPONENT DESCRIPTION:

The operating environment of the back-up lamp switch may expose the internal switch contacts to heated oil. When heated, sulfur in the oil may cause a chemical reaction with the materials used on the switch terminal contact surfaces and plate spring. This chemical reaction may cause corrosion and a non-conductive film to form on the contacts resulting in poor electrical conductivity.

For all potentially affected vehicles, Subaru retailers will conduct an inspection and replace the back-up lamp switch with improved one, if necessary, at no cost to the customer.

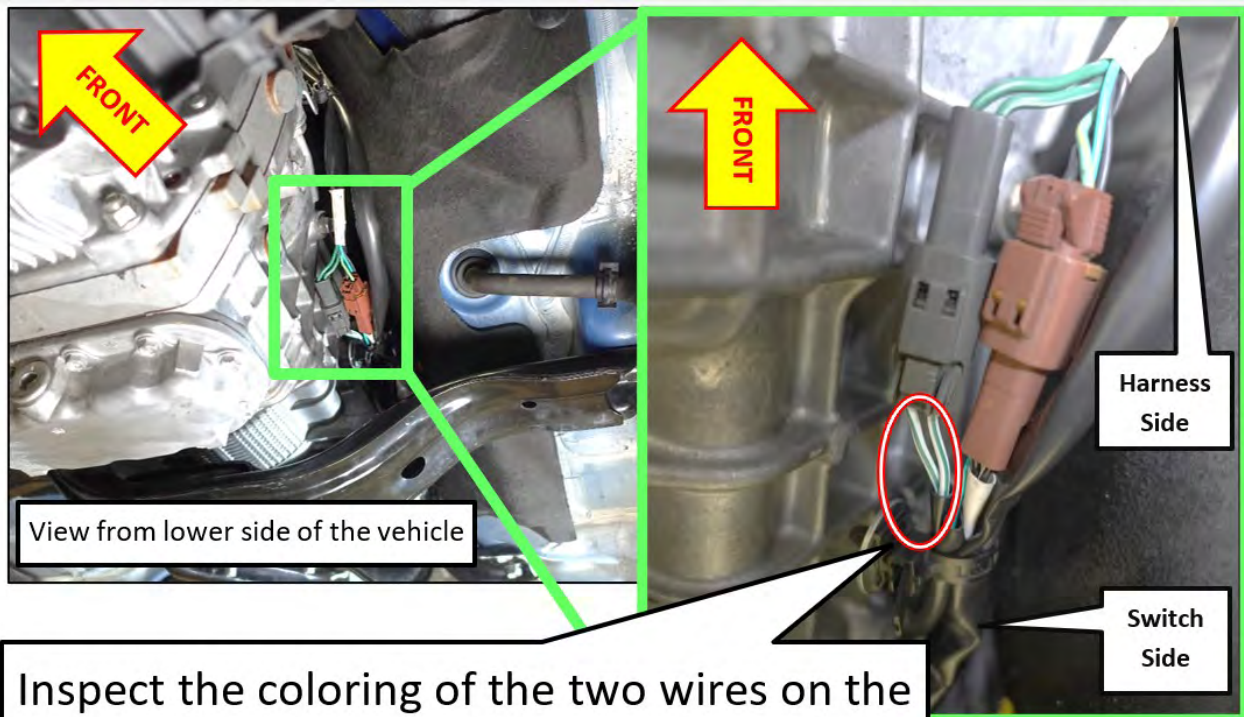
STEP 4: Perform a visual inspection of the wiring harness colors on the back-up lamp switch.

Inspect the coloring of the two wires on the switch side of the gray connector
The black protection tube can be pulled back for inspection

STEP 5: Apply the visual inspection results from **STEP 4** to the table below to verify the next course of action.

Back-Up Lamp Switch Version	OLD	NEW
Back-Up Lamp Switch Replacement	REQUIRED	<u>NOT</u> REQUIRED
Next Step	Proceed to STEP 6	No further action is required. Reinstall the removed parts in the reverse order of disassembly.
