Technical Service Bulletin

91 No diagnostics communication to the telematics control module; DTC U142100

91 23 49 2056076/20 November 17, 2023. Supersedes Technical Service Bulletin Group 91 number 23-19 dated August 8, 2023 for reasons listed below.

Model(s)	Year	VIN Range	Vehicle-Specific Equipment
All Audi Vehicles	2019 – 2020	Not Applicable	ConBox Low

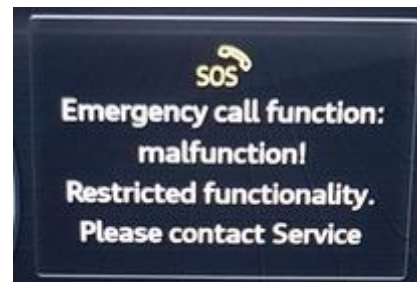
- An SOS Warning might be displayed in the instrument cluster (Figure 1).

Figure 1. Emergency call malfunction warning.

A software bug can cause the control module to freeze during a cold start.

1. Perform a power reset (terminal 30 reset) of the ConBox by pulling its fuse and reinstalling it after a couple minutes. Please check the repair manual regarding the fuse locations.
2. If ODIS **still cannot** connect to the telematics control module, -J949- (address word 0075), then follow the ODIS test plan and replace the telematics control module with part number **992 035 286 C**.

1. Follow all instructions in TSB 2011732: *00 Software Version Management (SVM), operating instructions.*
2. Update the telematics control module, -J949- (address word 0075) using the SVM action code as listed in the table below, if necessary:
