Technical Service Bulletin

91 MIB3 ASI: Apple CarPlay screen is blank

91 23 51 2065728/6 November 22, 2023. Supersedes Technical Service Bulletin Group 91 number 23-14 dated July 17, 2023 for reasons listed below.

Model(s)	Year	VIN Range	Vehicle-Specific Equipment
All Audi Vehicles	2020 – 2025	Not Applicable	MIB3 with Apple CarPlay

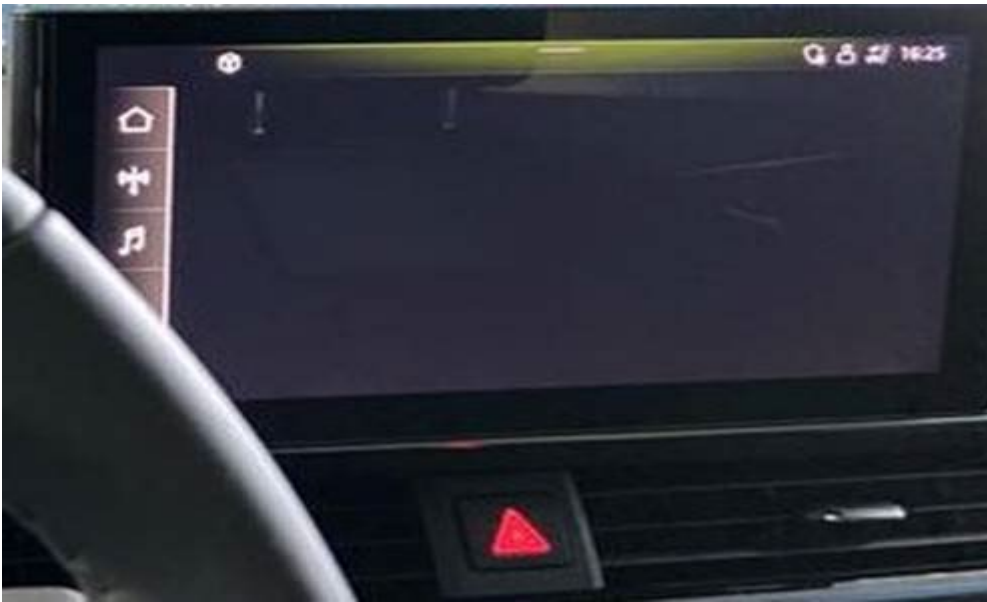
- An iPhone is connected via wireless Apple CarPlay (wACP) to the vehicle's MMI system.
- The Audi Smartphone Integration (ASI) feature is selected in the vehicle.
- Audio dropouts can be heard.
- The ASI display goes blank. The shortcut bar on the left side of the screen, as well as the top dropdown menu anchor, can still be seen on the screen (see *Figure 1*).

Figure 1: ASI display is blank when using wACP.

A non-standard behavior of the previous Apple iOS versions (including all 14.x, 15.x, and early 16.x versions) causes the phone to fail to send screen data to the vehicle. Additionally, a hardware issue in iPhone 8, iPhone X, and iPhone XR models can cause the display to blank out.

1. Do not perform any repairs. Any repairs for this concern may be denied.
2. **For customers with iPhone 8, iPhone X, and iPhone XR:**
The problem is due to a hardware issue in the WiFi chipset of the listed phone models. As those phone models are already out of production, no repair will be available. It is advisable to use a wired connection to use Apple CarPlay for those models.
3. **All other iPhone models:**
Please inform the customer that this behavior is due to a bug in the phone's operating system (iOS). **The iOS bug is fixed in iOS version 16.5 or newer.**

In some cases, going to the home menu by clicking the home shortcut on the left of the screen and then reentering ASI resolves the concern. In other cases, the phone might need to be disconnected and then reconnected.
