SIB 11 07 23

**VOLUNTARY EMISSION RECALL 23E-A05: REPLACE SWITCHABLE
ROCKER ARM**

The return springs on the exhaust camshaft followers may break.

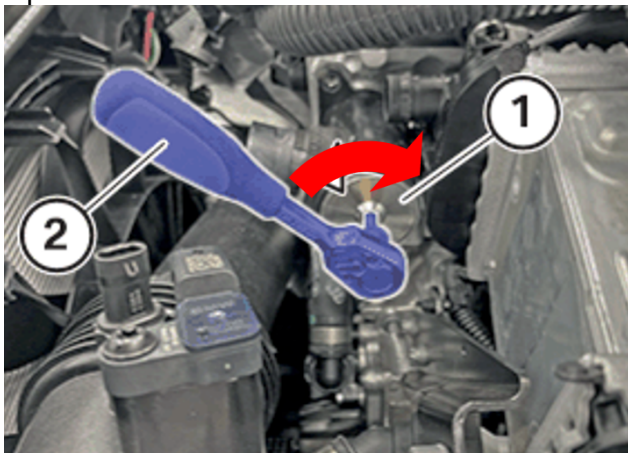
Cylinder 1 intermediate lever may interfere when trying to install the intake camshaft timing tools.

Place the VVT motor in minimum lift before installing the camshaft timing tools.

Use a 4mm Allen socket (1) and a ratchet (2) to turn the VVT motor clockwise until it stops at the minimum lift end stop.

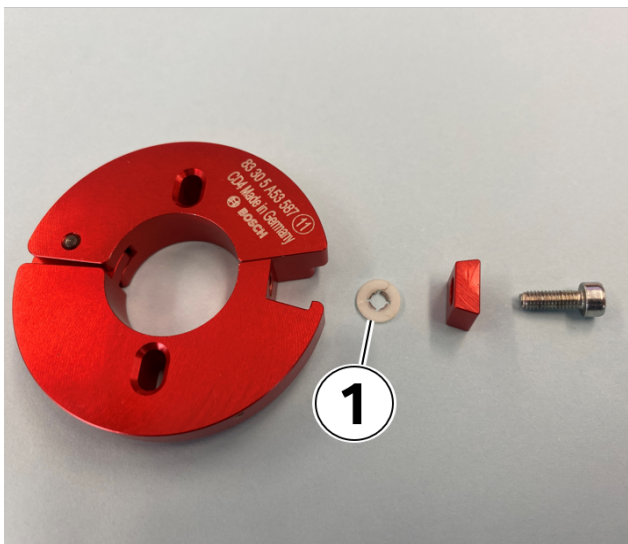
Tool 83 30 5 A53 587 may bind when removing it from both of the VANOS adjusters, the plastic washer (1) may be binding the tool and will not allow it to collapse when the screw is loosened.

Using a fine metal file, reduce the outside diameter of the plastic washer by approximately 1 mm to avoid this interference.

Removing the washer entirely could result in the screw and wedge falling into the engine, the washer avoids loosening the screw too much.

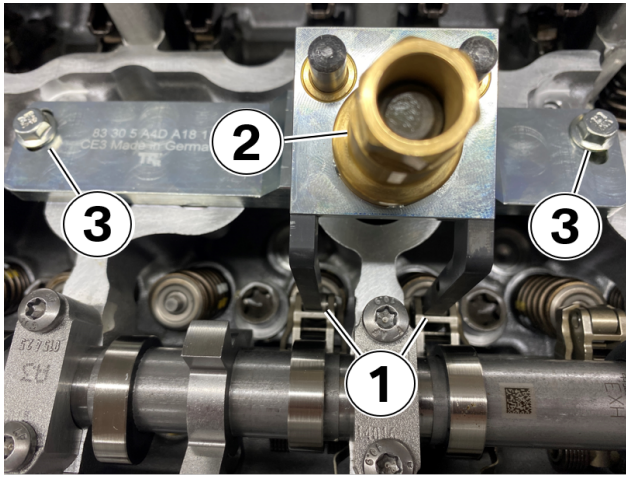
Special tool 83 30 5 A4D A18 must be aligned properly with the rollers (1).

Turn the brass nut (2) to make contact with the rollers.

Tighten the screws on the base plate of the tool (3).

Finish compressing the springs with the brass nut (2).

The tool must remain installed during the entire camshaft removal and installation procedure.
