Technical product information

Topic	HVAC distribution/operational issues - HVAC Motor defect DTC's logged
Market area	Australia E04 Bentley rest Asia and Australia (6E04),China 723 Volkswagen (Anhui) Automotive CO (6723),China 796 VW Import Comp. Ltd (Vico), Beijing (6796),Germany E02 Bentley rest Europe (6E02),Japan E03 Bentley Japan (6E03),Korea, (South) E08 Bentley South Korea (6E08),United Arab Emirates E06 Bentley Middle East and Africa (6E06),United Kingdom E01 Bentley UK (6E01),United States E05 Bentley USA and rest America (6E05)
Brand	Bentley
Transaction No.	2051519/13
Level	EH
Status	Approval
Release date

- HVAC distribution/operational issues
- HVAC motor defect (DTC's) evident within address 08 - Climatronic control unit, the DTC's can be static or Intermittent

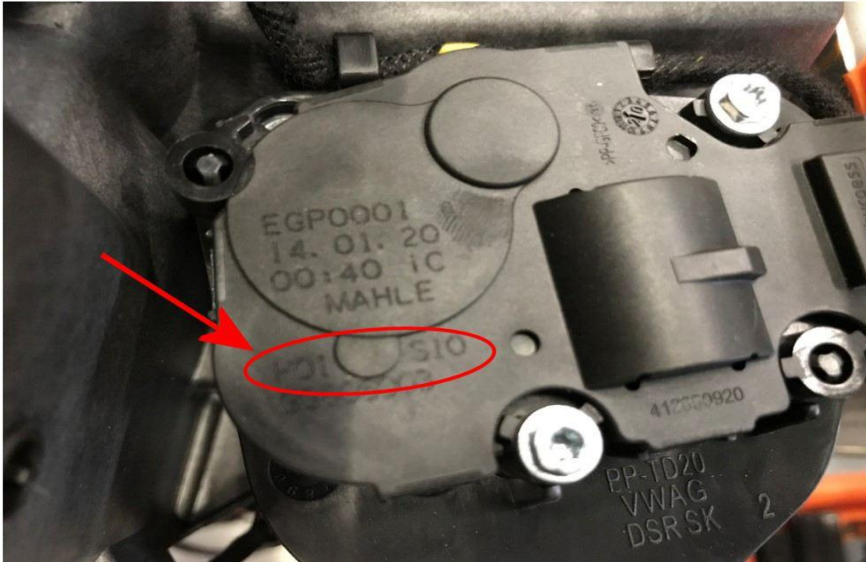
Note: Figure 1 shows a Bentayga motor and Figure 2 shows a New Continental GT/GTC and New Flying Spur motor

Scenario 1- Motors identified as PRIOR/BEFORE Hardware H01 and Software S10

- Replace all motors ensuring the latest specification parts are ordered and fitted

Scenario 2 - Motors identified as Hardware H01 and Software S10

- Motors **MUST NOT** be replaced unless diagnosed **and** proven to be faulty

Scenario 3 - Motors identified as POST/AFTER Hardware H01 and Software S10

For example: Motors with H07 / S11 should not be replaced unless faulty
