# Service Bulletin

Bulletin No.: 23-NA-176

**Subject: Dead Battery, No Start, and/or Vehicle Will Not Shut Down**

Brand:	Model:	Model Year:		VIN:		Engine:	Transmission: (Automatic)
		from	to	from	to		
Chevrolet	Corvette	2020	2024	—	—	—	M1L, M1M

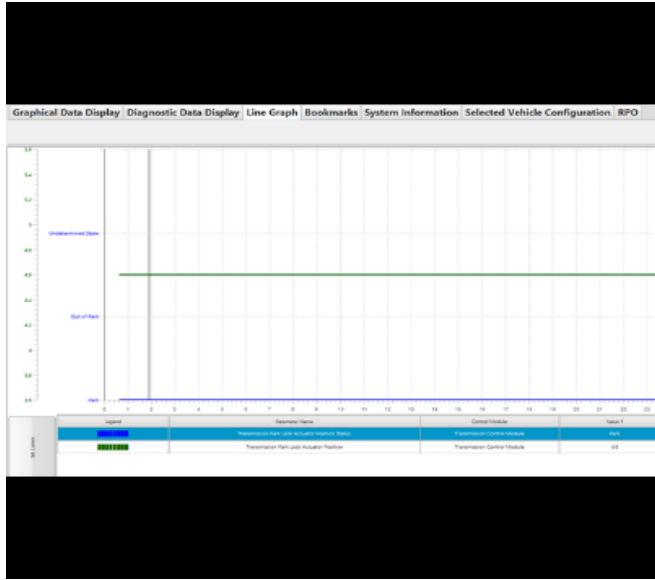
<b>Cause</b>	This condition may be caused by park sensor drift or communication error, caused by module or circuitry.

<p><b>Correction</b></p>	<p>The technician is advised to start a TAC case immediately and forward the park sensor measurement found in GDS transmission data.</p> <div style="text-align: center;">

</div> <p style="text-align: right; font-size: small;">6444770</p> <p>The TAC agent will use this data to request that engineering verify the park position at birth. Comparison of this data will confirm whether the transmission has park sensor drift that will require transmission replacement, or the correct direction of vehicle repair.</p>
--------------------------	---
