Service Bulletin

Bulletin No.: 23-NA-196

Subject: Ratcheting Type Noise Heard from Under the Vehicle when Disengaging All Wheel Drive (AWD)

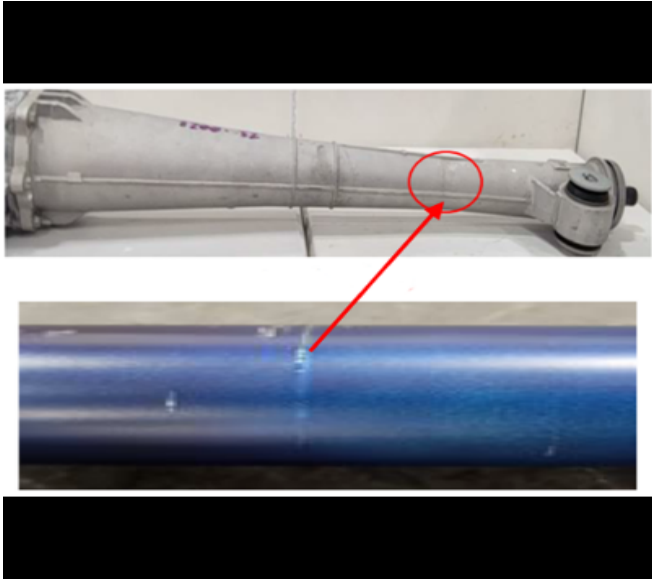
</div> <p style="text-align: right; font-size: small;">6472057</p> <p>This condition may be caused by the inner differential carrier output shaft contacting the driveline torque tube.</p>
Correction	If the noise has been verified to be coming from the driveline torque tube, replace the driveline torque tube.

Refer to *Driveline Torque Tube Replacement* in the Service Manual.
