Technical product information

Topic	New Continental GT, GTC and Flying Spur - Front anti roll bar link - Diagnosis guidelines
Market area	Australia E04 Bentley rest Asia and Australia (6E04),China 796 VW Import Comp. Ltd (Vico), Beijing (6796),Germany E02 Bentley rest Europe (6E02),Japan E03 Bentley Japan (6E03),Korea, (South) E08 Bentley South Korea (6E08),United Arab Emirates E06 Bentley Middle East and Africa (6E06),United Kingdom E01 Bentley UK (6E01),United States E05 Bentley USA and rest America (6E05)
Brand	Bentley
Transaction No.	2071772/1
Level	EH
Status	Approval
Release date

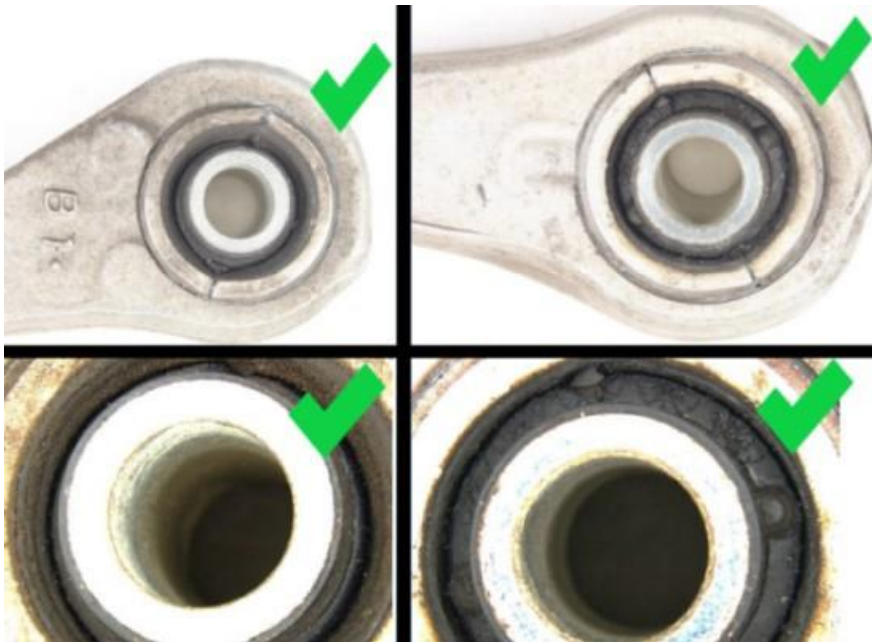
Front anti roll bar link lower bushes have small cracks on the surface

Front anti roll bar links have been incorrectly diagnosed and unnecessarily replaced

The minor splits (Figure 1) are visible on the surface and do not effect bush integrity

Do Not replace the front anti roll bar links when small splits are identified on the lower bushes as shown in Figure 1

NOTICE
 In the event that one or a combination of the following issues are evident relating to the front anti roll bar link bushes, the operative must raise a technical DISS query and await feedback before replacing any parts

- Excessive wear
- Excessive cracks/splits
- Noise emitting from the front anti roll bar links
- Loose lower anti roll bar link fixings
