Technical product information

Topic	DTC B17B801 and/or B17B804 - evident within address 0019 and/or DTC U112300 evident in 00A5
Market area	Australia E04 Bentley rest Asia and Australia (6E04),China 723 Volkswagen (Anhui) Automotive CO (6723),China 796 VW Import Comp. Ltd (Vico), Beijing (6796),Germany E02 Bentley rest Europe (6E02),Japan E03 Bentley Japan (6E03),Korea, (South) E08 Bentley South Korea (6E08),United Arab Emirates E06 Bentley Middle East and Africa (6E06),United Kingdom E01 Bentley UK (6E01),United States E05 Bentley USA and rest America (6E05)
Brand	Bentley
Transaction No.	2063855/9
Level	EH
Status	Approval
Release date

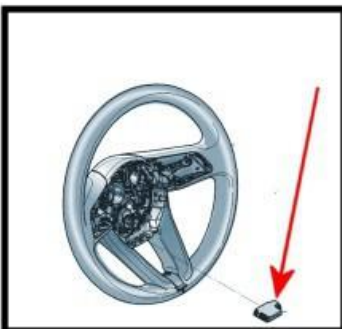
- DTC - B17B801 - Steering Wheel Touch Recognition Control Module evident within **address 0019**

- DTC B17B804 - Steering Wheel Touch Recognition Control Module electrical error - evident within **address 0019**

- DTC U112300 with symptom Code 1123220 within **address 00A5**

- 1) Referring to Rep.Gr 69 - Remove the driver's air bag
- 2) Referring to Figure 1 - Replace the Steering Wheel Contact Detection control unit (J1158)
