Technical product information

Topic	Audible creak from the lower/central A Post when opening and/or closing the front door/s
Market area	Australia E04 Bentley rest Asia and Australia (6E04),China 723 Volkswagen (Anhui) Automotive CO (6723),China 796 VW Import Comp. Ltd (Vico), Beijing (6796),Germany E02 Bentley rest Europe (6E02),Japan E03 Bentley Japan (6E03),Korea, (South) E08 Bentley South Korea (6E08),United Arab Emirates E06 Bentley Middle East and Africa (6E06),United Kingdom E01 Bentley UK (6E01),United States E05 Bentley USA and rest America (6E05)
Brand	Bentley
Transaction No.	2064482/3
Level	EH
Status	Approval
Release date

Bentayga

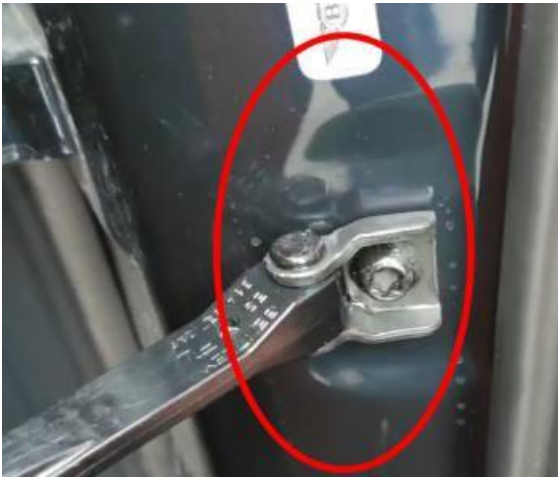
Figure 1

Audible creak coming from the lower/central A post in the vicinity of the check strap fixing point (Figure 1) during the opening and/or closing of the driver/passenger door

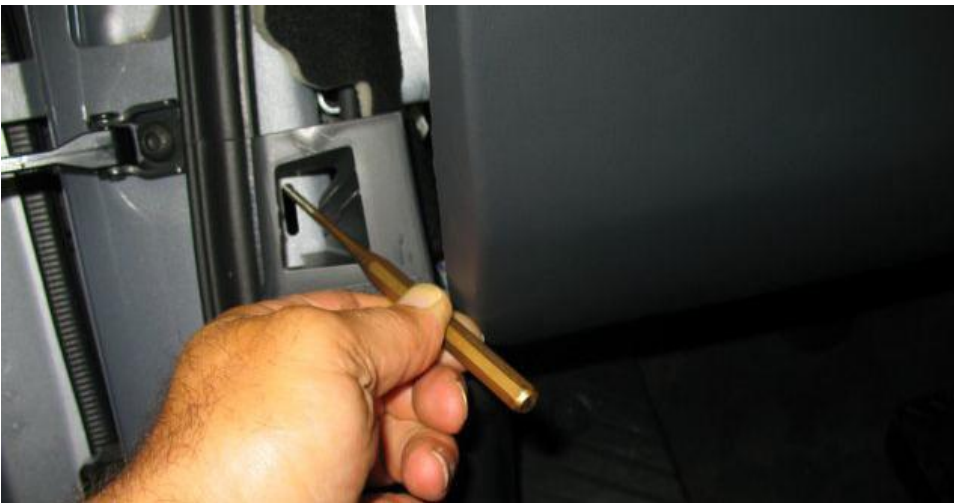
TIP: This creates enough space between the hinge reinforcement panel and the inner face of the A Post panel, the two panels can no longer rub against each other when opening and/or closing the door

3) Referring to Figure 4 - Place a suitable drift with a diameter of 4mm onto the hinge reinforcement panel as shown

- Using a suitable hammer in conjunction with the drift - Relocate the hinge reinforcement panel forward by 10 mm
