Technical product information

Topic	Keyless door entry does not work - Front Outside Door Handle(s) - Touch Sensor DTC B147613 and/or B147713 are present
Market area	Australia E04 Bentley rest Asia and Australia (6E04),China 723 Volkswagen (Anhui) Automotive CO (6723),China 796 VW Import Comp. Ltd (Vico), Beijing (6796),Germany E02 Bentley rest Europe (6E02),Japan E03 Bentley Japan (6E03),Korea, (South) E08 Bentley South Korea (6E08),United Arab Emirates E06 Bentley Middle East and Africa (6E06),United Kingdom E01 Bentley UK (6E01),United States E05 Bentley USA and rest America (6E05)
Brand	Bentley
Transaction No.	2062257/6
Level	EH
Status	Approval
Release date

New Continental GT/GTC and New Flying Spur Series

Keyless door entry does not work - Front Outside Door Handle(s) - Touch Sensor DTC B147613 and/or B147713 are present

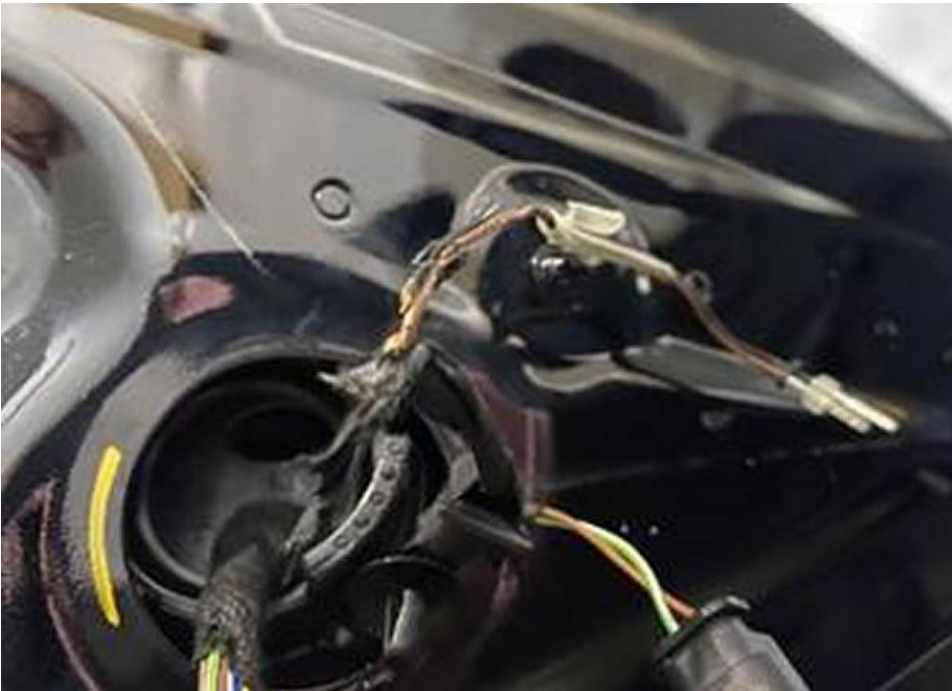
Figure 1

Front outside door handle(s) touch sensor open circuit DTC(s) present within address 0046

- Referring to Figures 1 and 2 - Perform a check of the wiring that is routed through the exterior door handle (from the convenience control module), including the wiring inside the clear heat shrink and/or insulation tape
- In the event that any wires show damage or signs of chaffing/breaks continue with the suggested repair as detailed in Step 3

3) Repair the broken or damaged wires as per Rep.Gr 97

TIP: Where possible, extend the length of the wires by 10mm

- Ensure the wiring does not clash with and components in particular the window mechanism
