Technical product information

Topic	New Flying Spur Hybrid - 12 volt battery draining during the charging of the high voltage battery
Market area	Australia E04 Bentley rest Asia and Australia (6E04),China 723 Volkswagen (Anhui) Automotive CO (6723),China 796 VW Import Comp. Ltd (Vico), Beijing (6796),Germany E02 Bentley rest Europe (6E02),United Arab Emirates E06 Bentley Middle East and Africa (6E06),United Kingdom E01 Bentley UK (6E01),United States E05 Bentley USA and rest America (6E05)
Brand	Bentley
Transaction No.	2068627/3
Level	EH
Status	Approval
Release date

New Flying Spur Hybrid

The 12 volt battery is draining during the charging of the high voltage battery

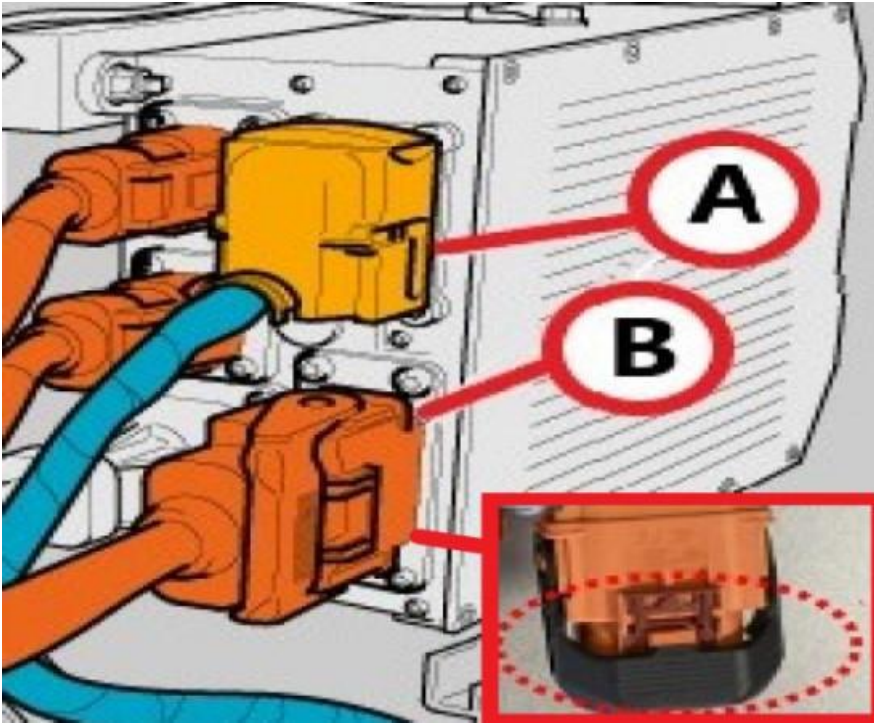
4) Referring to Figure 1 point A - Check and confirm the primary and secondary latches are fully locked in position

- Referring to point B and inset - Check and confirm the primary and secondary latches are fully locked in position
- Referring to the inset - Check and confirm the primary and secondary latches (red and black) are fully locked in position

IMPORTANT: In the event that any of the plugs shown in Figures 1 and 2 are found not to be secure (primary and secondary latch are not fully locked into position) the operative must respond via the open DISS query and await feedback before conducting any further work

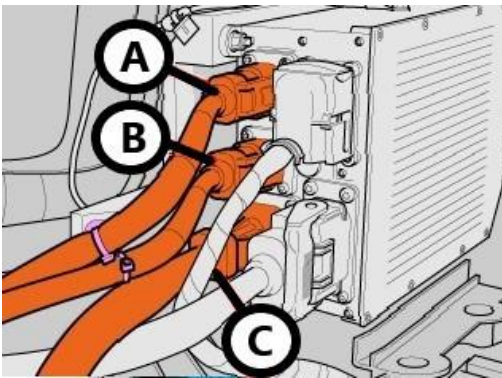
- Referring to Figure 2 (Points A,B and C) Check and confirm the primary and secondary latches are fully locked in position

Should any issues be found, the operative **MUST** respond via the open DISS query ensuring all findings are included within the DISS, the operative must await feedback before conducting any further work
