Service Bulletin

Bulletin No.: 23-NA-115

Subject: Ticking, Tapping or Snapping Noise from Engine - 5.5L RPO LT6 Realign Camshaft Caps as Required

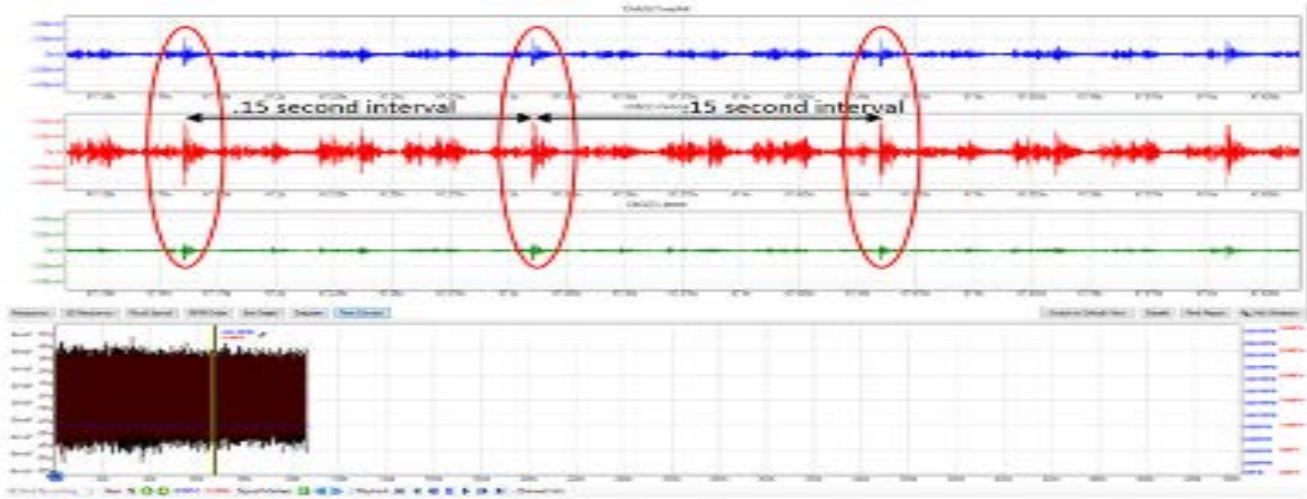
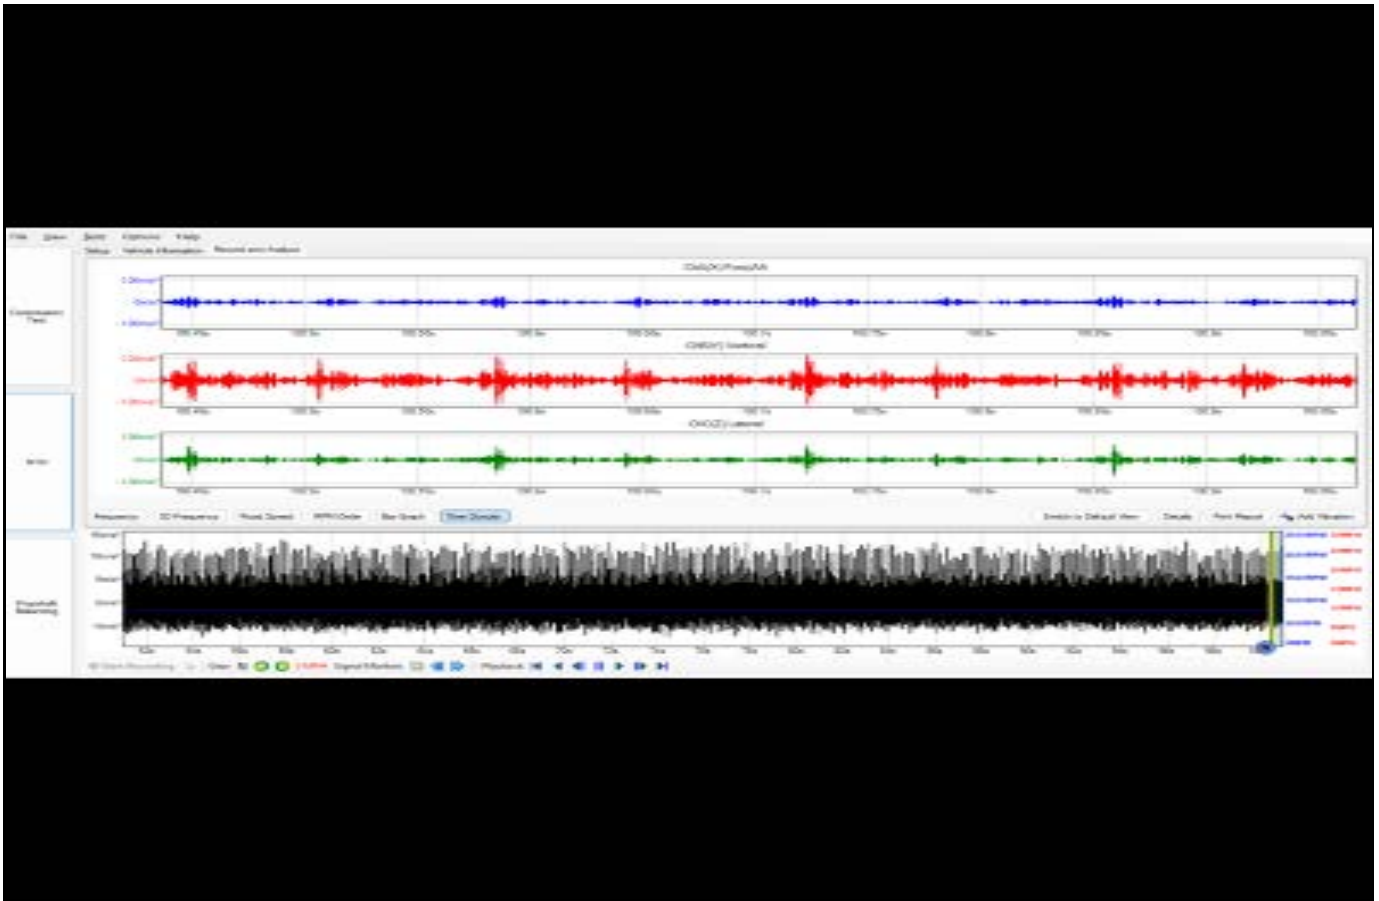
Examples of Tick:

- Right click in the time domain display and change the display mode to single.
- If scales on the left end for each channel are not ranging from -4 m/s² to 4 m/s², right click in the time domain display and select “reset scale.”
- Pull the yellow window cursors on the bottom in as close together as they will go.
- Look at the channel lines in the time domain window for ticks with a .15s gap between them.
 - ⇒ Compare to the examples below for an engine with a tick and an engine without a tick:

Once it is determined which bank the noise is coming from, it will be necessary to follow the service procedure below to adjust the camshaft cap torque.
