CLICKING/TICKING NOISE FROM FRONT AXLE WHEN TURNING AT FULL LOCK AT LOW SPEEDS

- SSM 75779 has been published to provide repair guidance.
- Please ensure the service instructions are followed exactly upon customer complaint.

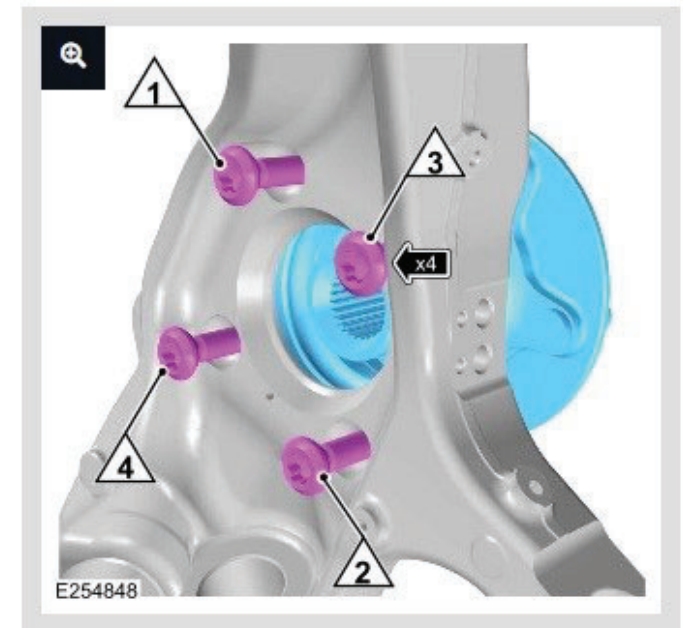
- There is a clicking or ticking type noise from the front axle area of the vehicle while turning either left or right at or near full lock at low speeds.

- This may be caused by the front wheel bearing/hub assembly not being fully seated.
