Technical product information

Topic	Rear screen sunblind not operating to specification - Minimum diagnosis requirements before replacing the sunblind
Market area	Australia E04 Bentley rest Asia and Australia (6E04),China 723 Volkswagen (Anhui) Automotive CO (6723),China 796 VW Import Comp. Ltd (Vico), Beijing (6796),Germany E02 Bentley rest Europe (6E02),Japan E03 Bentley Japan (6E03),Korea, (South) E08 Bentley South Korea (6E08),United Arab Emirates E06 Bentley Middle East and Africa (6E06),United Kingdom E01 Bentley UK (6E01),United States E05 Bentley USA and rest America (6E05)
Brand	Bentley
Transaction No.	2070643/3
Level	EH
Status	Approval
Release date

New Flying Spur

Rear screen sunblind not operating to specification - Minimum diagnosis requirements before replacing the sunblind

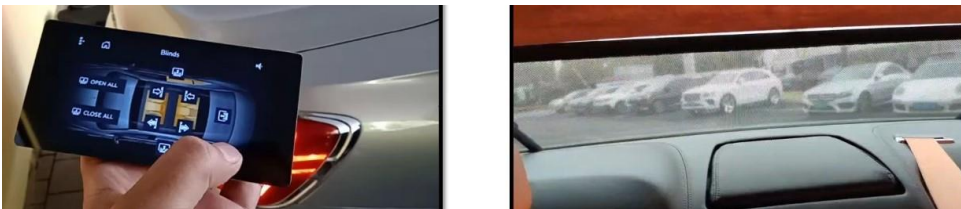
- Attach a clear video and photographs of the actual failure mode (see examples of the requirements in Figure 1

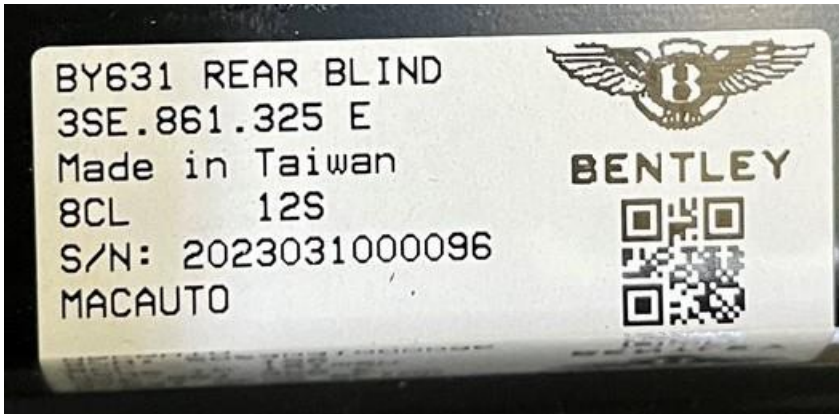
In the event permission was given to replace the rear sunblind (via DISS) the operative must attach a photo of the original rear sunblind identification label as shown in Figure 3

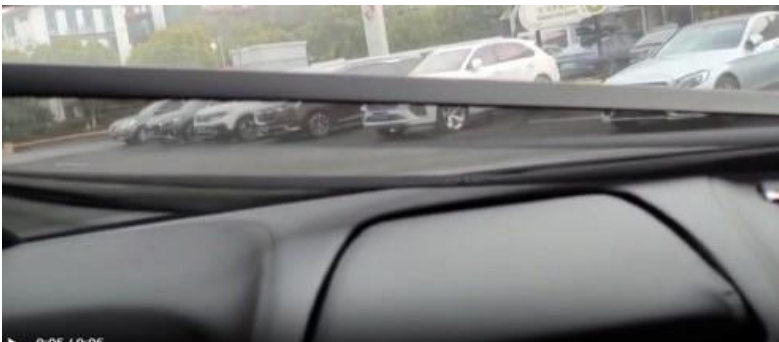
Figure 4

Rear blind is detached on one side (Figure 4)

NOTE: In this scenario (rear blind detached) the rear blind must be replaced

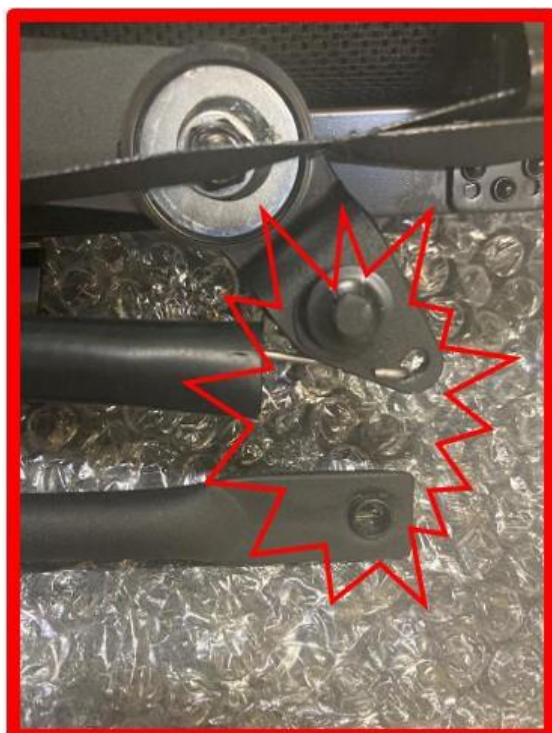
- Referring to Figure 5 - Check to confirm if the rivet and star washer is fitted/secure

NOTE: Figure 5 shows the rivet and star washer detached

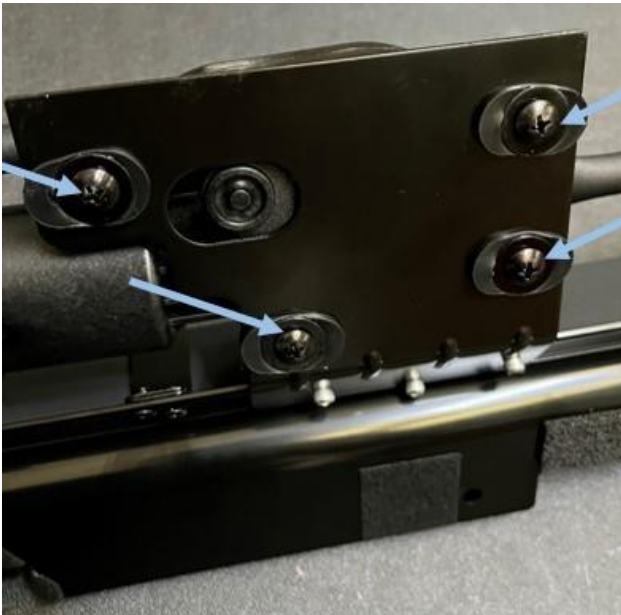
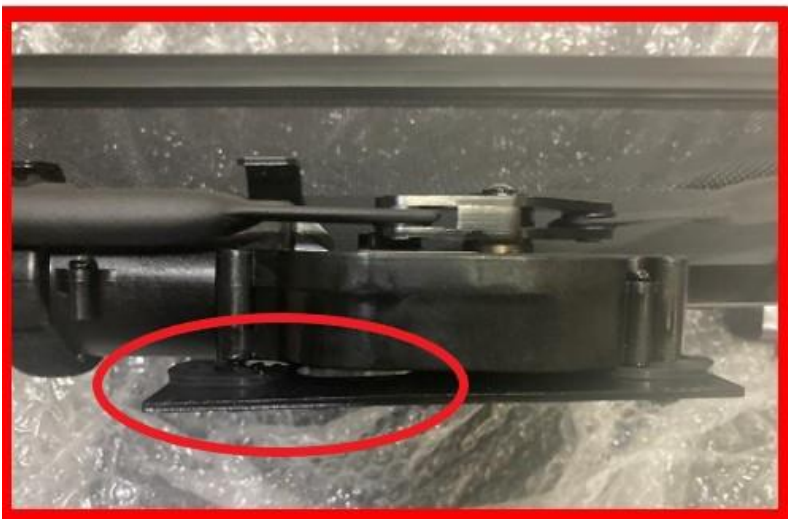
[Gearbox screws loose \(Figure 6 and Figure 7\)](#)

NOTE: Figure 6 and Figure 7 shows loose gearbox screws

NOTE: In this scenario (gearbox screws loose) the rear blind must be replaced

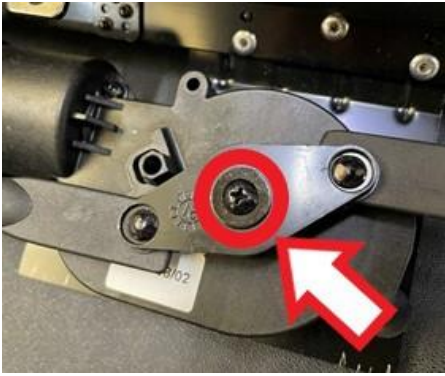
- Referring to Figure 8 - Remove the rotator plate fixing

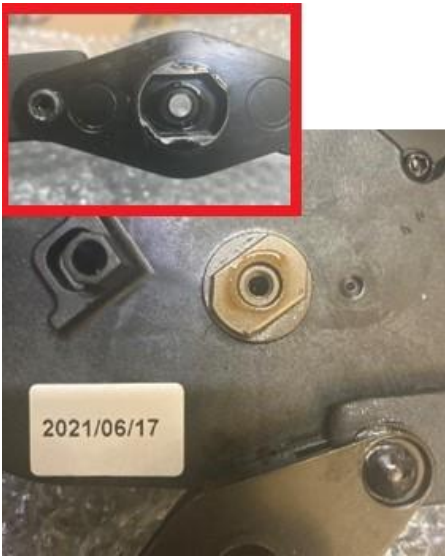
- Referring to Figure 9 - Remove the rotator plate
