## Technical product information

<b>Topic</b>	Oil leak from the oil separator/breather connection - Intake manifold whistle - Engine warning lamp illuminated
<b>Market area</b>	Australia E04 Bentley rest Asia and Australia (6E04),China 723 Volkswagen (Anhui) Automotive CO (6723),China 796 VW Import Comp. Ltd (Vico), Beijing (6796),Germany E02 Bentley rest Europe (6E02),Japan E03 Bentley Japan (6E03),Korea, (South) E08 Bentley South Korea (6E08),United Arab Emirates E06 Bentley Middle East and Africa (6E06),United Kingdom E01 Bentley UK (6E01),United States E05 Bentley USA and rest America (6E05)
<b>Brand</b>	Bentley
<b>Transaction No.</b>	2066040/3
<b>Level</b>	EH
<b>Status</b>	Approval
<b>Release date</b>

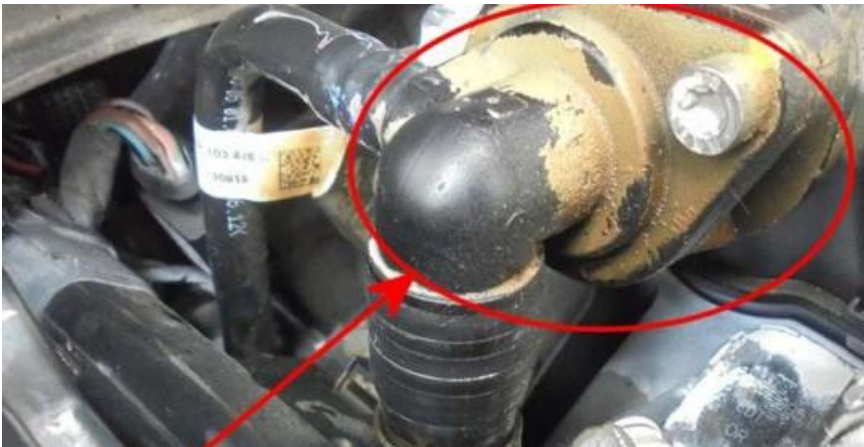
Figure 1

Oil leak between the oil separator tank and the Bank 1 breather line connection (Figure 1)

NOTE: Oil leak detection spray is evident within Figure 1, the use of detection spray in the example shown is used to highlight the location of the leak

1) Remove the right hand engine cover - Refer to Rep.Gr 10

2) Referring to Figure 2 - Replace the following parts and all associated parts as detailed within the applicable Rep.Gr and the ETKA parts catalogue
