UPDATE PRIOR TO SALE NOTICE

Global Service Action
Number: N845 UPS6023-3

Subject: Oil Cooler Pipe Joint Integrity Concern	Publication No.: N845 UPS6023-3
	Model: Range Rover (LK)
	Model Year: 2024
	Model: Range Rover Sport (L1)
	Model Year: 2024
	Date of Issue: 17 November 2023
	Expiry Date: 17 November 2024

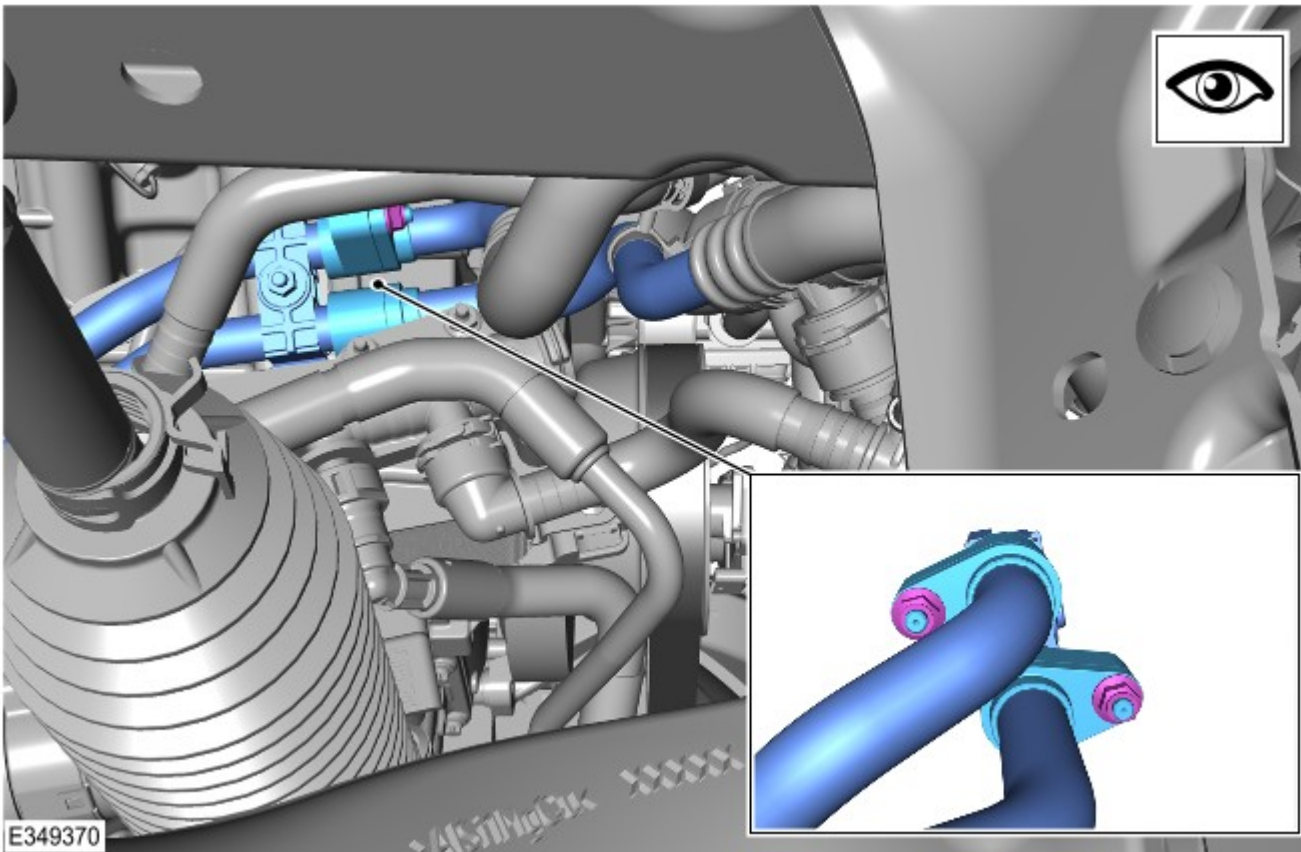
E349370

3. Locate both engine oil cooler pipe joints.

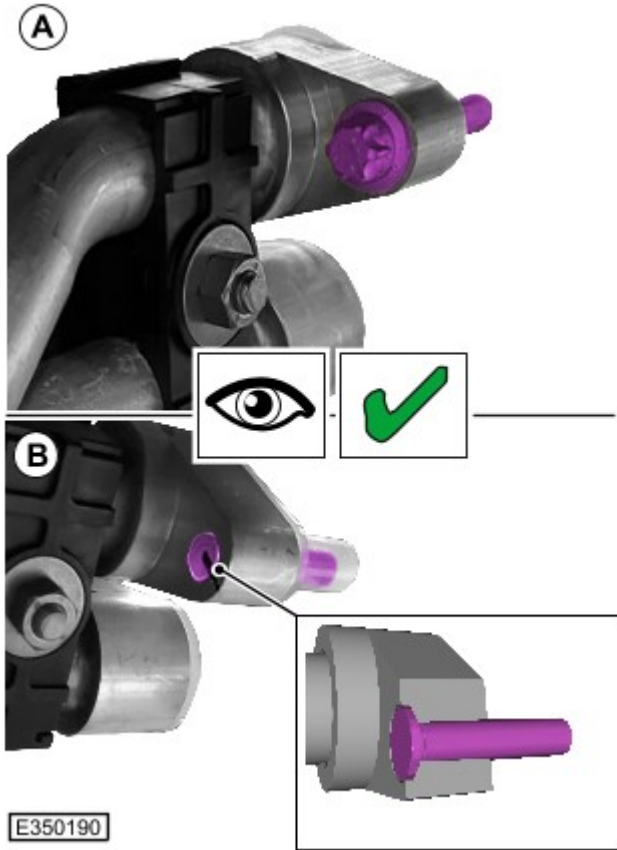
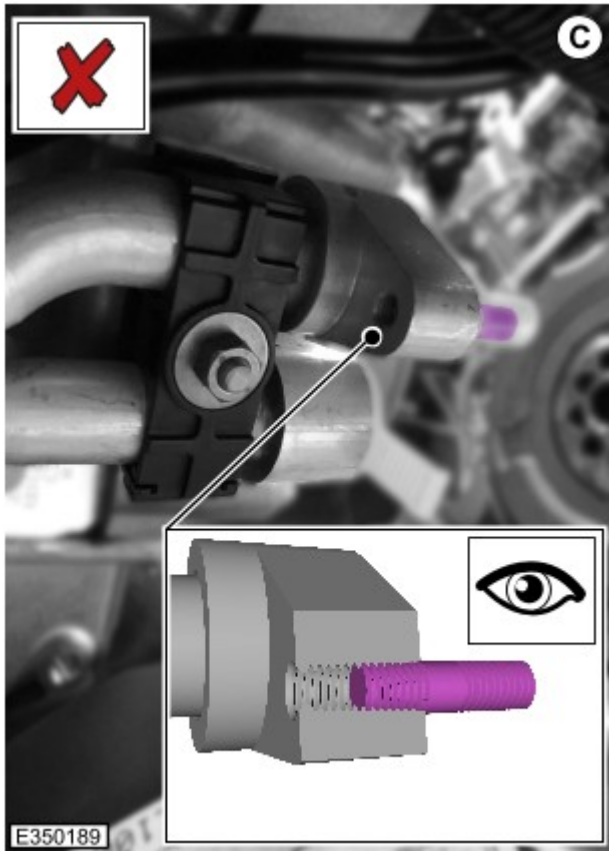
- The image labeled 'A' shows a reworked engine oil cooler pipe with a suitable bolt installed through the joint from the rear of the vehicle.
- The image labeled 'B' shows a new level engine oil cooler pipe with a suitable stud installed through the joint from the rear of the vehicle. The stud can be seen from the rear of the joint.
- The image labeled 'C' shows an previous level engine oil cooler pipe with a stud installed into the joint from the front of the vehicle. The stud cannot be seen from the rear of the joint.
- Use a suitable mirror to inspect the rear of both engine oil cooler pipe joints.

Inspect the fixings/studs on both engine oil cooler pipes.

- If **BOTH** engine oil cooler pipes **ARE** installed with **EITHER** the reworked fixing or the new level stud shown in the image 'A' and 'B' with a **GREEN '✓'**, the vehicle has **PASSED** the inspection. Reverse steps 1 to 3 and release the vehicle.
- If **1 or BOTH** engine oil cooler pipes **ARE** installed with a previous level stud as shown in the image 'C' with a **RED 'X'**, the vehicle has **FAILED** the inspection. Continue to the **SERVICE INSTRUCTION**. To renew the previous level studs that have failed the inspection.

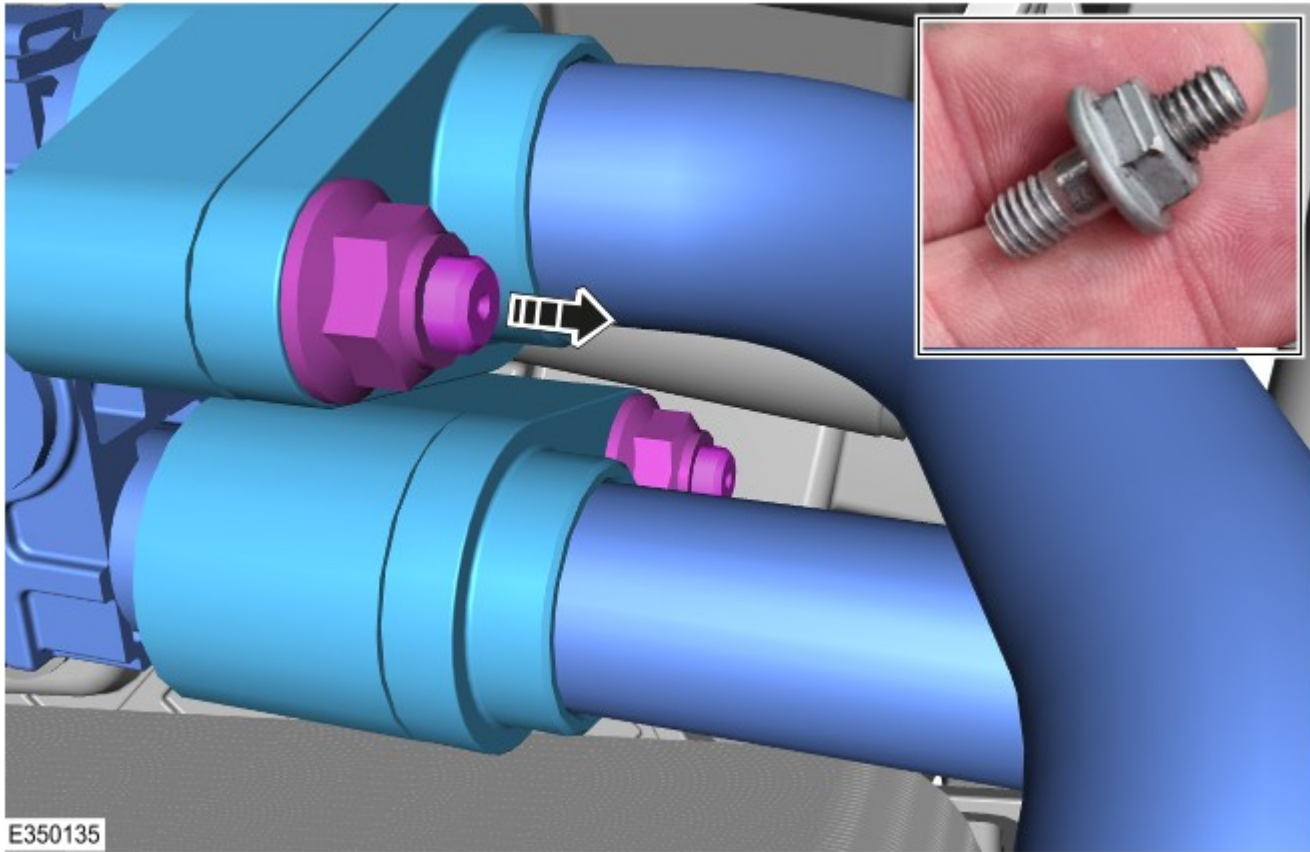
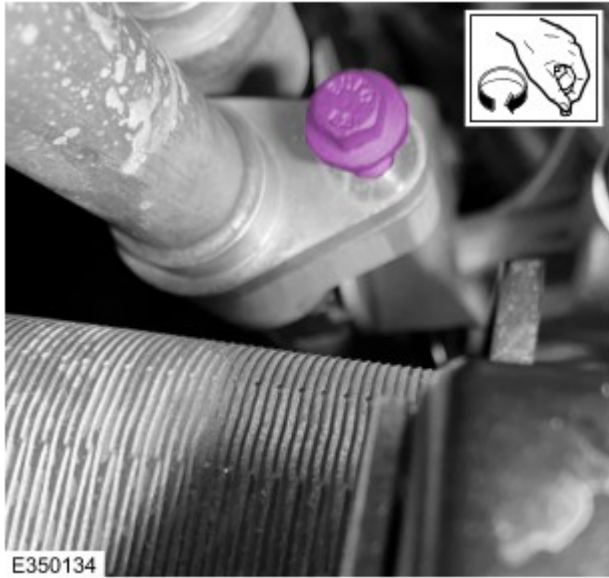
E350135

The stud should release from the engine oil cooler pipe during the removal of the nut.

Remove the nut/stud assembly.

- If a stud cannot be removed from an engine oil cooler pipe when removing the nut **OR** a stud snaps during removal, **DO NOT** continue with this SERVICE INSTRUCTION. Email JLRcamp@jaguarlandrover.com to confirm how many studs could not be removed. Use the campaign number **N845** and the full 17 digit [Vehicle Identification Number \(VIN\)](#) as the subject of the email.
 - Continue to hold the vehicle and wait for further instructions.
