**Cayenne E-Hybrid – Thermal Management Fault P26B100 Causes Check Engine Light**

**Vehicles Affected**

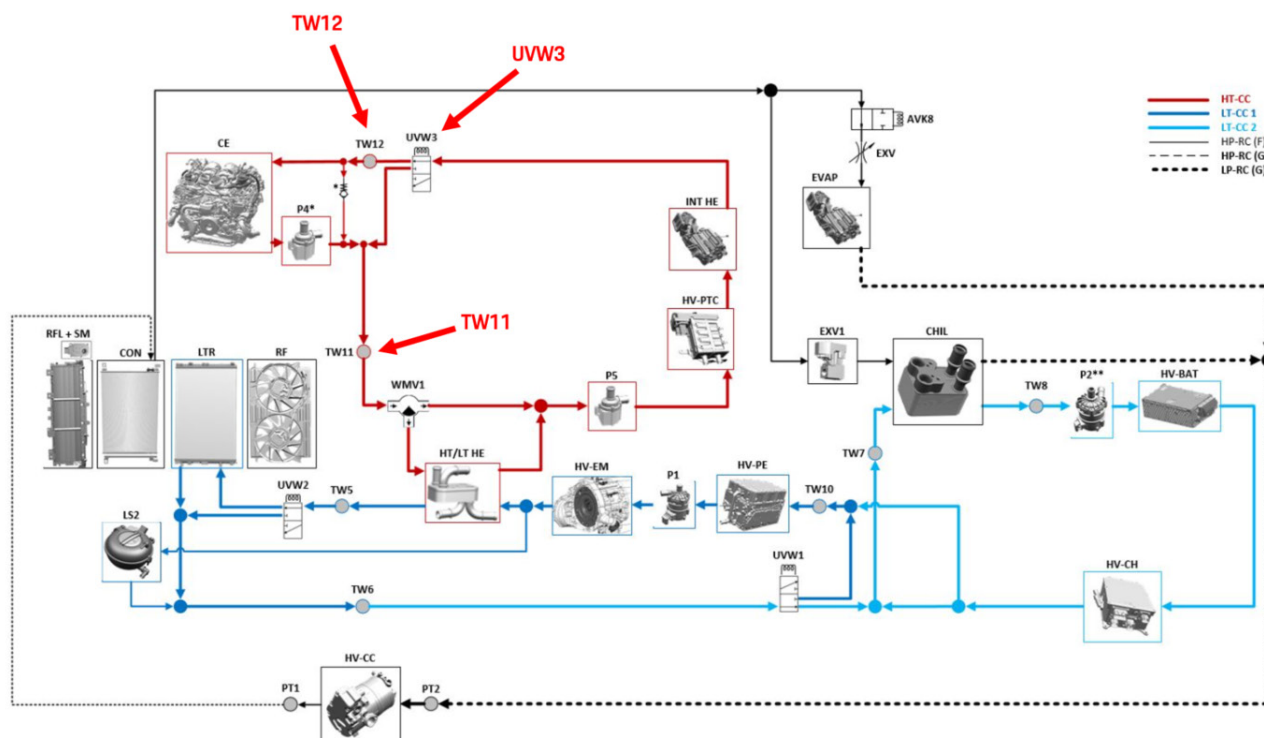
**Figure 1 - Cayenne E-Hybrid Cooling Circuits**

Valve UVW3 controls the direction of coolant flow based on engine temperature. The valve defaults to closed, such that the high-temp circuit excludes the engine coolant circuit. During this “small-circuit” operation, the HV PTC controls the temperature of the high-temp circuit to meet the heating and air conditioning demands of the customer. Once the engine reaches 40° C, the valve opens (“large-circuit” operation) and the high-temp circuit uses the engine heat instead of the HV PTC.

The status of UVW3 is diagnosed by the absolute value of the temperature difference between TW11 and TW12. The TME expects this difference to be **larger than 7° C while the valve is closed, but smaller than 7° C while the valve is open**. Certain operating conditions may cause the temperature difference to fall below 7° C while the valve is closed. If this condition exists while the TME is performing diagnostics, the valve will be diagnosed as open, although it is closed due to the engine temperature being less than 40° C.

1. Please create a VAL to document the occurrence of the fault.
2. Workshop Campaign WPRO has been launched for MY20-23 as of November 15, 2023. Please complete this Campaign per the instructions in TI 177/23, if applicable, before performing any other diagnosis work for the subject fault code.
3. If the fault persists after performing WPRO, please continue with other means of diagnosis.
