Symptom - Engine - Warning Message “Refill Coolant Immediately/ Stop Driving” in Instrument Cluster: Installing Components from Repair Kit (SY 62/18)

Model Year: **As of 2017 up to 2018**

Vehicle Type: **718 Boxster / 718 Cayman (982)**

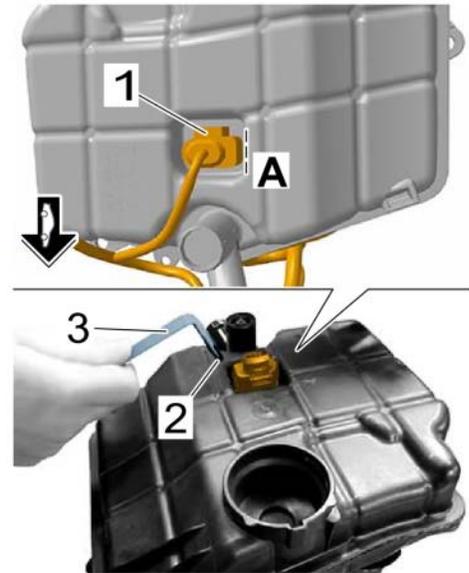
Retaining clip for electric plug connection

Cause: The connector between the vehicle wiring harness and coolant reservoir may not be connected correctly and, as a result, the electric plug connection on the coolant reservoir may not be locked correctly.

*Repair set*2 **Secure electric plug connection (⇒ *Retaining clip for electric plug connection -1-*):**

In the event of a complaint and if the plug connection is loose, the electric plug connection must be connected correctly and secured using the repair kit **(00004330676)**. The repair kit installs an additional retaining clip on the electric plug connection, to ensure the electric plug connection remains securely connected.

- 2.1 Check that the electric plug connection is installed correctly and push it on fully if necessary.
- 2.2 Place the retaining clip (⇒ *Retaining clip for electric plug connection -2-*) on the supplied assembly tool (⇒ *Retaining clip for electric plug connection -3-*).
- 2.3 Install the retaining clip between the flat side of the electric plug connection and the coolant reservoir (⇒ *Retaining clip for electric plug connection -A-*) and remove the assembly tool.
- 2.4 Check that the electric plug connection is installed securely.
