**WPQ8 – Reviewing Supply Fuel Line and Evap Purge Line and Reworking if Necessary
(Workshop Campaign)**

Model Line: **Cayenne (9YA / 9YB)**

Model Year: **2024**

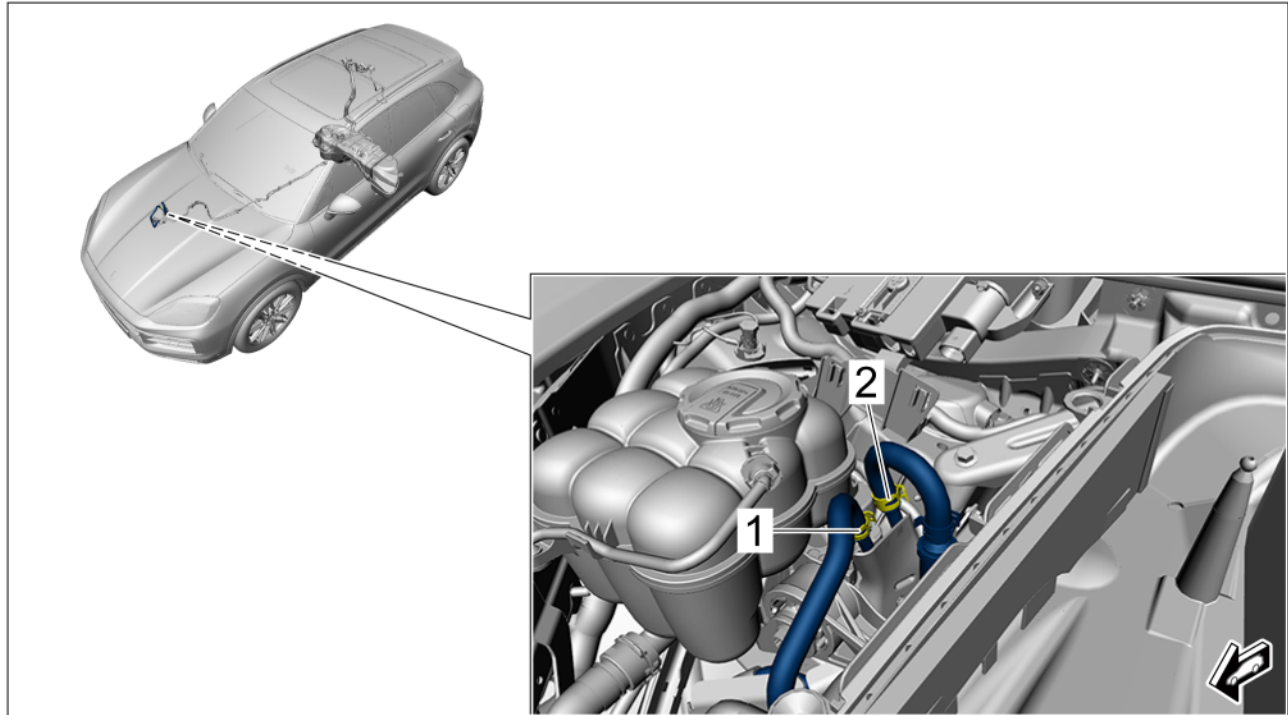
Installation position for supply and evap purge line

- 1 – Supply fuel line
- 2 – Evap Purge line

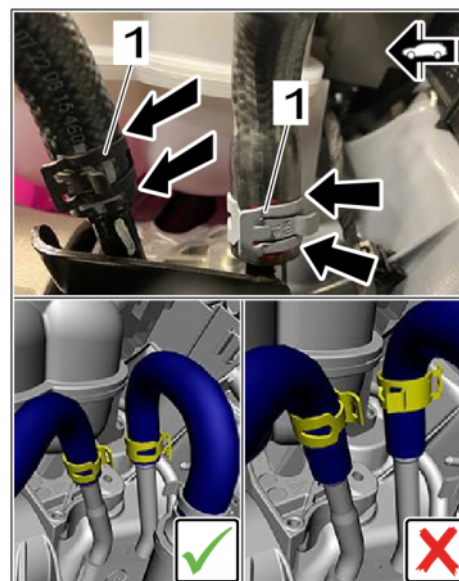
Checking supply and evap purge line

Work Procedure: 1 Check the supply and evap purge line as well as spring band clamps ⇒ *Checking supply and evap purge line -1-* for correct fit and alignment (marking) ⇒ *Checking supply and evap purge line -Arrows-*.

Assessment		Action
(✓)	Fuel line and spring band clamps on the supply and evap purge line are correctly secured.	End of action <ul style="list-style-type: none"> Continue with Follow-up actions. Invoicing for Scope 1.
(x)	Fuel line and/or spring band clamps on the supply and evap purge line are not correctly secured.	Continue with Rework supply and evap purge line . <ul style="list-style-type: none"> Invoicing for Scope 2.

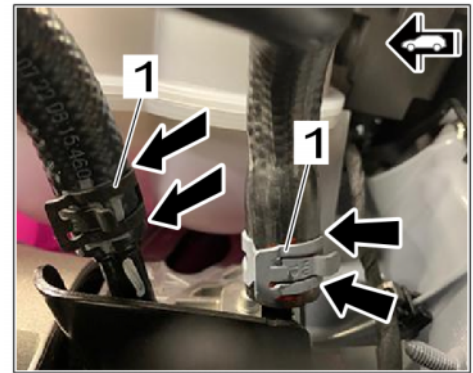
Reworking supply and evap purge line

The following procedure must be observed if the fuel line and / or spring band clamp are **not** correctly fastened to the inflow and / or evap purge line:

Work Procedure: 1 Secure supply and evap purge line correctly.

1.1 Ensure correct fit and alignment (marking) ⇒ *Reworking supply and evap purge line* -**Arrows**- of the fuel lines.

1.2 Align spring band clamps ⇒ *Reworking supply and evap purge line -1-* correctly (marking) ⇒ *Reworking supply and evap purge line -Arrows-* and secure fuel lines.
