TECHNICAL SERVICE BULLETIN

| Classification: EC17-031B | Reference: ITB17-050B | Date: November 6, 2023 |

MIL ON WITH DTC(S) STORED IN THE ECM

APPLIED VEHICLES: 2016-2018 Q50 (V37)
2017 Q60 (CV37)
APPLIED ENGINES: VR30DDTT

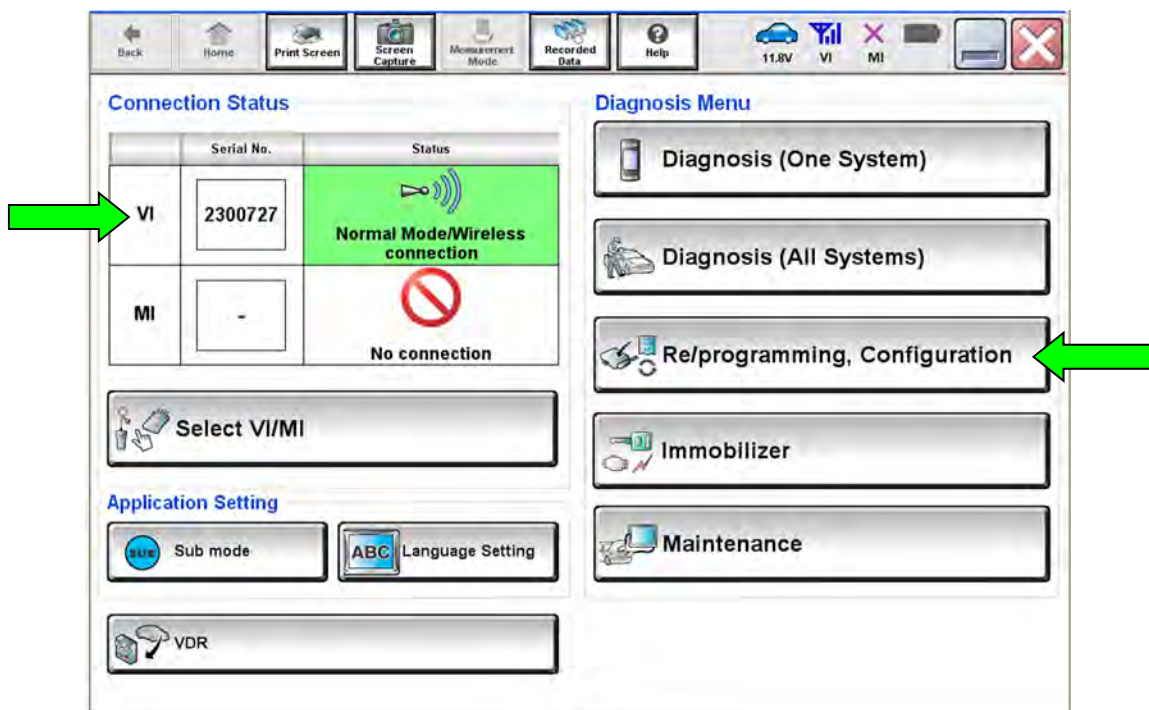
Figure 1

1. Connect the VI to the vehicle.
2. Start CONSULT.
3. Wait for the VI to be recognized.
 - The serial number will display when the VI is recognized (Figure 1).
4. Select **Re/programming, Configuration**.

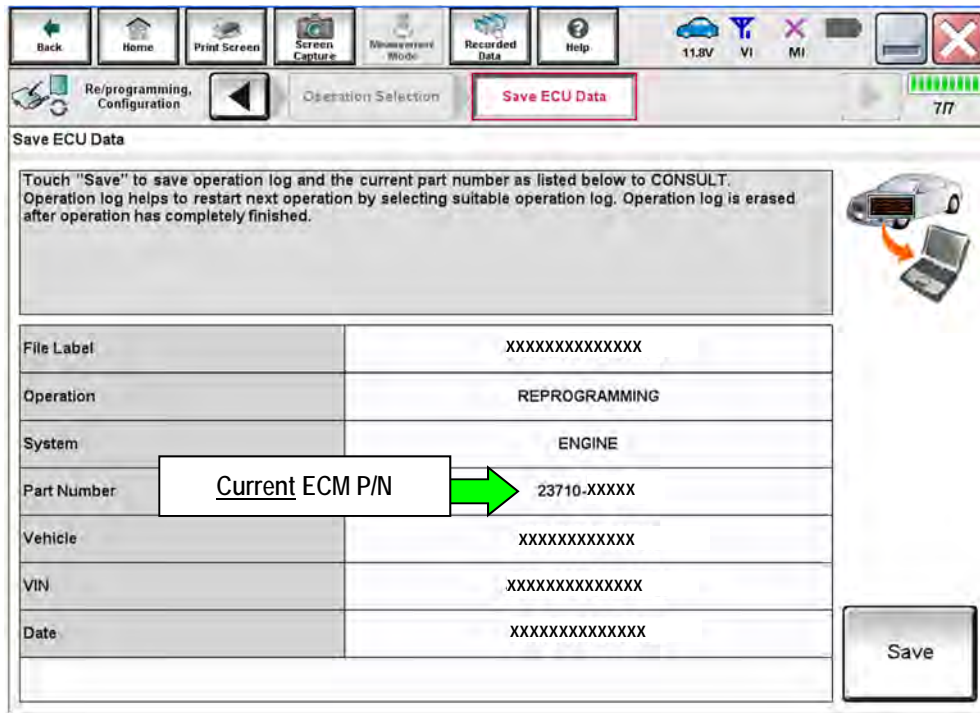
Figure 2

6. When you get to the screen shown in Figure 2, confirm that a reprogram is available as follows.
- a. Find the ECM **Part Number** and write it on the repair order.

HINT: This is the current ECM Part Number (P/N).

- b. Compare the P/N you wrote down to the numbers in the **CURRENT ECM PART NUMBER** column in **Table A**, beginning on the next page.
- If there is a match, this bulletin applies. Continue with the reprogramming procedure.
 - If there is not a match, this bulletin does not apply. Refer to ASIST for further diagnostic and repair information.

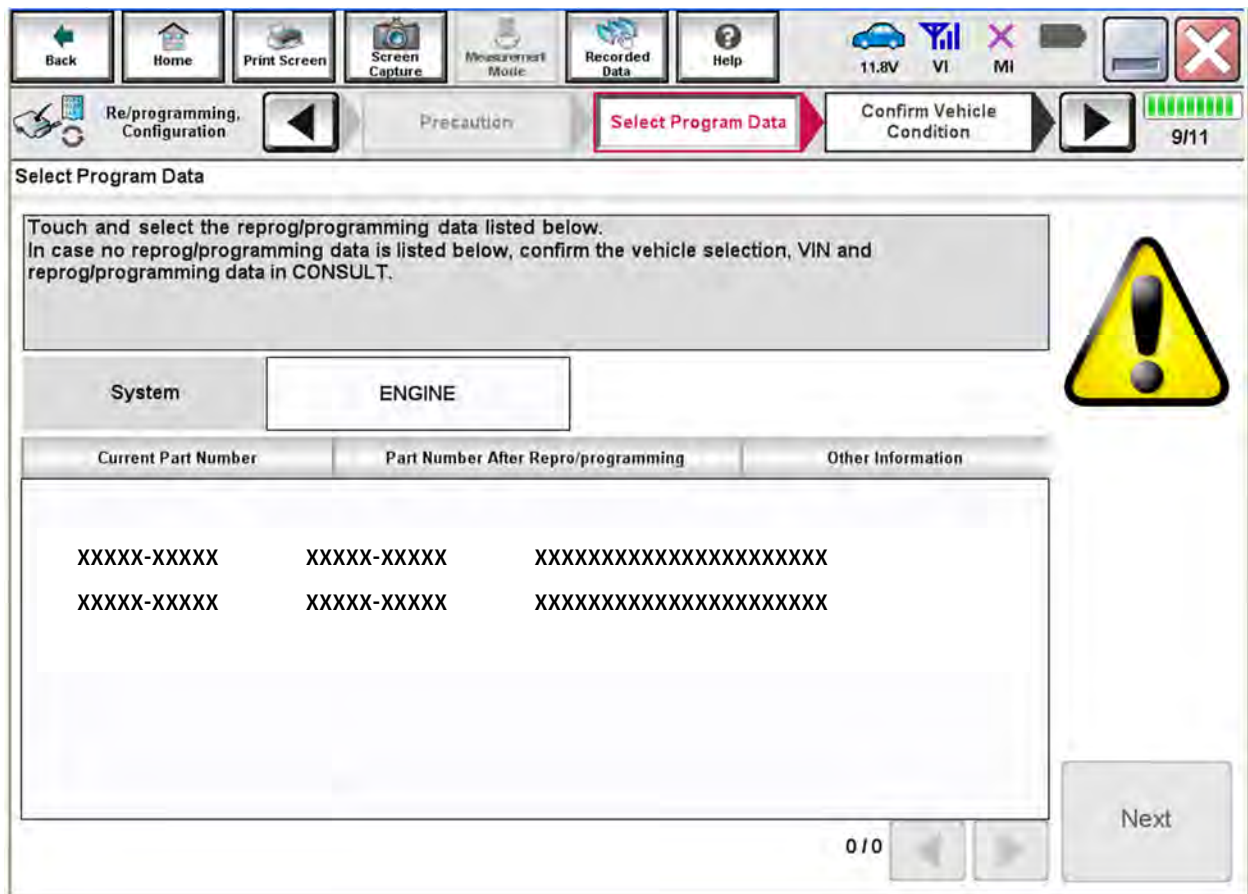
- In some cases, more than one new P/N for reprogramming is available.
 - In this case, the screen in Figure 3 displays.
 - Select and use the reprogramming option that **does not** have the message "Caution! Use ONLY with ITBXX-XXX".
 - If you get this screen and it is blank (no reprogramming listed), it means there is no reprogramming available for this vehicle. Close CONSULT and disconnect from the vehicle.

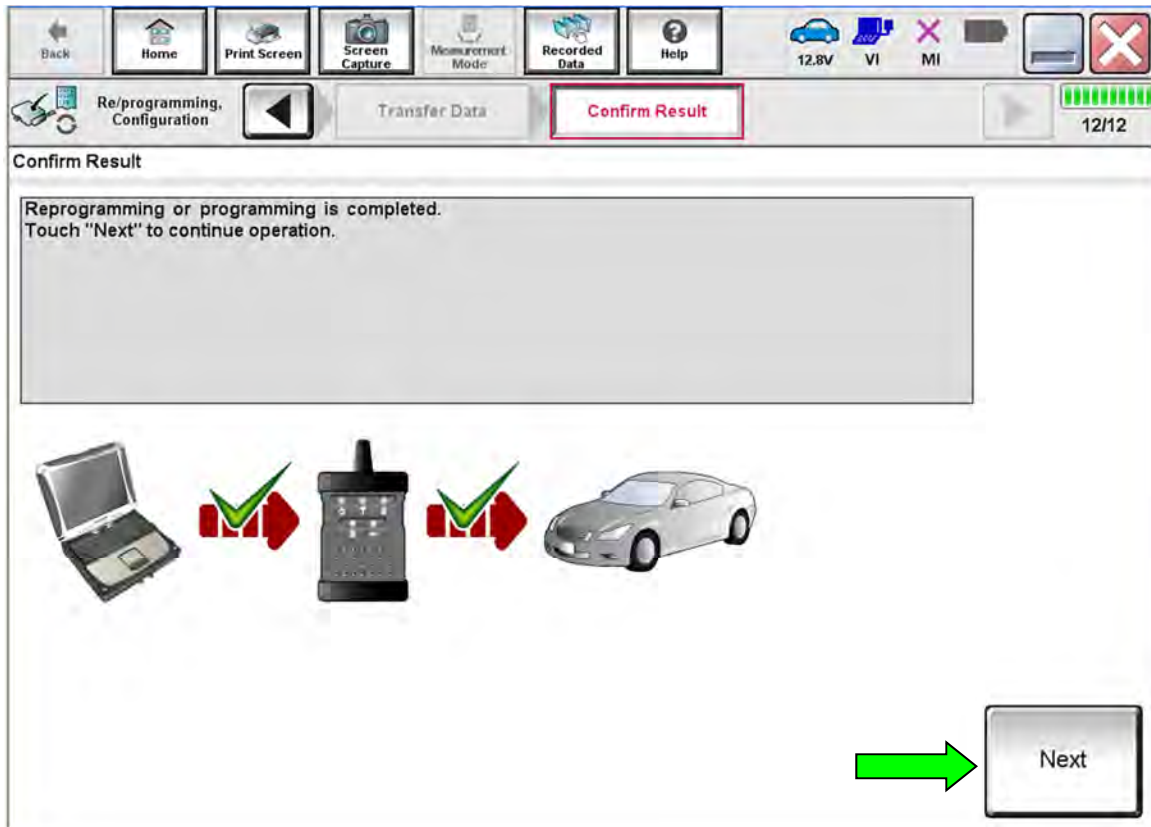
8. When the screen in Figure 4 displays, reprogramming is complete.

HINT: If the screen in Figure 4 does not display (reprogramming does not complete), refer to the information on the next page.

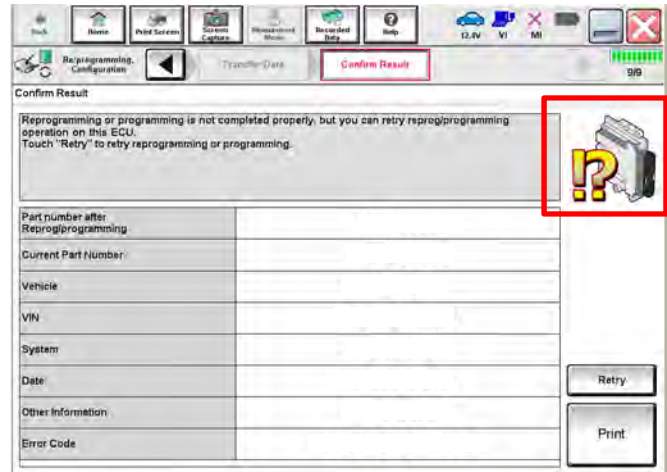
Figure 5

If reprogramming does not complete and the “!?” symbol displays, as shown in Figure 5:

- Check battery voltage (12.0 – 15.5V).
- Ignition is ON, engine is OFF.
- External Bluetooth® devices are OFF.
- All electrical loads are OFF.
- Select **Retry** and follow the on screen instructions.

HINT: Retry may not go through on first attempt and can be selected more than once.

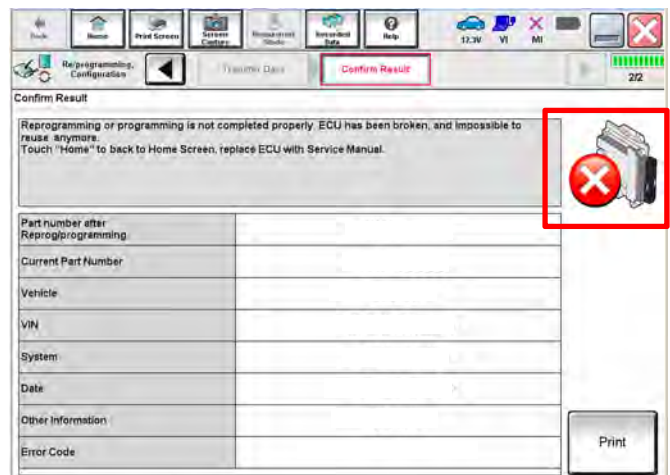
Figure 6

If reprogramming does not complete and the “X” symbol displays, as shown in Figure 6:

- Check battery voltage (12.0 – 15.5V).
- CONSULT A/C adapter is plugged in.
- Ignition is ON, Engine is OFF.
- Transmission in Park.
- All CONSULT / VI cables are securely connected.
- All CONSULT updates are installed.
- Select **Home**, and then restart the reprogram procedure from the beginning.

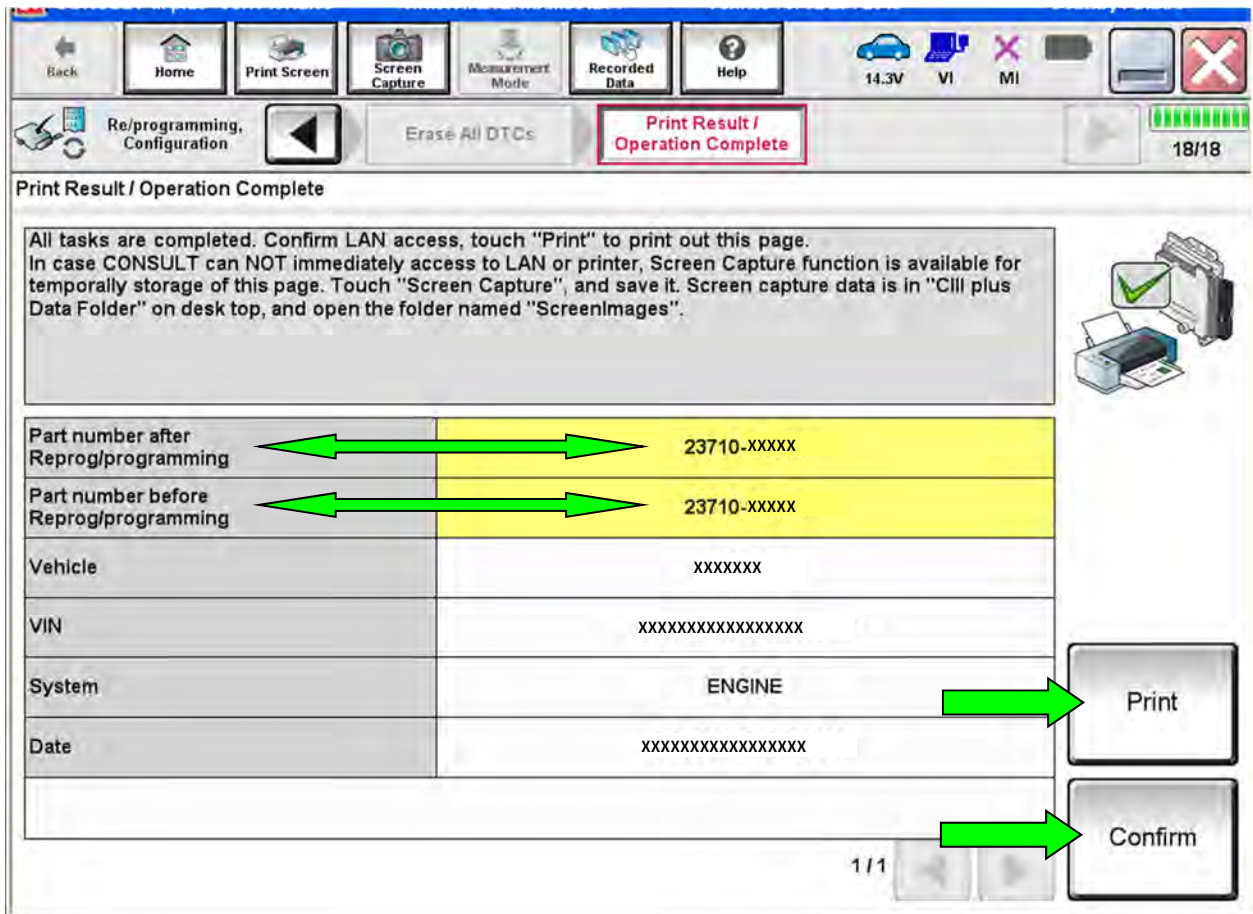
12. When the entire reprogramming process is complete, the screen in Figure 7 will display.
13. Verify the before and after part numbers are different.
14. Print a copy of this screen (Figure 7) and attach it to the repair order for warranty documentation.
15. Select **Confirm**.
