# Technical product information

<b>Topic</b>	New Flying Spur Hybrid - 12 volt battery draining during the charging of the high voltage battery
<b>Market area</b>	Australia E04 Bentley rest Asia and Australia (6E04),China 723 Volkswagen (Anhui) Automotive CO (6723),China 796 VW Import Comp. Ltd (Vico), Beijing (6796),Germany E02 Bentley rest Europe (6E02),United Arab Emirates E06 Bentley Middle East and Africa (6E06),United Kingdom E01 Bentley UK (6E01),United States E05 Bentley USA and rest America (6E05)
<b>Brand</b>	Bentley
<b>Transaction No.</b>	2068627/4
<b>Level</b>	EH
<b>Status</b>	Approval
<b>Release date</b>

The 12 volt battery is draining during the charging of the high voltage battery

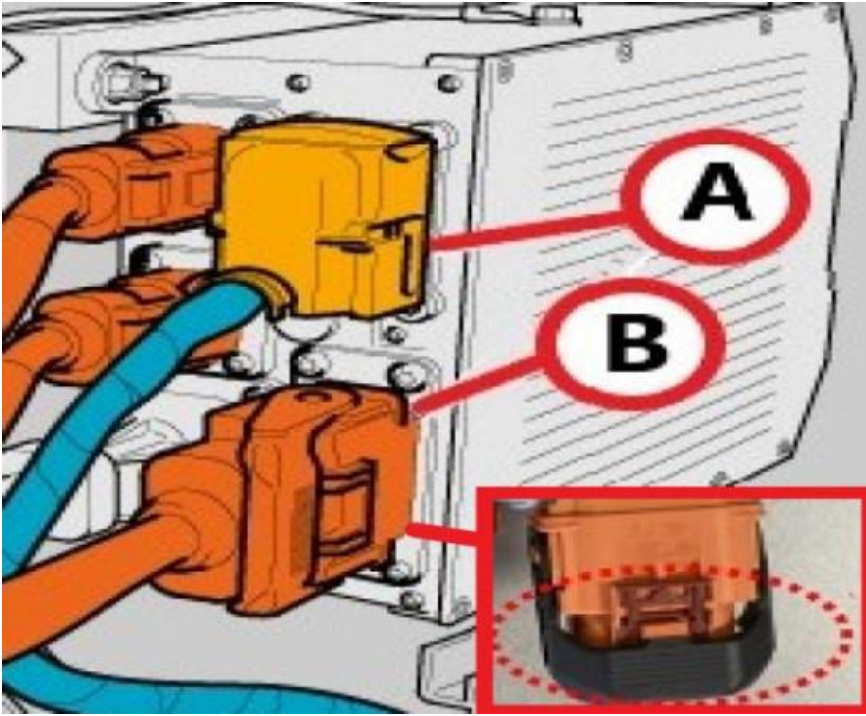
**IMPORTANT:** In the event that any of the plugs shown in Figures 1 and 2 are found not to be secure (primary and secondary latch are not fully locked into position) the operative must respond via the open DISS query and await feedback before conducting any further work

4) Referring to Figure 1 point A - Check and confirm the primary and secondary latches are fully locked in position

- Referring to point B and inset - Check and confirm the primary and secondary latches are fully locked in position
- Referring to the inset - Check and confirm the primary and secondary latches (red and black) are fully locked in position

Should any issues be found, the operative **MUST** respond via the open DISS query ensuring all findings are included within the DISS, the operative must await feedback before conducting any further work

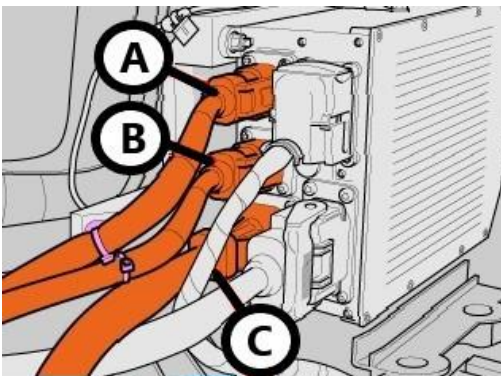
- Referring to Figure 2 (Points A,B and C) Check and confirm the primary and secondary latches are fully locked in position
