Little or No Cooling Power from the Air-Conditioning System: Checking Refrigerant Lines on Air-Conditioning Compressor (174/23)

Model Line: **Panamera (971)**
Cayenne (9YA / 9YB)

Model Year: **As of 2019 up to 2024**

Concerns: **Air-conditioning compressor**

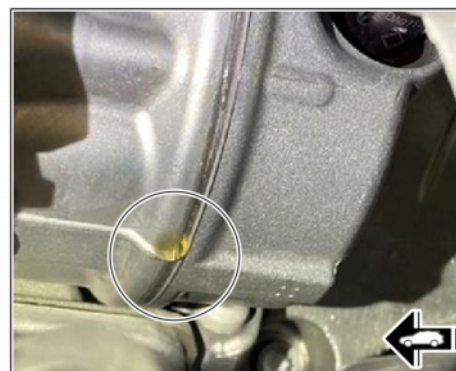
Information: **Customers complain that the air-conditioning system cooling performance is too low. Drop formation of refrigerant compressor oil is detected at the low point of the air-conditioning compressor housing. ⇒ Drop formation on air-conditioning compressor**

Drop formation on air-conditioning compressor

Cause: Insufficient sealing of the refrigerant lines on the air-conditioning compressor can lead to a leak in the air-conditioning system.

Action: If there is a complaint, check the respective O-ring of the affected refrigerant line and replace it if necessary.

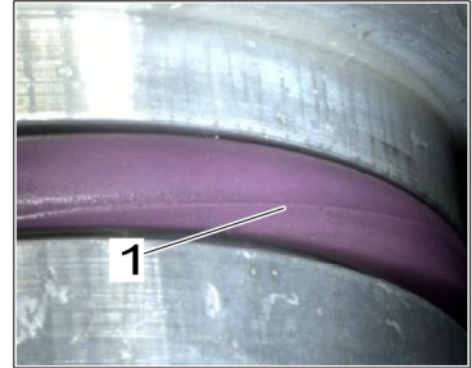
This leak can be caused by a twisted O-ring \Rightarrow *Twisted O-ring* installed in conjunction with the design-related burr on the O-ring \Rightarrow *Twisted O-ring -1-* or by a damaged O-ring on the refrigerant line.

As a result, refrigerant compressor oil can leak and collect at the flange of the refrigerant line and at the lowest point of the air-conditioning compressor.

Twisted O-ring

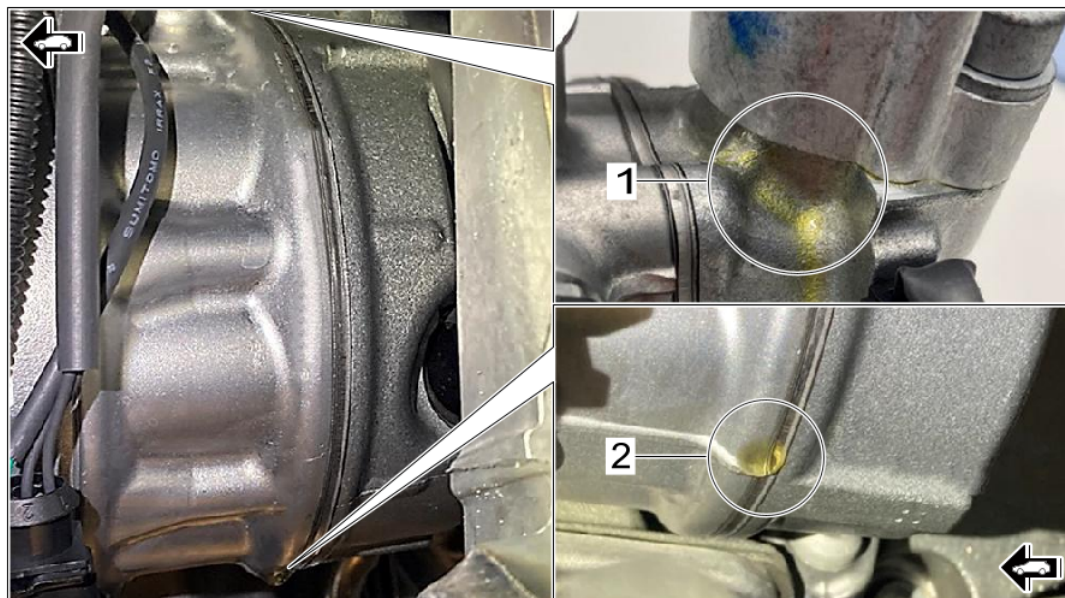
Oil loss on air-conditioning compressor

Assessment	Action
(✓)	<p>No refrigerant compressor oil loss can be detected on flange ⇒ <i>Oil loss on air-conditioning compressor -1-</i> or air-conditioning compressor ⇒ <i>Oil loss on air-conditioning compressor -2-</i>.</p>	<p>Locate the complaint elsewhere. End of test. Continue with: ⇒ <i>Technical Information '505619 Follow-up actions'</i></p>

(x)	<p>Refrigerant compressor oil loss can be detected on flange ⇒ <i>Oil loss on air-conditioning compressor -1-</i> or air-conditioning compressor ⇒ <i>Oil loss on air-conditioning compressor -2-</i>. ⇒ <i>Flange refrigerant line leak</i></p> <div data-bbox="446 1518 902 1885" style="text-align: center;"> </div> <p style="text-align: center;"><i>Flange refrigerant line leak</i></p>	<p>Replace the O-ring of the affected refrigerant line. Continue with: ⇒ <i>Technical Information '505619 Replacing O-ring refrigerant line on air-conditioning compressor'</i></p>

- Work Procedure: 1 Replace the O-ring of the affected refrigerant line on the air-conditioning compressor.
 For procedure, see:
 ⇒ *Workshop Manual '874319 Removing and installing refrigerant line between compressor and condenser'*
 ⇒ *Workshop Manual '874519 Removing and installing compressor/evaporator line (section from air-conditioning compressor to internal heat exchanger)'*
