Service Bulletin

Bulletin No.: 19-NA-256

Subject: Diagnostic Tips for Knocking, Rattle, Squeak and/or Squeal Type Noise from Engine – Engine Replacement Recommendations for HFV6 Gen 1 and Gen 2

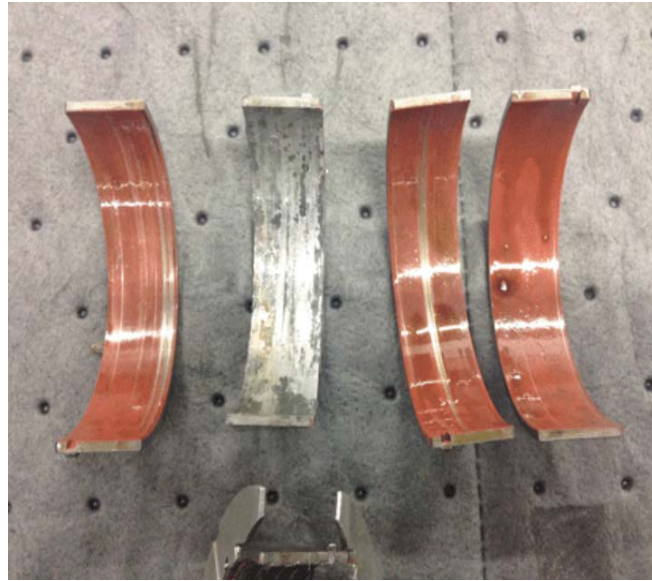
3961446

1. Verify there is metal in the engine oil by removing the oil pan.
2. Remove the main or rod bearing caps:
 - If the main and/or rod bearing are not the cause of the debris, refer to SI for further diagnostics.

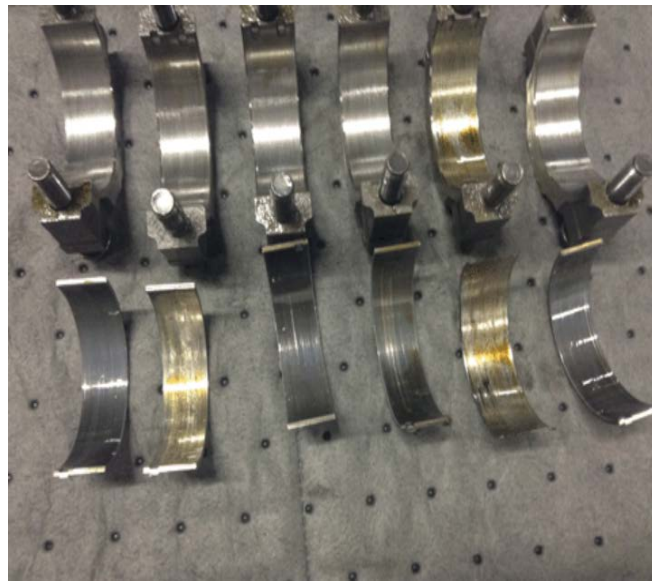
3961447

- If the main and/or rod bearings are found to be the cause of the debris, before deciding whether to replace the engine or repair it, refer to the Service Procedure below before making that determination.

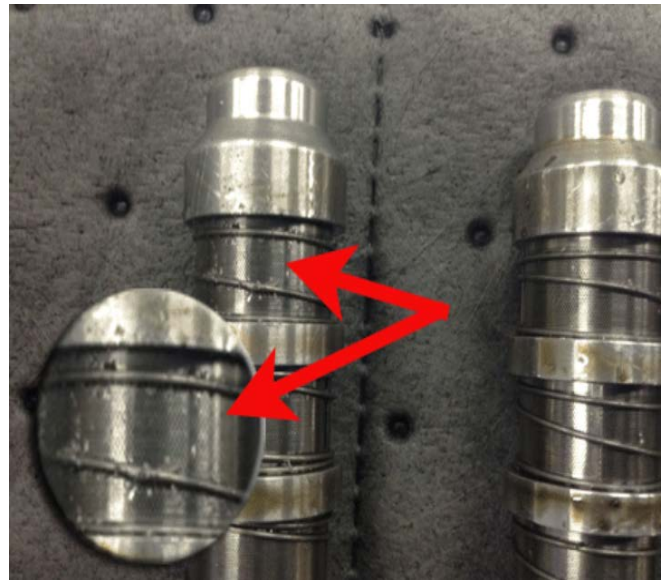
3961450

1. Inspect the oil control solenoids for metal debris. This shows the oil filter is in by-pass and unfiltered oil with bearing debris was pumped into the oil lubrication galleys, throughout the engine.

Any of the above 3 instances would be cause to replace the engine instead of repair.

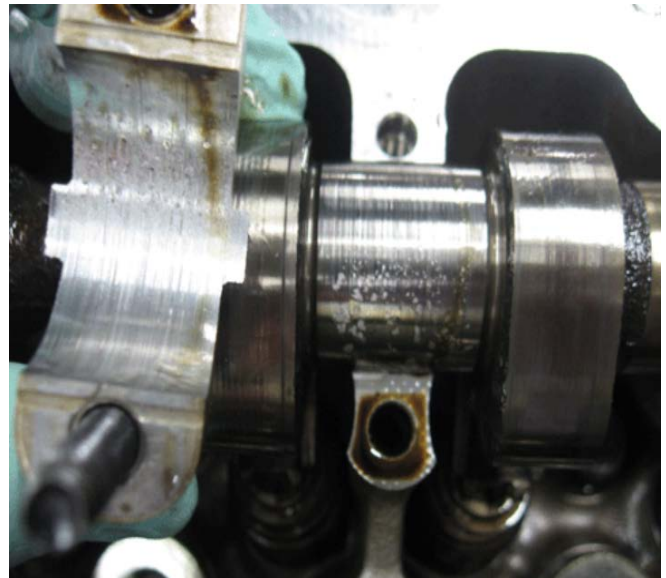
3966789

2. Inspect for damage to the cam caps journals and camshaft journals on the heads (obvious signs of metal through the cap).

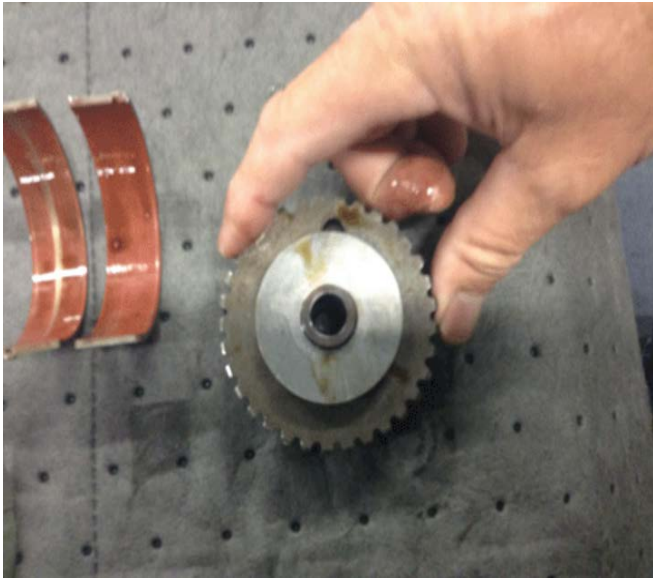
3961451

3. Inspect the timing chain idler sprockets for stiffness when turning (Should turn smooth and free).
