Recall Bulletin

PRODUCT SAFETY RECALL

SUBJECT: Front Passenger Air Bag Inflator

MODELS: 2003-2004 Pontiac Vibe

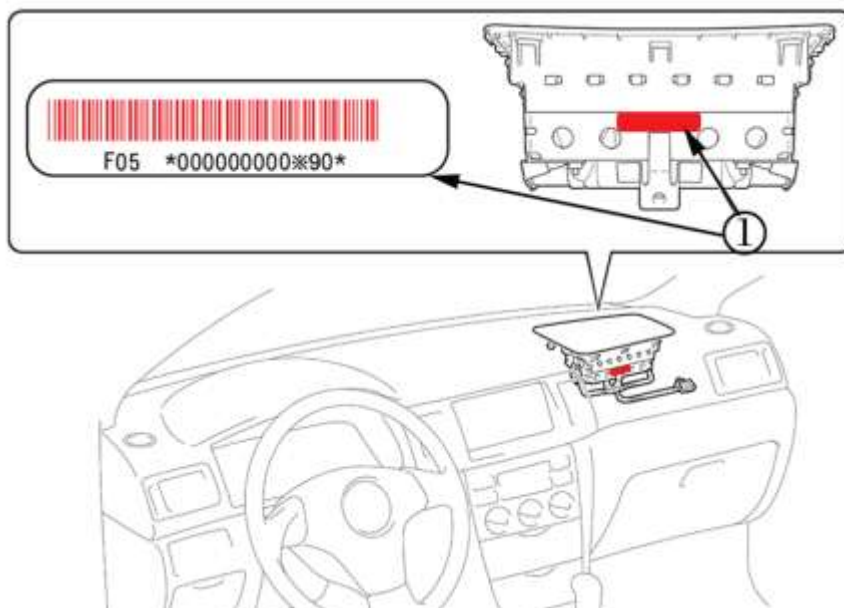
7. Locate passenger air bag barcode label (1). Refer to illustration.

8. Determine if an 'X' is present on the barcode label. The 'X', if present, will be located in the lower right-hand corner of the bar code label.
 - If an 'X' is NOT present, proceed to step 9.
 - If an 'X' is present, the air bag module has already been repaired. Re-install the air bag module. Refer to *Air bag Instrument Panel Module Replacement* in SI. Proceed to step 25.

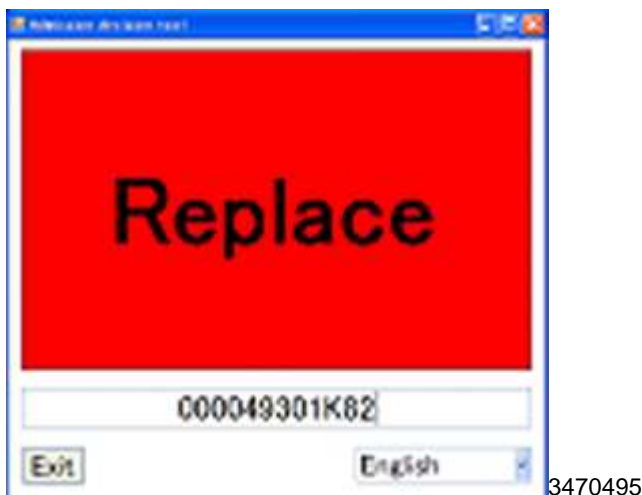
- If the scan tool result screen indicates the passenger air bag inflator requires replacement, proceed to *Safety Precautions and Passenger Air bag Inflator Module Replacement* in this bulletin.

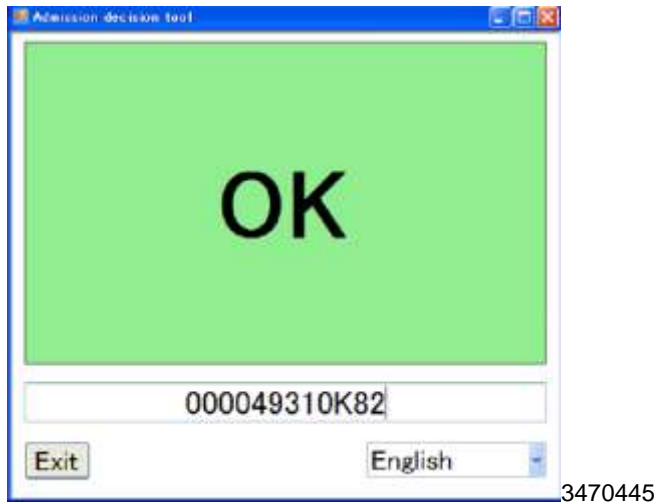
- If the scan tool result screen indicates the passenger air bag inflator does NOT require replacement, re-install the air bag module and install the instrument panel (I/P) compartment. Refer to *Instrument Panel Compartment Replacement* in SI. No further action is required.

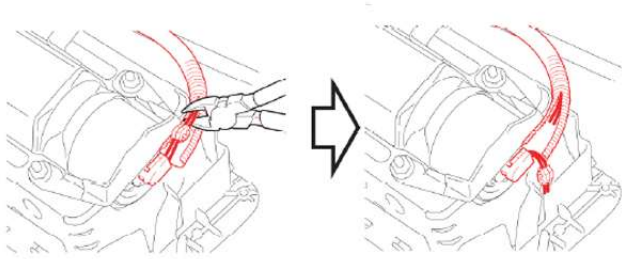
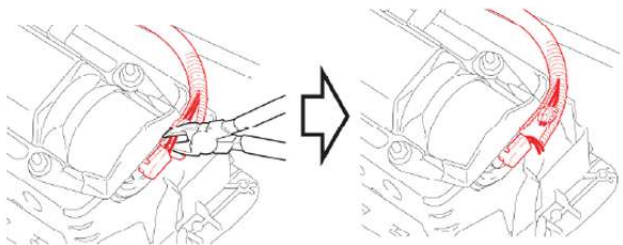
OK: Cut wires at opposite side to inflator. NG: Do NOT cut at inflator side.

Caution: Ensure to cut the two wires at the correct location. Refer to the illustration.

8. Cut the two wires at the side of the electro tap opposite to the inflator (the side of the electro tap that is farthest away from the inflator).
