19-23-01 - Service Information, ID.4 Coolant Hose Improper Assembly

Release date: 12/4/2023

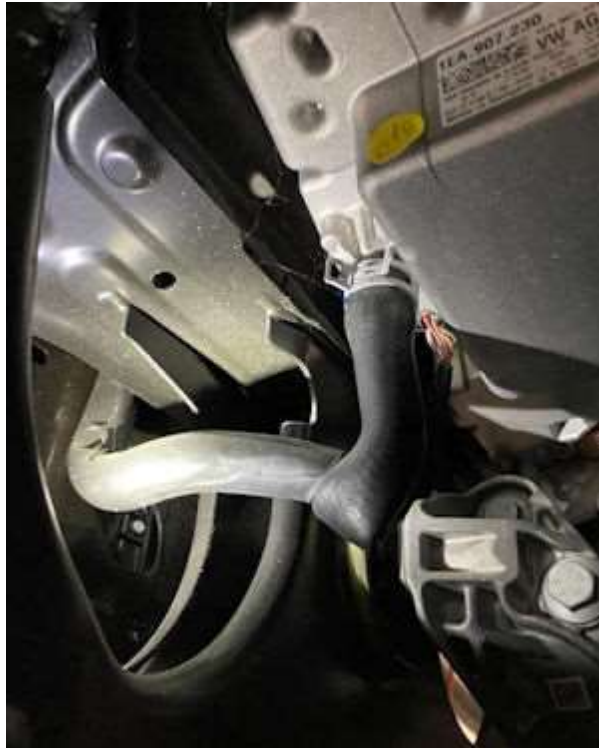
Field cases have been identified with coolant hoses twisted, kinked, and/or misrouted in various locations. This condition can lead to restricted or incorrect coolant flow, reduced power, and electrical system error messages.

Figure 1. Hose twisted at rear power electronics.

If a coolant hose is identified with a concern, then no parts replacement is necessary. Repair the identified concern, clear all relevant DTCs, and retest the vehicle.

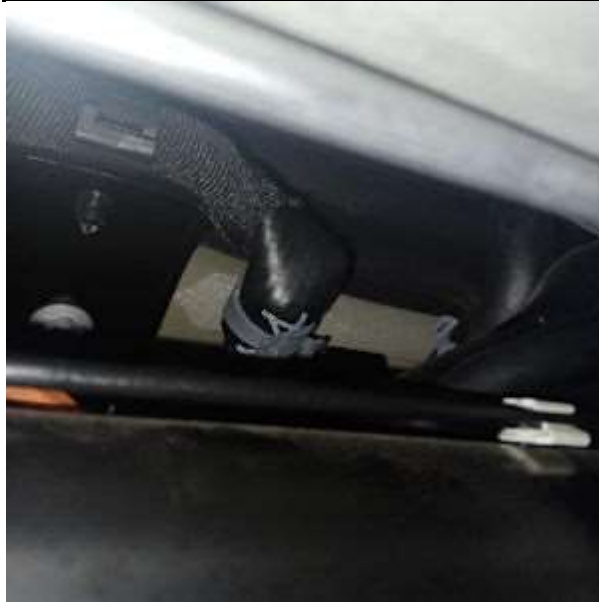
Figure 2. Hose twisted at rear power electronics.

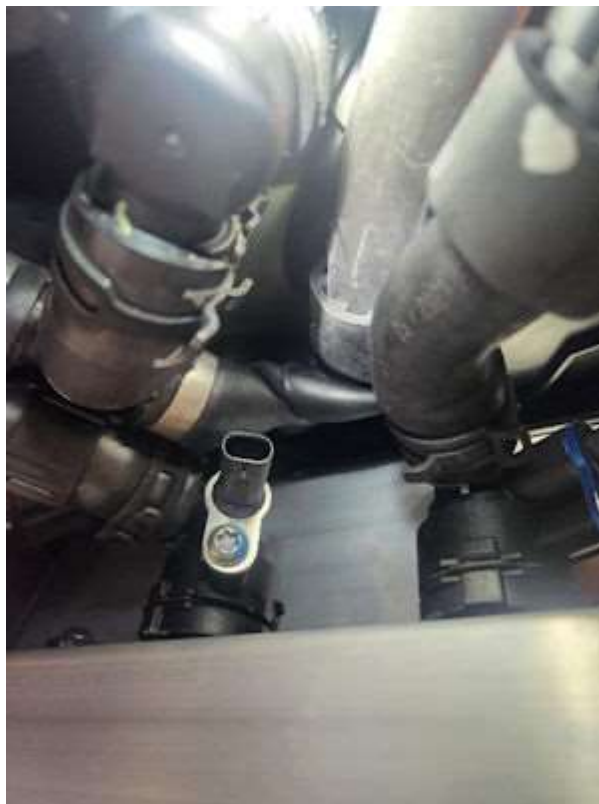
Figure 3. Hose twisted at front of high-voltage battery.

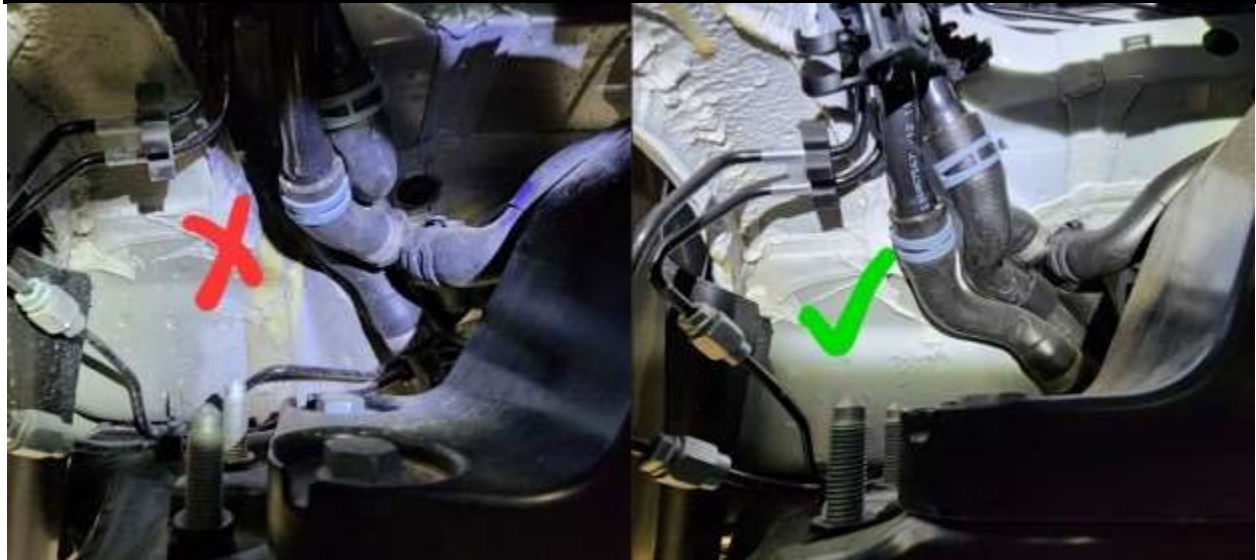
Figure 4. Hoses misrouted in right-front frame.
