Technical Service Bulletin

19 loss of coolant from coolant pump - V6 TFSI

19 23 46 2070349/3 December 12, 2023. Supersedes Technical Service Bulletin Group 19 number 23-45 dated November 1, 2023 for reasons listed below.

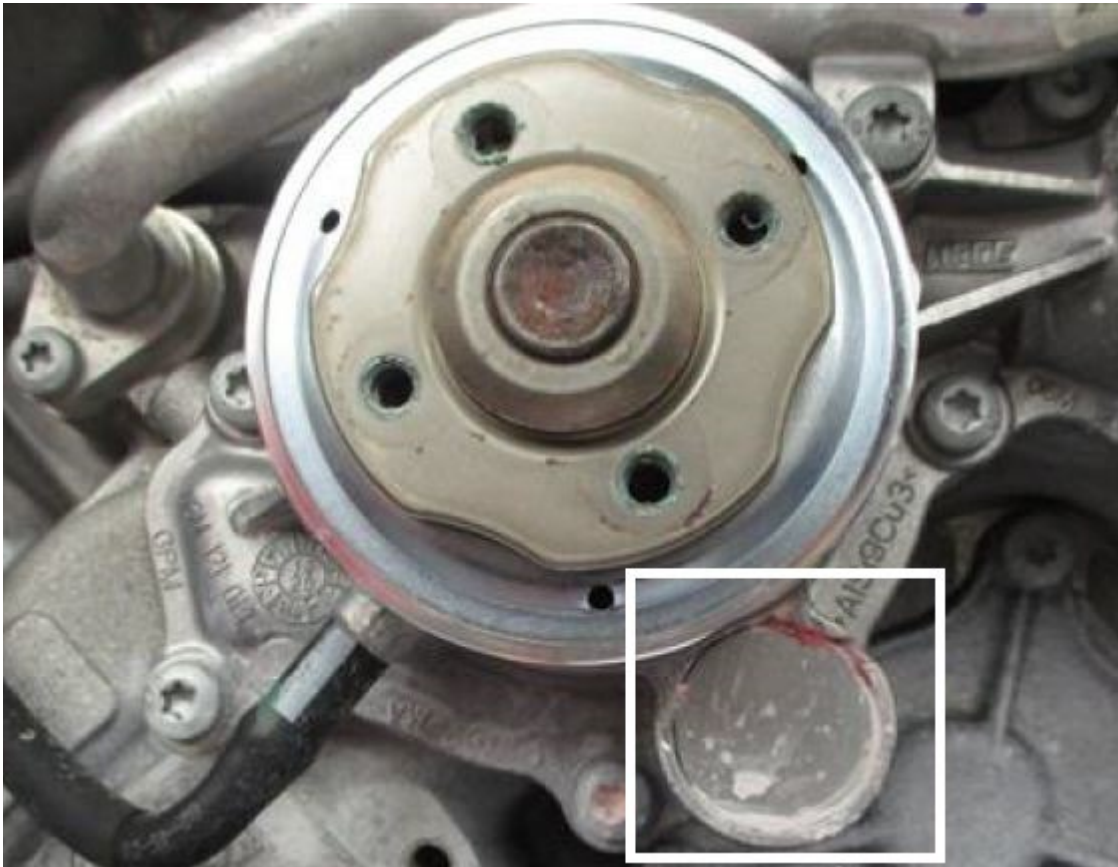
Traces of coolant (small quantity) on drip cup (refer to figure 1).

Due to lubrication/cooling of the seal, up to 3 ml may escape over the course of 100 hours of operation. This is quite normal and does not constitute a reason for a complaint.

Figure 1: Traces of coolant on the drip cup.
