# Recall Bulletin

## PRODUCT SAFETY RECALL

**SUBJECT:** Replace Ignition Lock Cylinder and Ignition Key

**MODELS:** 2005-2010 Chevrolet Cobalt  
2006-2011 Chevrolet HHR  
2006-2010 Pontiac Solstice  
2005-2006 Pontiac Pursuit (Canada Only)  
2007-2010 Pontiac G5  
2003-2007 Saturn Ion  
2007-2010 Saturn Sky

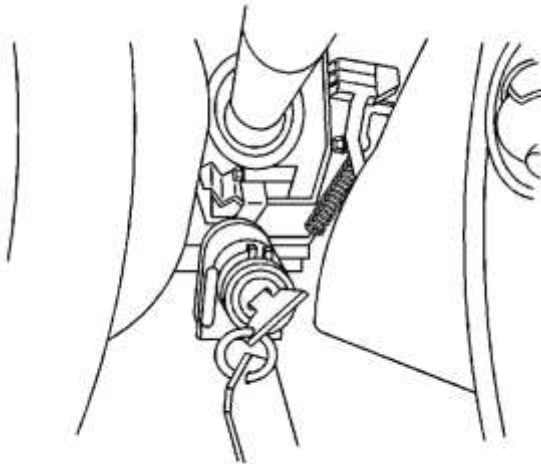
874786

General Motors has decided that a defect which relates to motor vehicle safety exists in all 2005-2010 model year (MY) Chevrolet Cobalt, 2006-2011 MY Chevrolet HHR, 2007-2010 MY Pontiac G5, 2006-2010 MY Pontiac Solstice, 2003-2007 MY Saturn Ion, and 2007-2010 MY Saturn Sky vehicles. Some of these vehicles may have a condition in which the ignition key may be removed when the ignition is not in the "Off" position. If the ignition key is removed when the ignition is not in the "Off" position, unintended vehicle motion may occur: (a) for an automatic transmission, if the transmission is not in "Park"; or (b) for a manual transmission, if the parking brake is not engaged and the transmission is not in reverse gear. This could result in a vehicle crash and occupant or pedestrian injuries.

1. Remove the ignition lock cylinder. Refer to *Ignition Lock Cylinder Replacement* in SI.

**Note:** For ignition lock cylinder assembly and coding, use the instructions provided with the new cylinder. Refer to Corporate Bulletin 10-00-89-009B (USA) or 10-00-89-010 (Canada) for key code security guidelines and key code access information. GMODC locations should contact their local TAC. To properly seat the new ignition lock cylinder into the housing, the key must be inserted and turned to the RUN position.

2. Install a new ignition lock cylinder. Refer to *Ignition Lock Cylinder Replacement* in SI.
