Recall Bulletin

PRODUCT SAFETY RECALL

SUBJECT: Replace Ignition Lock Cylinder and Ignition Key

MODELS: 2005-2010 Chevrolet Cobalt
2006-2011 Chevrolet HHR
2006-2010 Pontiac Solstice
2005-2006 Pontiac Pursuit (Canada Only)
2007-2010 Pontiac G5
2003-2007 Saturn Ion
2007-2010 Saturn Sky

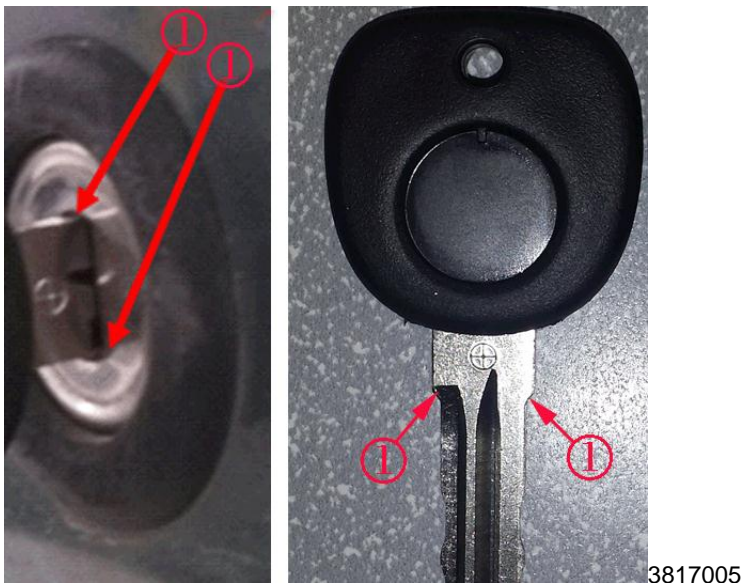
Note: Without the modification, the key stops on the shoulder and will not fully enter the key lock cylinder. Refer to the photograph.
