Recall Bulletin

PRODUCT SAFETY RECALL

SUBJECT: Replace Ignition Key

MODELS: 2005-2010 Chevrolet Cobalt
2006-2011 Chevrolet HHR
2006-2010 Pontiac Solstice
2005-2006 Pontiac Pursuit (Canada Only)
2007-2010 Pontiac G5
2003-2007 Saturn Ion
2007-2010 Saturn Sky

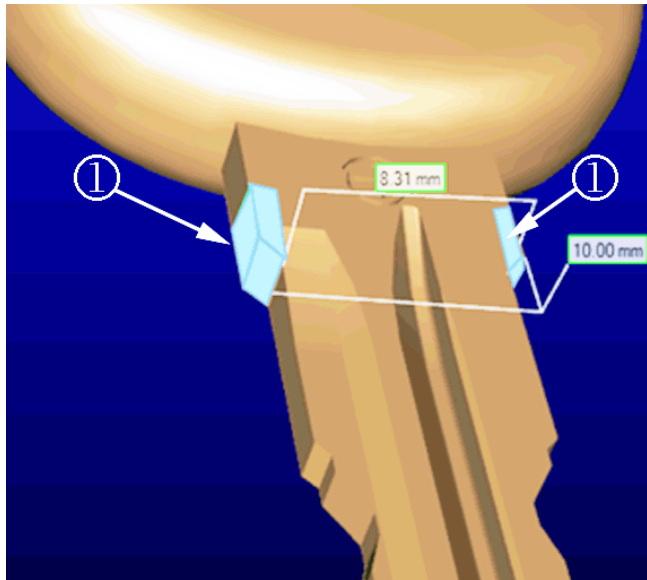
3816569

For the Saturn Ion only, if the replacement key profile is wider near the key head than the original equipment manufacturer (OEM) key, it may only work in the ignition lock cylinder and not in the doors or trunk. The replacement key may require modification BEFORE it can be used to open a vehicle door or trunk. Perform the *Key Modification* procedure in this bulletin if the replacement key will not open the doors or trunk of the vehicle.

1. Using a file, remove the extra width of key near the over molded head as shown in blue (1) in the photograph above. Removing this material makes the width of the key 8.3mm (same as the OEM key) rather than 10mm. This will allow the key to enter fully into the door and trunk lock cylinders.

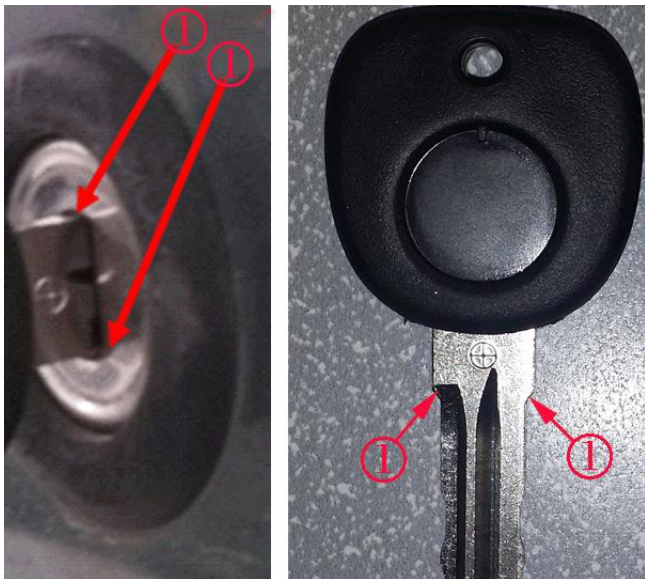
3817005

Note: Without the modification, the key stops on the shoulder and will not fully enter the key lock cylinder. Refer to the photograph.

2. Verify key function in the ignition cylinder as well as all door and trunk lock cylinders prior to delivery to the customer.
